# Ocean House Anchor (Cocos Keeling Islands) Inspection Report

## **The Oceania House Anchor**

### **An historic relic: pointer to a recently-located shipwreck in the Cocos Islands**

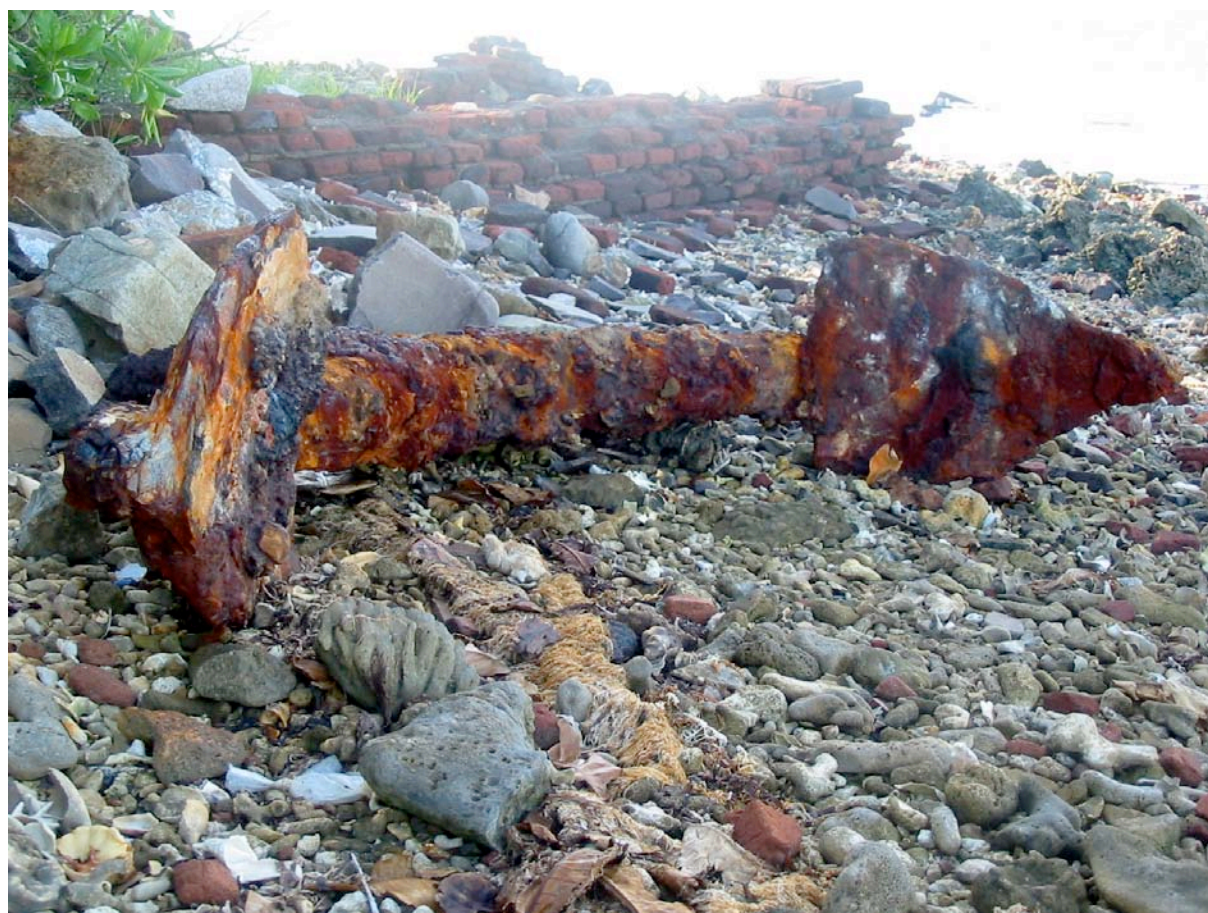
In December 2004, a portion of an early ship's anchor was seen adjacent the old boat ramp on the beachfront at Oceania House on Home Island in the Cocos (Keeling) Island group. The iron shank and the stock (which from the design was clearly a wooden one) were missing, indicating that they had been either lost in a mooring accident, in the salvage of this relic or in a wrecking process. Either way, the anchor appears to have been recovered from the sea in recent years.

*The anchor with outbuildings of Oceania House in the background*  
(R. Thorn, Parks Australia)

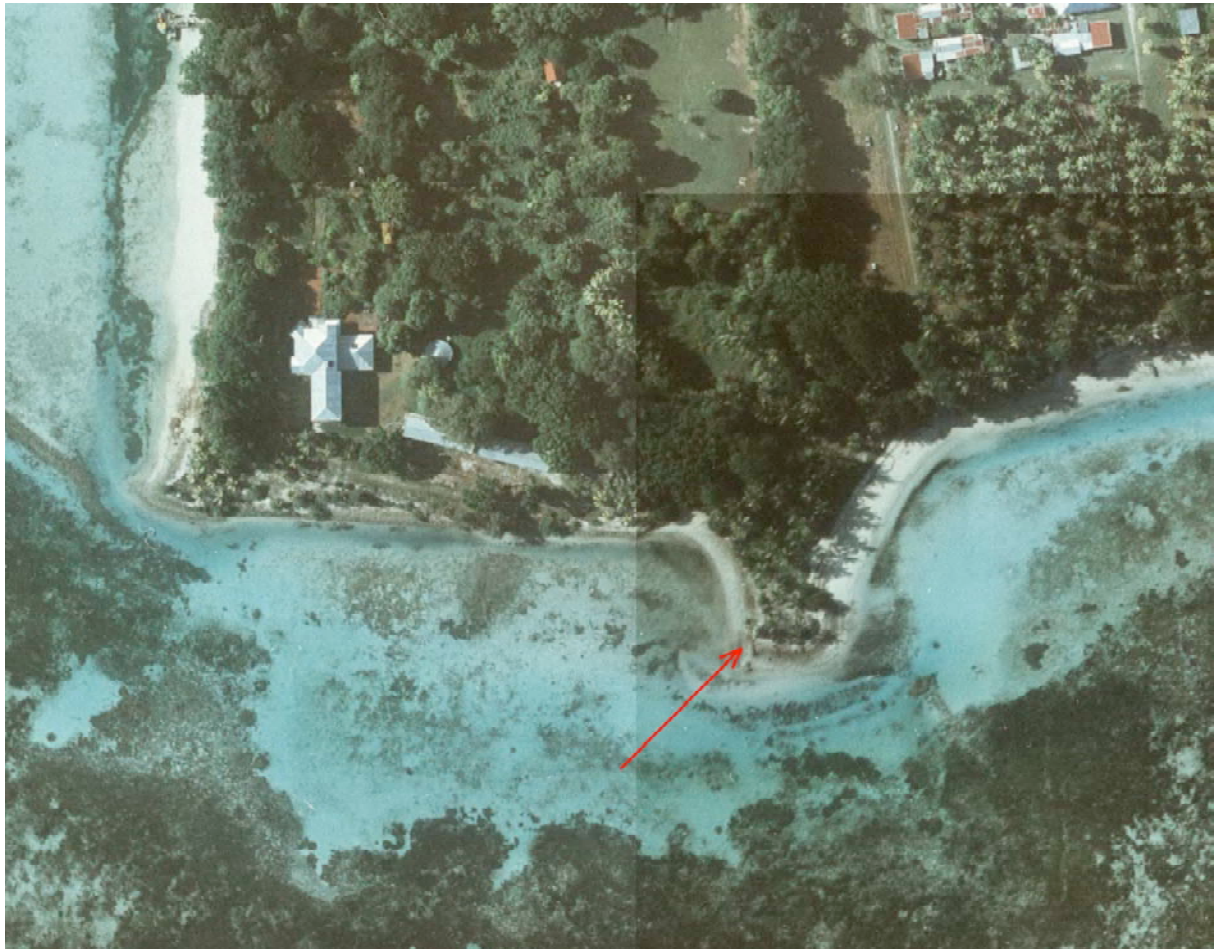
**Aerial Photograph of Home Island, South Keeling showing anchor site**

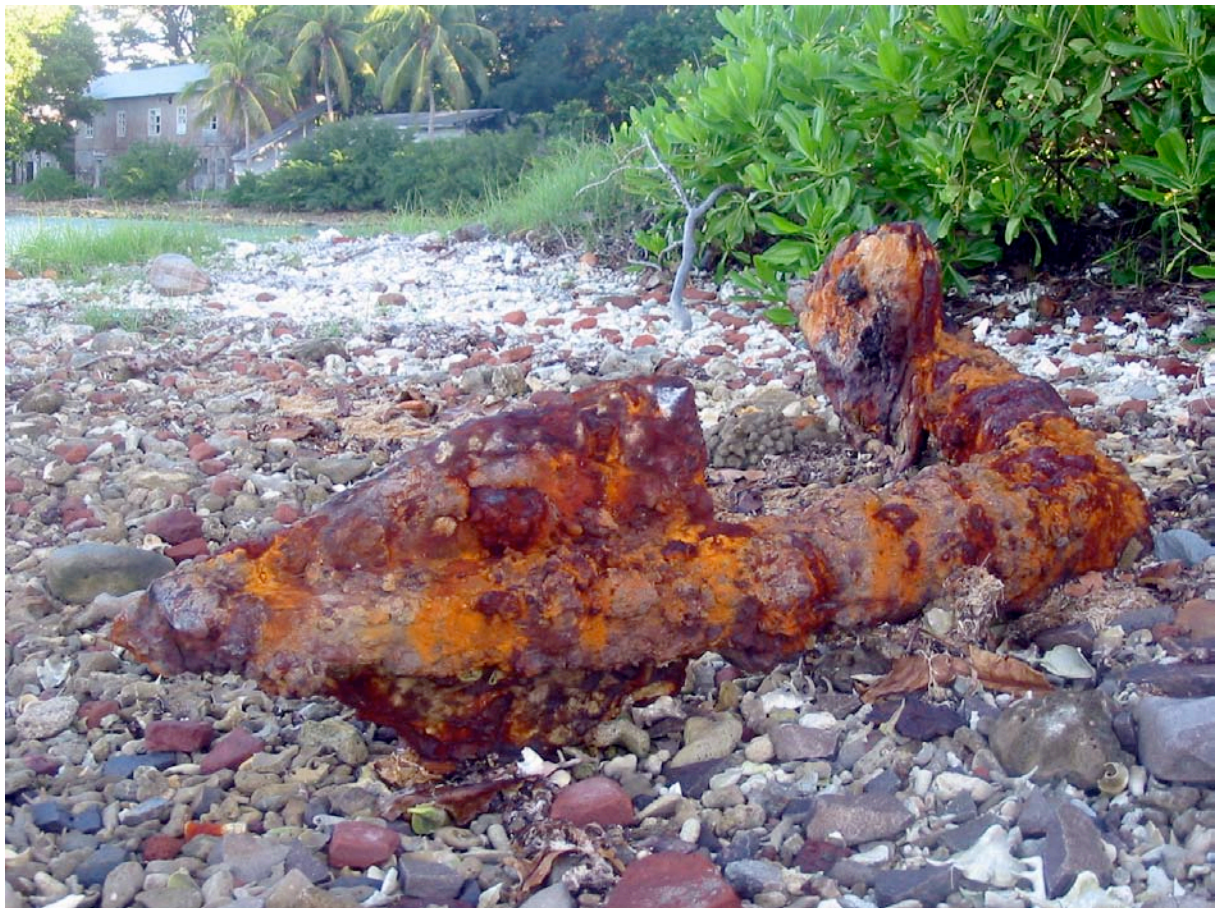
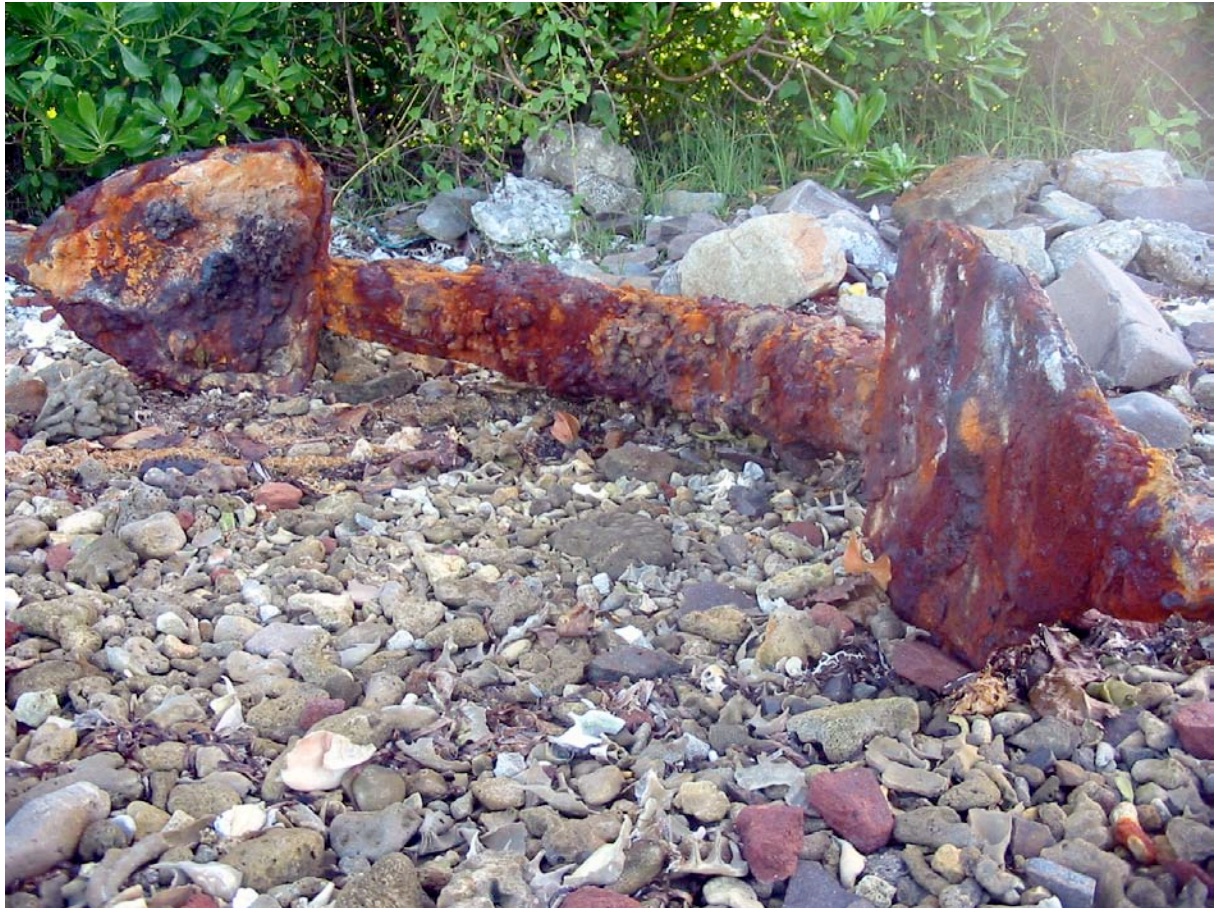
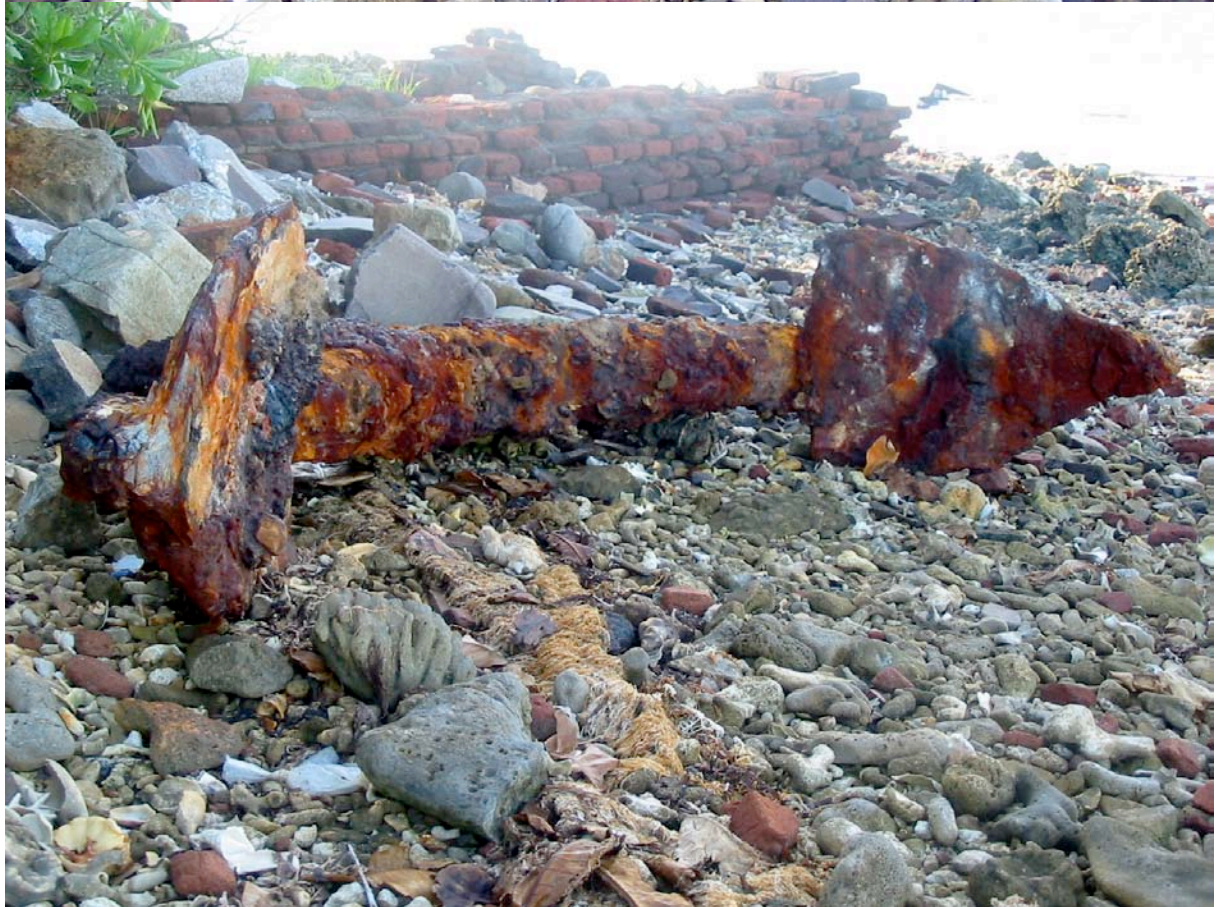
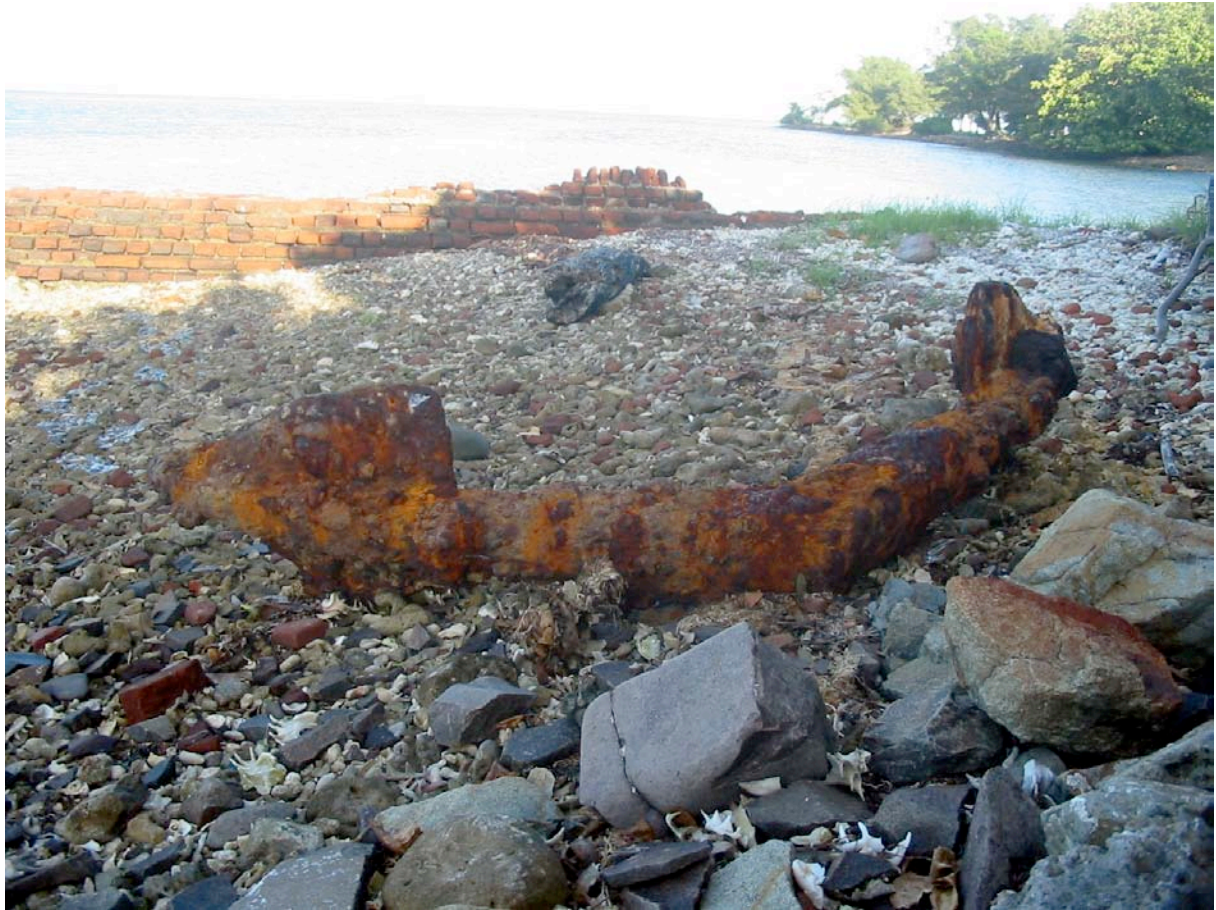
### **Other Views of the Anchor.**

From experience and from a reading of number of treatises on the ship's anchor (e. g. Cotsell, 1856; Curryer, 1999), it is evident from the heavily-concreted state of this anchor, from its size and its shape that the vessel from which this anchor came is from the late 18<sup>th</sup> to mid 19<sup>th</sup> Century and in the 300 tons plus range.

(Photo: R Thorn, Parks Australia)

In examining the possibility that this anchor broke and was abandoned, and did not necessarily emanate from an historic wreck, an examination of the concretion on the flukes shows that both are completely covered in the deposit and in being uniform in composition and colour, that one had not been buried i.e. it was not 'set' into the seabed before breaking at the joint between the crown and the shank, as is common in severe conditions. Indications then are that this anchor was recovered from a wreck. Given that the concretion at the joint between the crown and the shank is intact, however, the evidence is that the joint broke during the wrecking process and the anchor came to lie on its flukes and crown.
