CHAPTER 9: FLOOD RISKS

The Flood Threat

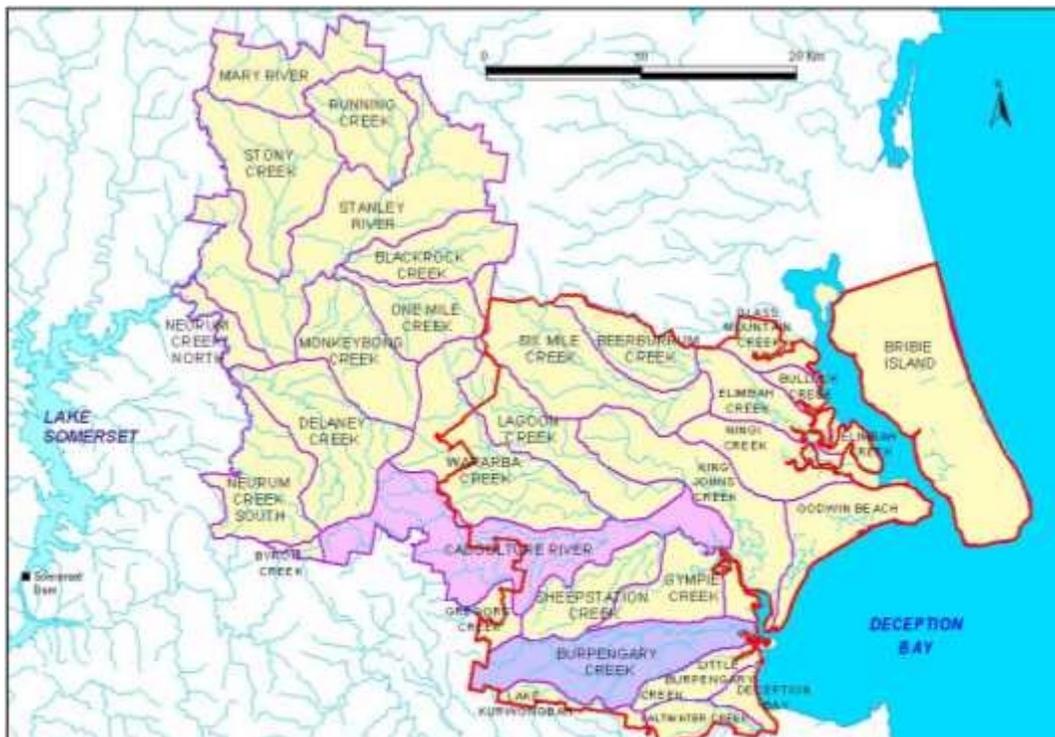
Figure 9. 2 Caboolture River catchment

The Caboolture River is situated about 40 km north of Brisbane and has a total catchment area of 370 square kilometres (CSC 1994a). It rises in the D'Aguilar Ranges and flows in an easterly direction towards the coast, passing through Caboolture and entering Deception Bay (the northern part of Moreton Bay) near the township of Beachmere. Its major tributaries include Wararba, Sheep Station, King John and Lagoon Creeks. The topography is steep in the upper portions but flattens out progressively towards the coast, forming a mature floodplain in the middle and lower reaches. Downstream of Caboolture, the floodplain is very flat and consists of scattered swamps and extensive areas that are highly floodprone. Other than the townships of Caboolture (12 km from the mouth) and Morayfield, Beachmere is the only other significant urban area on the lower floodplain, which is otherwise characterised by rural industry, pastures and pine forest plantations. Figure 9.2 indicates the extent of the Caboolture River catchment.

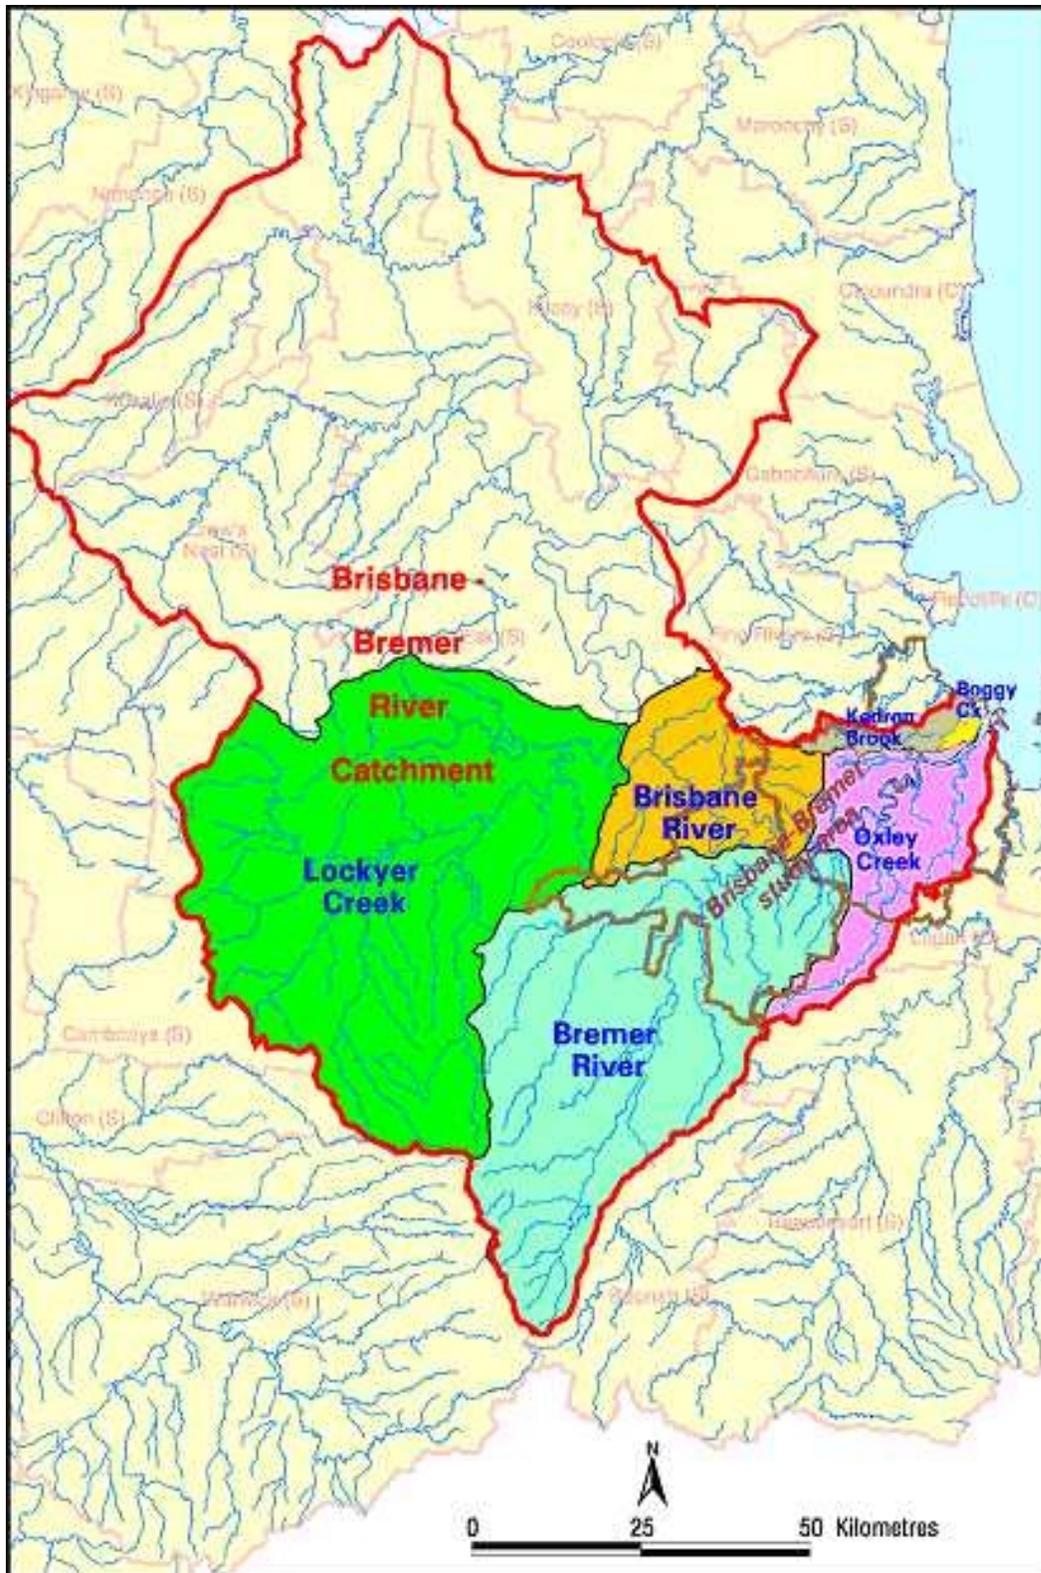
Figure 9.4: Brisbane-Bremer River catchment

The Brisbane River catchment (Figure 9.4) is the largest in the region and covers an area of 13 570 square kilometres (BCC 1998). The catchment is bounded to the west by the Great Dividing Range and by a number of smaller coastal ranges to the east and north. Most of the catchment comprises of forest and grazing land, with the exception of the Brisbane – Ipswich metropolitan regions and numerous small rural townships. The headwaters are at the northerly extent of the catchment bounded by the Brisbane Range. The overall length of the main stream is approximately 300 km.
