Survey of Kalgoorlie earthquake damage

Assessing the vulnerability of older buildings

Martin Wehner, Mark Edwards and Neil Corby

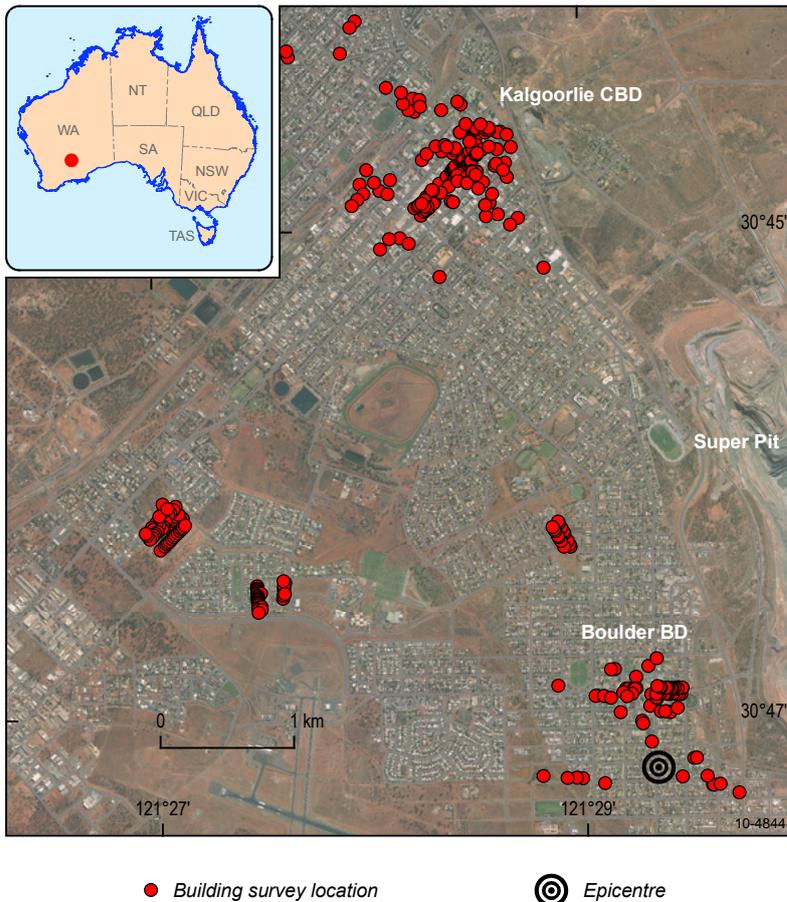
Figure 1. View of Kalgoorlie showing the epicentre of the 20 April 2010 earthquake and the location of the buildings surveyed between 18 and 22 May 2010. The 'Super Pit' open cut mine workings which are over 500 metres deep are visible to the right of the aerial view.

On the 20 April 2010 a magnitude 5.0 (M_L) earthquake shook the Western Australian goldfields town of Kalgoorlie. The earthquake was shallow (1.7 kilometres) and was located immediately south of the business district of the Kalgoorlie suburb of Boulder (figure 1). The severity of ground motion was found to vary markedly across the town with the older masonry building stock in Boulder experiencing a greater intensity of shaking than the corresponding building stock in the Kalgoorlie business district four kilometres away. The event has provided the best opportunity to examine the earthquake vulnerability of Australian buildings since the Newcastle Earthquake of 28 December 1989 more than twenty years ago.

within Kalgoorlie between 28 April and 1 May. The team used a vehicle-mounted camera array developed by Geoscience Australia known as the Rapid Inventory Collection System (RICS). In total 230 000 geo-referenced high resolution images were captured within the urban area. This work was complemented by a detailed field survey which was conducted on foot between 18 and 22 May. Survey information was recorded using hand-held mini-computers which allowed the team of nine engineers and geographic information system (GIS) specialists to capture data about the damage caused. The team included two earthquake engineering researchers from the University of Adelaide and the University of Melbourne respectively. Over 400 buildings in four age categories were surveyed and assessments were made of the felt intensity in those locations. The survey locations are also shown in Figure 1.

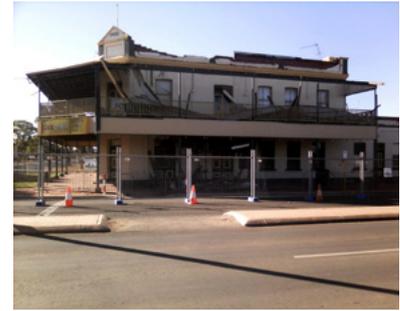
Figure 2. Damage caused to a hotel in Boulder. The damage is typical for two storey unreinforced masonry buildings with toppling of parapets either outwards into the street or inwards through the roof. This building also sustained other types of damage such as cracking over doors and windows and substantial cracking to internal masonry walls.

The field team found that the severity of shaking in the Boulder business district was approximately 6 on the Modified Mercalli scale. This level of shaking caused widespread damage to unreinforced masonry buildings built before World War One. The loss of chimneys, gables and parapets was widespread as well as extensive cracking of walls (figure 2). The timing of the event at 8:17am was fortunate as falling masonry would have landed on school children walking through the area if the earthquake had occurred just 15 minutes later. Only a few minor injuries resulted. More modern masonry residential buildings also experienced some damage. The severity of shaking beneath the Kalgoorlie business district was approximately 5 on the Modified Mercalli scale causing only slight damage to older masonry buildings. Preliminary findings from this work have shown that older masonry buildings are particularly vulnerable to the nature of the ground motion experienced in the Kalgoorlie event. Furthermore, more contemporary cavity brick construction was found to experience greater damage than equivalent wooden-framed construction, though damage was light.
