## **CHAPTER 4: MINIMISING COASTAL HAZARDS**

### **4.2 GEOTECHNICAL REPORTS**

### 4.3 MINIMISING COASTAL LIMESTONE HAZARDS

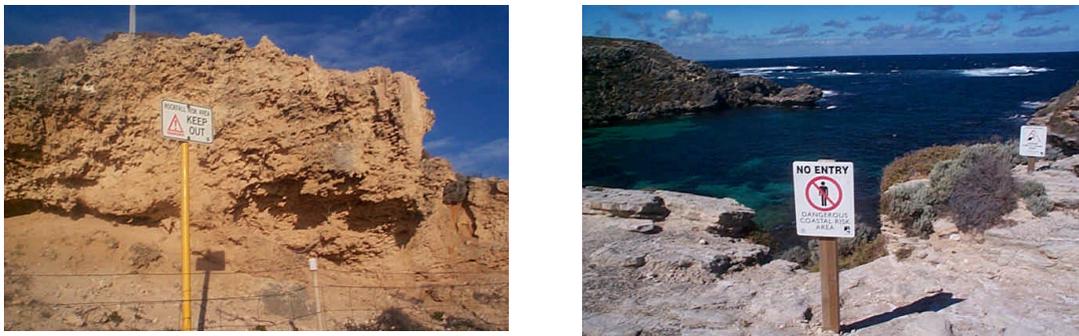
**Figure 4.1** A variety of prohibitive signs in conjunction with wire fences have been constructed to keep people out of hazardous areas.

Local Government Authorities have been quite active in erecting a variety of signs warning the public about limestone hazards. These warnings range from prohibitive signs such as ‘Keep Out’ and ‘No Entry’ (Figure 4.1), to more informative signs specifically warning people not to walk over the cliffs and not to shelter under overhangs (Figure 4.2).

Wire fences have been constructed around some of the more hazardous areas and are often used in conjunction with prohibitive signs such as ‘Keep Out’ (Figure 4.1). Railed walkways can also be an effective way of ensuring that the public walk on designated paths and stay out of hazardous areas.

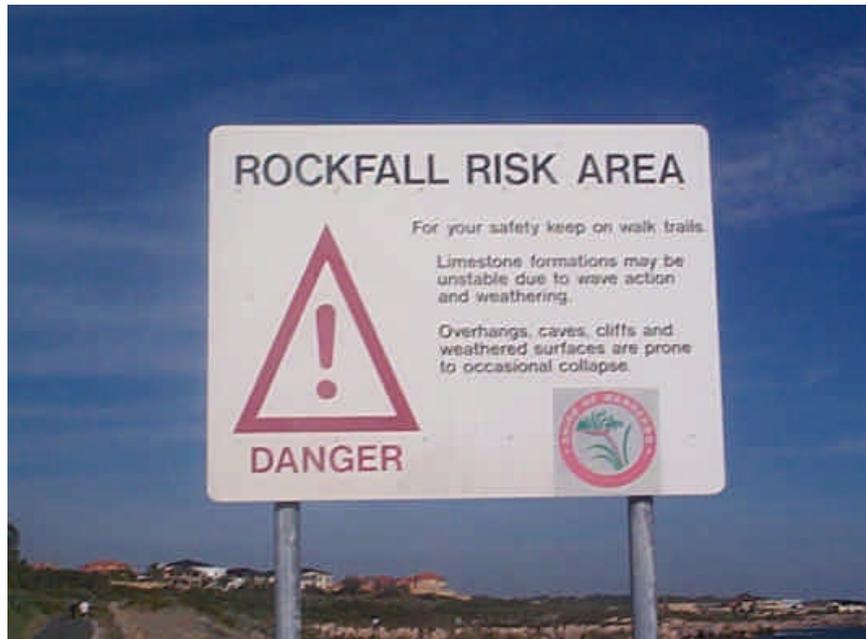
**Figure 4.2** An example of an informative sign within the City of Wanneroo. This type of sign does not deny public access, but alerts people to the dangers associated with limestone cliffs.

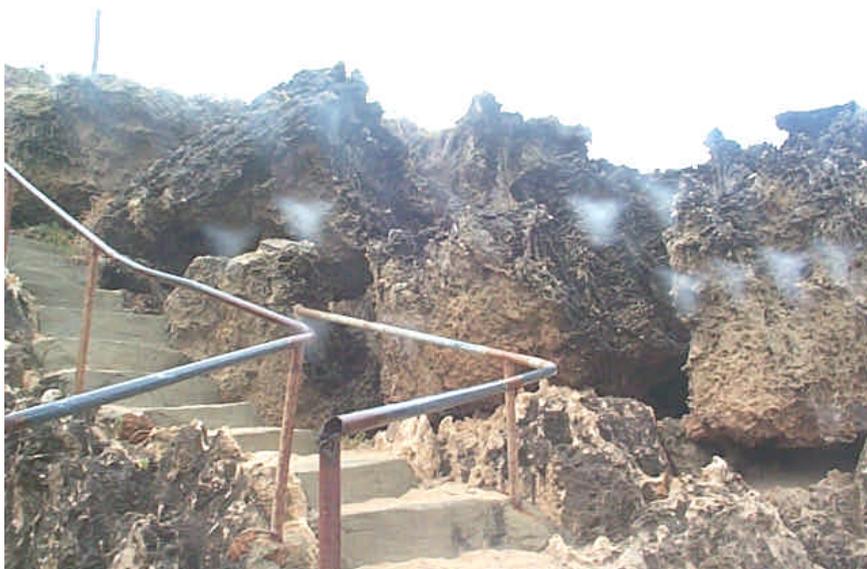
**Figure 4.3** Limestone blocks encroaching on to a stair way that provides the public with beach access.

While signs and fences cannot guarantee that everyone will observe the warnings and be responsible, they do inform people of the dangers, and discharge in whole, or in part a duty of care. In general, LGAs have implemented the use of signs and fences quite effectively, however there are some localities where more work could be done. For example, at site 15 (see Appendix A) located in the City of Mandurah, highly weathered limestone outcrop forms 3-4 m cliffs with clear evidence of undercutting and the development of overhangs. There are large sections of rock that have separated from

the cliff, and some of these are encroaching on to the public staircase that provides access to the beach (Figure 4.3). There did not appear to be any warning signs at this site, despite recommendations to do so in a draft safety audit for the City in 1997. It may be possible however, that these signs have been removed or are still in the process of being developed.
