Survey of Kalgoorlie earthquake damage

Assessing the vulnerability of older buildings

Martin Wehner, Mark Edwards and Neil Corby

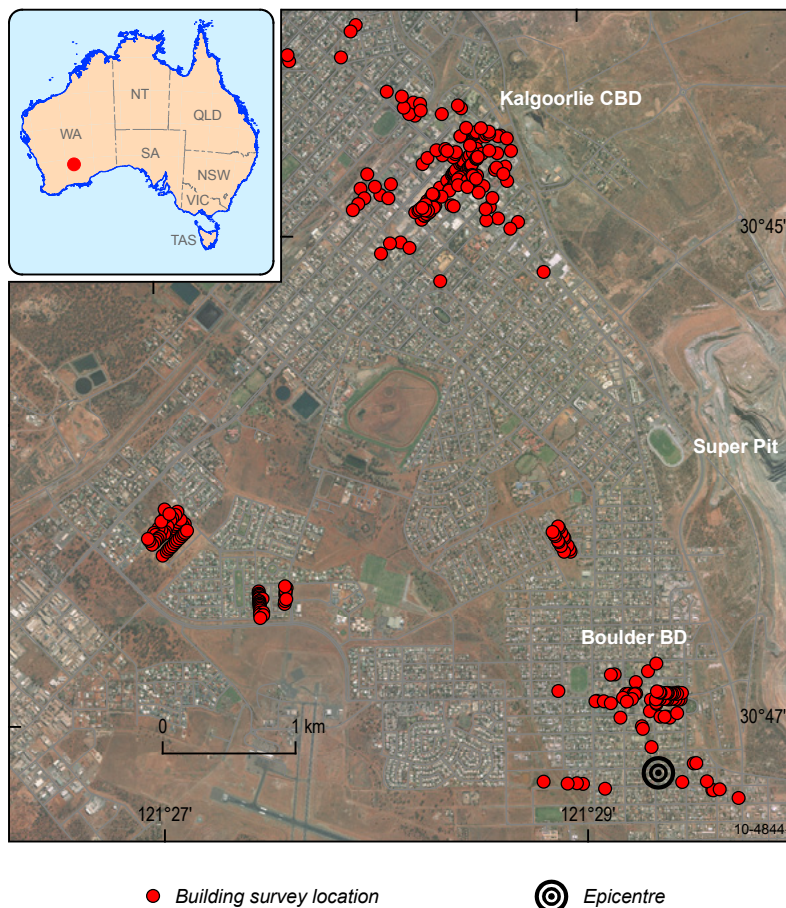
Figure 1. View of Kalgoorlie showing the epicentre of the 20 April 2010 earthquake and the location of the buildings surveyed between 18 and 22 May 2010. The 'Super Pit' open cut mine workings which are over 500 metres deep are visible to the right of the aerial view.

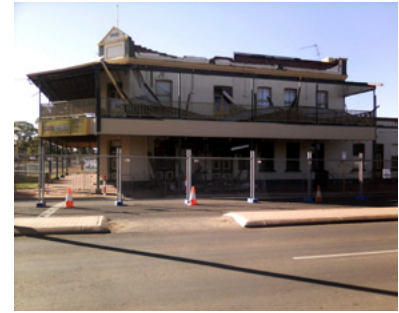
Figure 2. Damage caused to a hotel in Boulder. The damage is typical for two storey unreinforced masonry buildings with toppling of parapets either outwards into the street or inwards through the roof. This building also sustained other types of damage such as cracking over doors and windows and substantial cracking to internal masonry walls.

The field team found that the severity of shaking in the Boulder business district was approximately 6 on the Modified Mercalli scale. This level of shaking caused widespread damage to unreinforced masonry buildings built before World War One. The loss of chimneys, gables and parapets was widespread as well as extensive cracking of walls (figure 2). The timing of the event at 8:17am was fortunate as falling masonry would have landed on school children walking through the area if the earthquake had occurred just 15 minutes later. Only a few minor injuries resulted. More modern masonry residential buildings also experienced some damage. The severity of shaking beneath the Kalgoorlie business district was approximately 5 on the Modified Mercalli scale causing only slight damage to older masonry buildings. Preliminary findings from this work have shown that older masonry buildings are particularly vulnerable to the nature of the ground motion experienced in the Kalgoorlie event. Furthermore, more contemporary cavity brick construction was found to experience greater damage than equivalent wooden-framed construction, though damage was light.
