Record 1974/107

LUNAR LASER RANGER SITE, ORRORAL VALLEY A.C.T.

FOUNDATION INVESTIGATION - 1974

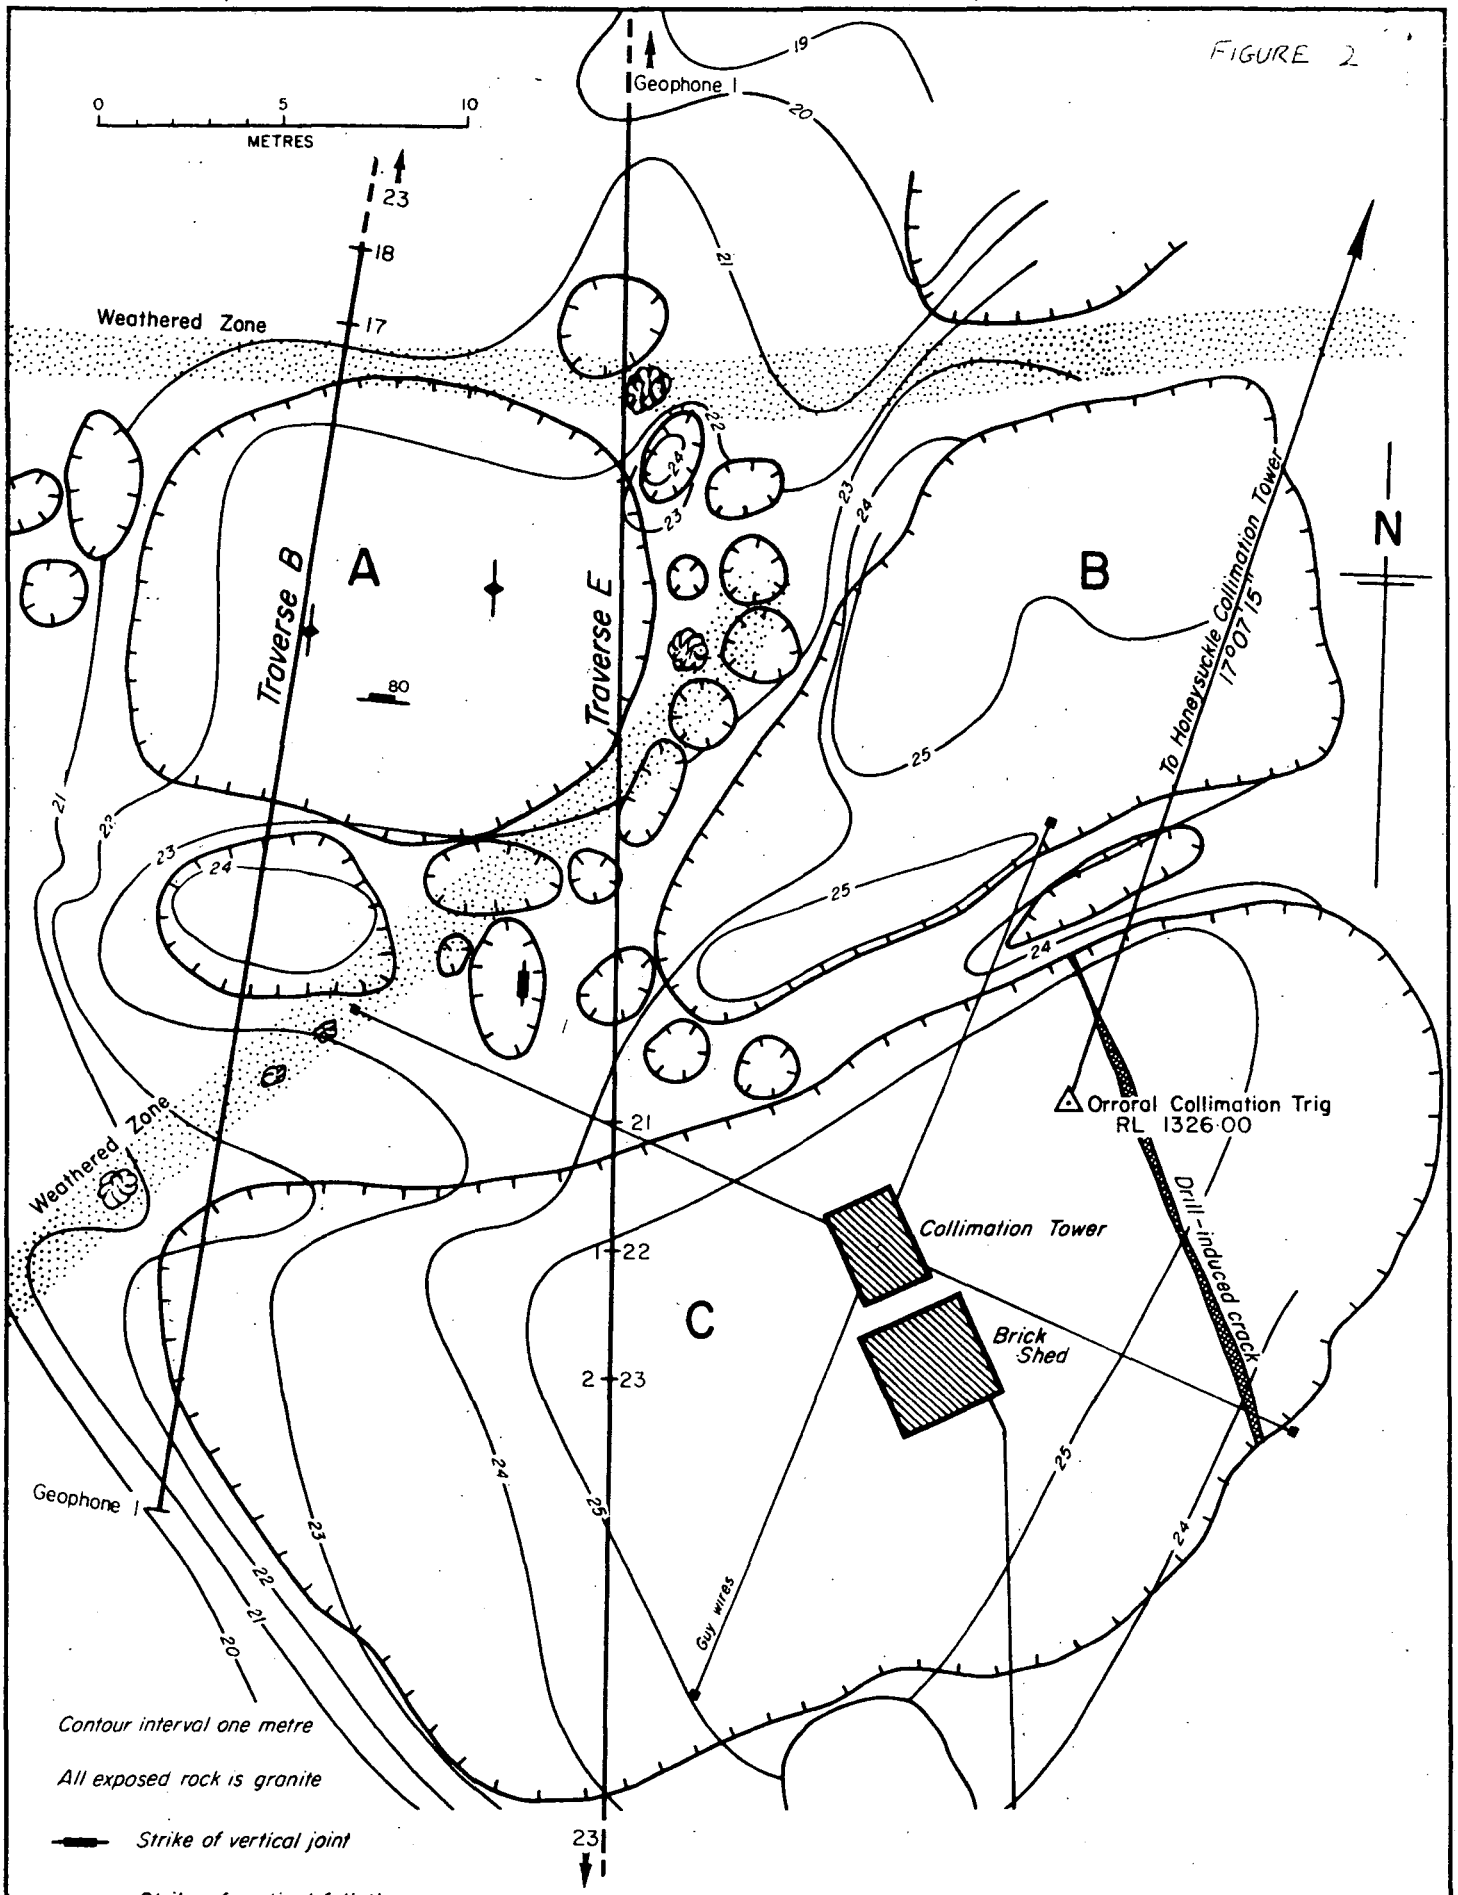
FIGURE 2

Figure 2 shows the approximate position of boulders at the site. The Ranger is to be sited on Boulder A; Boulder C forms the foundation of the existing Collimation Tower.

The joints at the base of Boulders B and C are well-exposed. About 35 cm of weathered material has been removed from these joints leaving the joints open. These open joints can be seen to extend about 5 m under the boulders.

Two weathered zones were observed and these are shown on Figures 2 and 3. It should be noted that gum trees with trunks up to 0.5 m diameter are growing in the weathered zones.

Movement of the surrounding boulders. Boulders B and C may be considered to be in a critical position. They are situated at the top of the steep valley slopes and are underlain by open joints. The critical state of these boulders is indicated by the drill-induced crack which formed across Boulder C when the anchorage for the collimation-tower guy wires were being installed. The crack is up to 4 cm wide and 15 m long. Movement of Boulders B and C may cause movement of Boulder A, either directly or indirectly by loosening the weathered material.

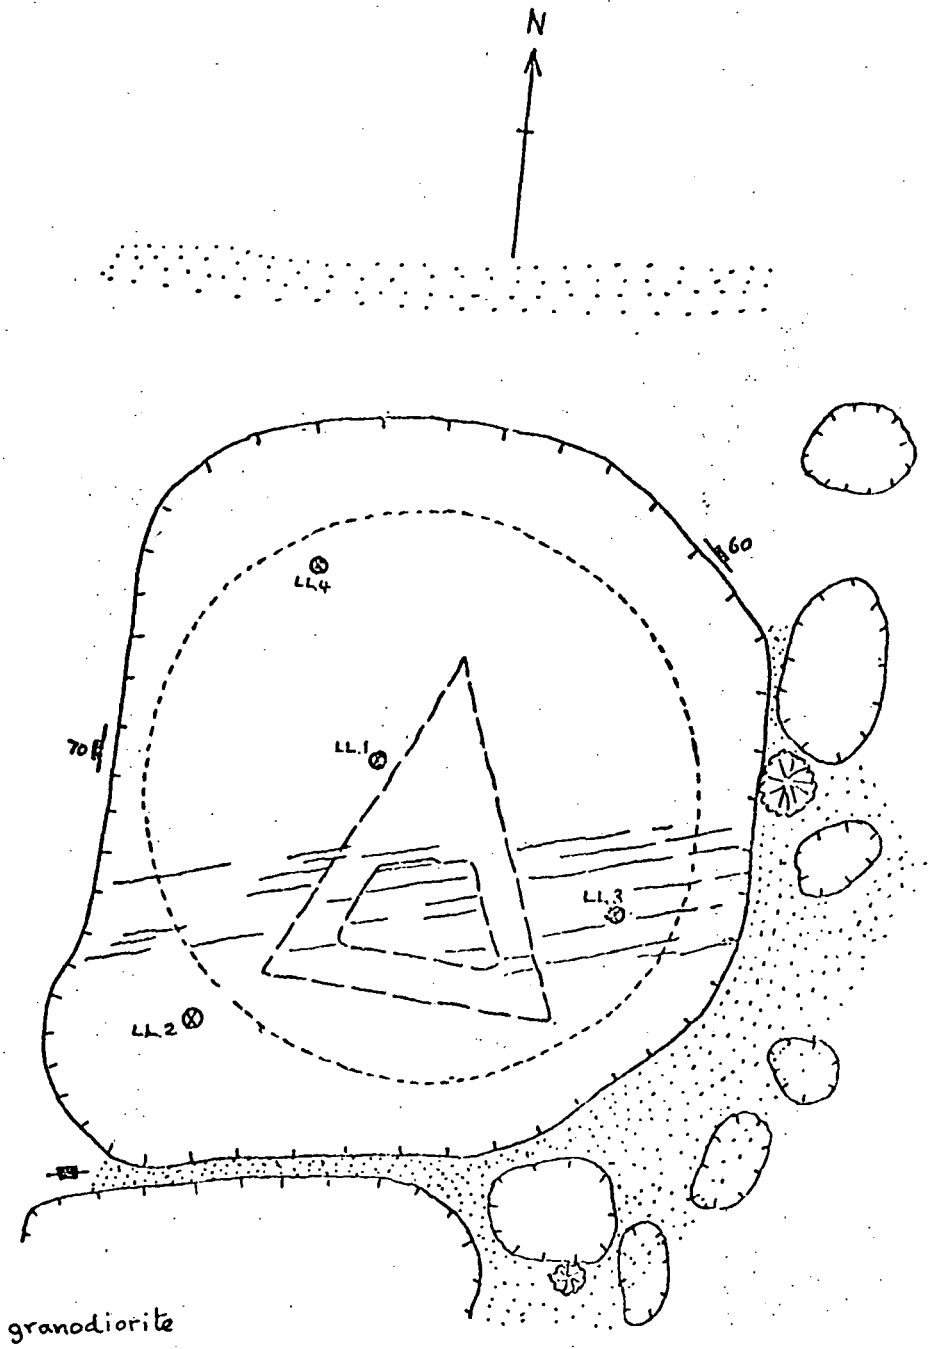
FIGURE 3

In November 1973 about 45 cm of rock was removed from the top of Boulder A by blasting to give a flat surface, and a triangular trench, about 45 cm deep, was excavated in the surface for the foundations of the ranger (Fig. 3).

The excavated surface of Boulder A shows no continuous joints but does show continuous incipient joints along narrow quartz-epidote veins trending 80N/260. The incipient joints are slightly weathered and the rock adjacent to them is limonite-stained for up to 15 cm either side.

Four diamond-drill holes were put down through the foundations (Fig. 3). Geological logs of the drill holes form Appendix 2.

The diamond drilling confirmed that Boulder A is a boulder of fresh granodiorite underlain by horizontal joints which have weathered to give between 60 cm and 2 m of highly and completely weathered granodiorite, at a depth of between 8 m and 10 m below the surface.

The thickest part of Boulder A penetrated by a drill hole was in hole 1. The base of the boulder dips from holes 2, 3 and 4 towards hole 1 at angles between 4 and 11 . The configuration of the base of the boulder is therefore convex.

Compaction and Settlement. The configuration of the base of Boulder A is convex and fairly uniform; however, the thickness of the weathered seam below the boulder is variable between 60 cm and 2 m. Within the weathered seam the thickness of completely weathered material varies from 30 to 60 cm. Compaction after construction is not expected to be uniform throughout the weathered zone, and the differential settlement may be in the order of 1 to 2 mm with the maximum settlement occurring on the north and west sides of the foundation.

(a) Grouting. Grouting will reduce permeabilities in the weathered zone by sealing up open joints. However grouting will not be effective in reducing permeability of completely weathered rock in the weathered zone. Restriction of groundwater movement will reduce the removal of material from the weathered zone, and therefore long-term settlement. Grouting will not act to directly strengthen the foundations.

(b) Anchoring Boulder A. Installing tension cables at the site would be both difficult and expensive with the risk that they would not achieve the desired result. Weathered seams are present to a depth of at least 15 m, and satisfactory anchorage of the cable may be difficult. The stressing of Boulder A by the cables might result in the boulder cracking along the incipient quartz-epidote vein fractures or parallel to the foliation as has occurred across Boulder C.
