DEPARTMENT OF NATIONAL DEVELOPMENT
BUREAU OF MINERAL RESOURCES
GEOLOGY AND GEOPHYSICS

AN INVESTIGATION OF THE COTTER AND OTHER FAULTS NEAR THE
CORIN DAMSITE, UPPER COTTER RIVER, A.C.T.

W. Oldershaw

Records 1965/86.

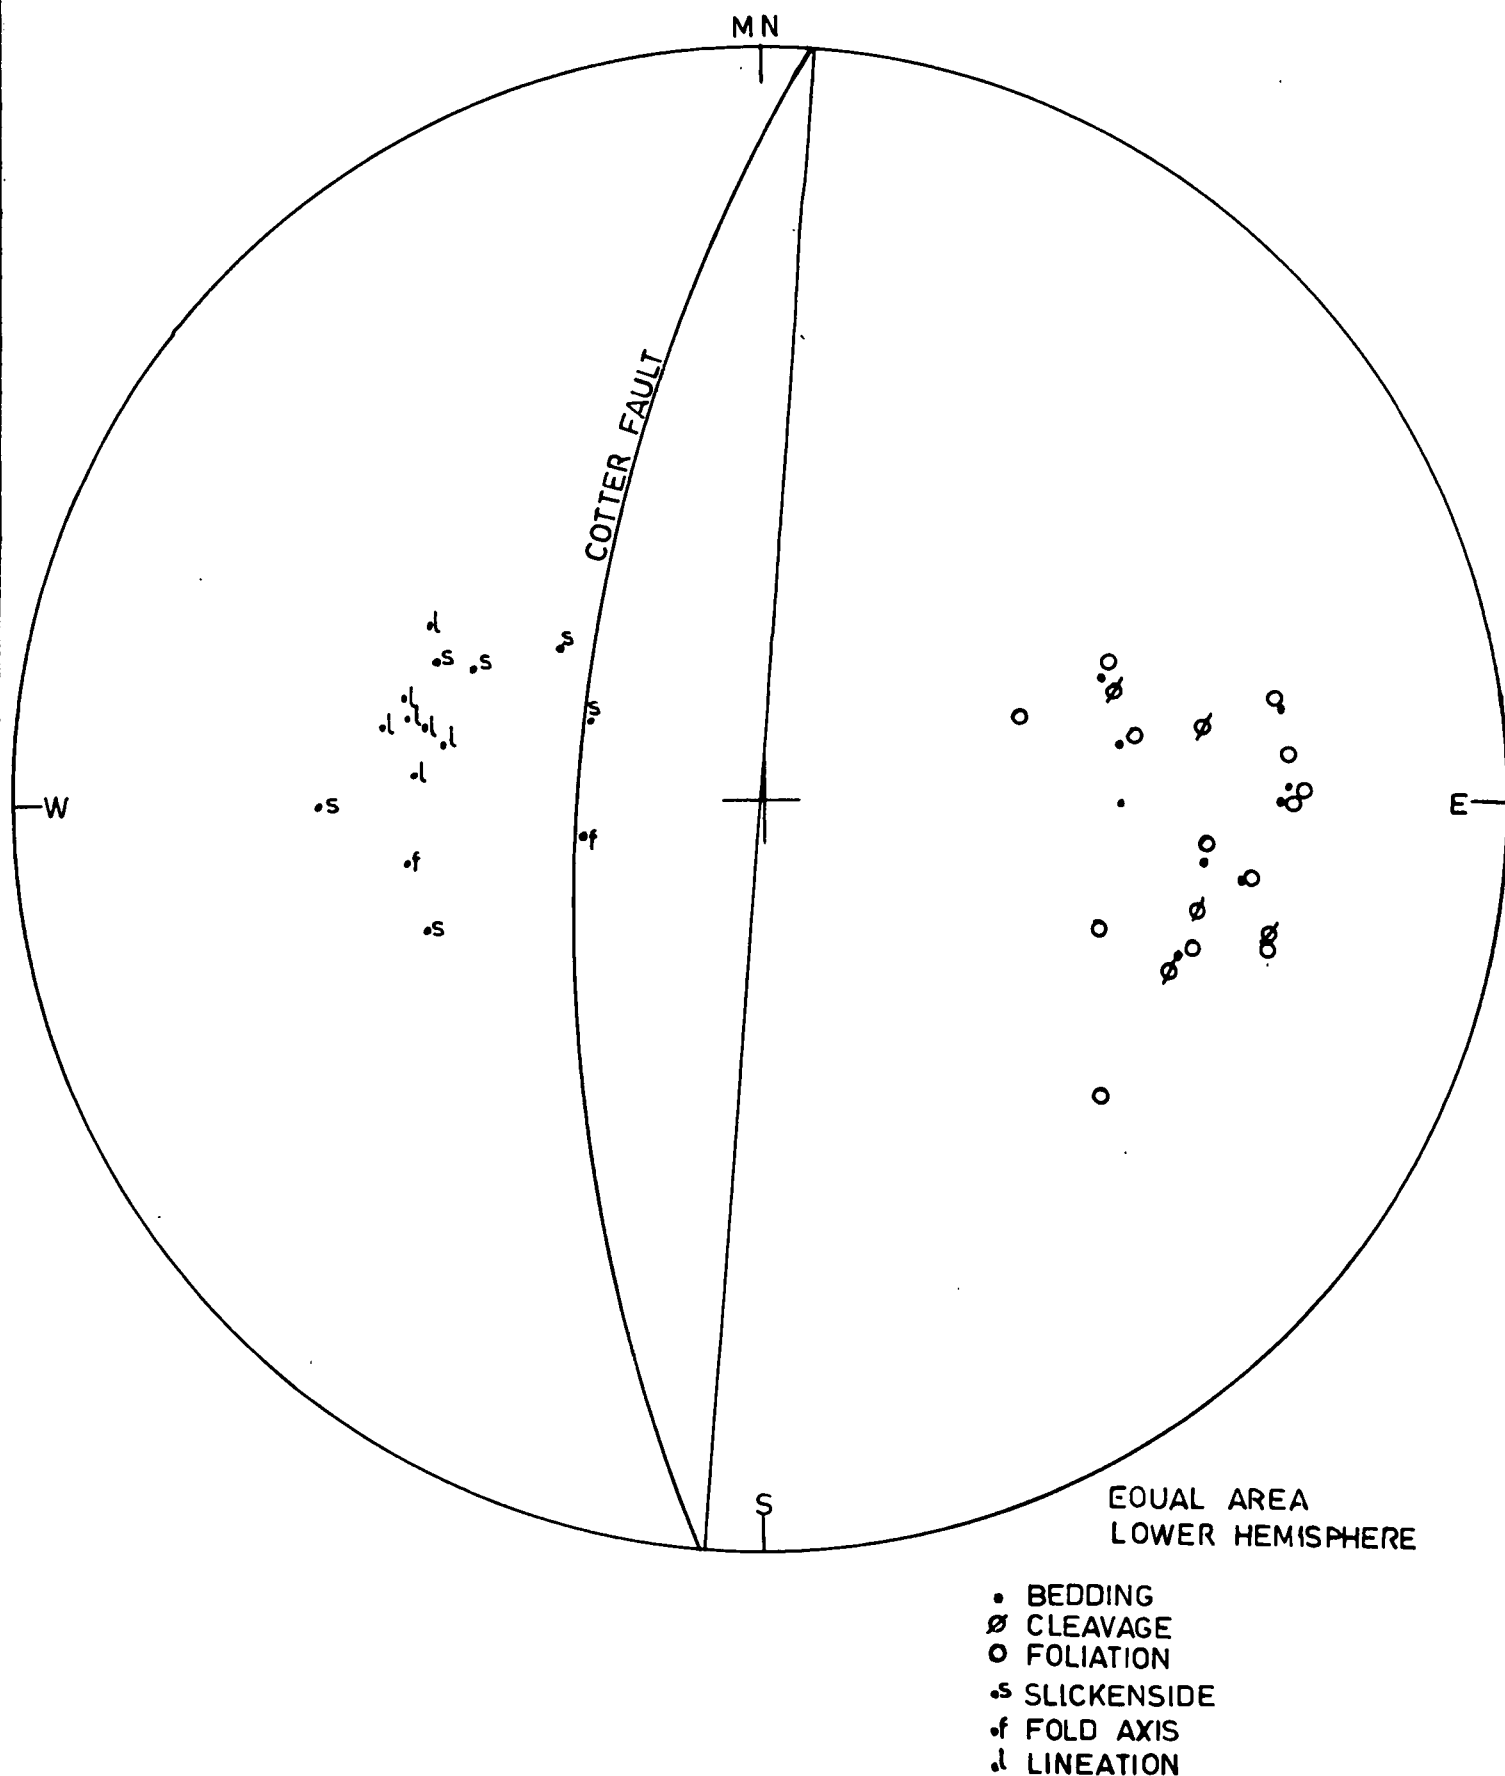
FIG. 8.
STEREOGRAM OF THE STRUCTURE OF THE PHYLLITE
TO THE WEST OF THE COTTER FAULT AT THE
CORIN DAMSITE.

THE STEREOGRAM SHOWS THE COINCIDENCE OF THE SHEARING IN THE SILTSTONE ABOVE THE FAULT WITH THE INFERRED POSITION OF THE FAULT.

Extensive movement along numerous zones in the phyllite has produced a shear foliation trending about 190° . In places this shear foliation has obliterated the earlier foliation (or bedding). Elsewhere the shear foliation intersects the earlier foliation at angles of about 20° and the intersection of these two planes produces the marked lineation plunging down dip which can be seen in most specimens of the phyllite.
