GEOLOGICAL INVESTIGATION OF BURBONG DAMSITE,
MOLONGLO RIVER, A.C.T., 1965-66

G.A.M. Henderson

Record 1966/212

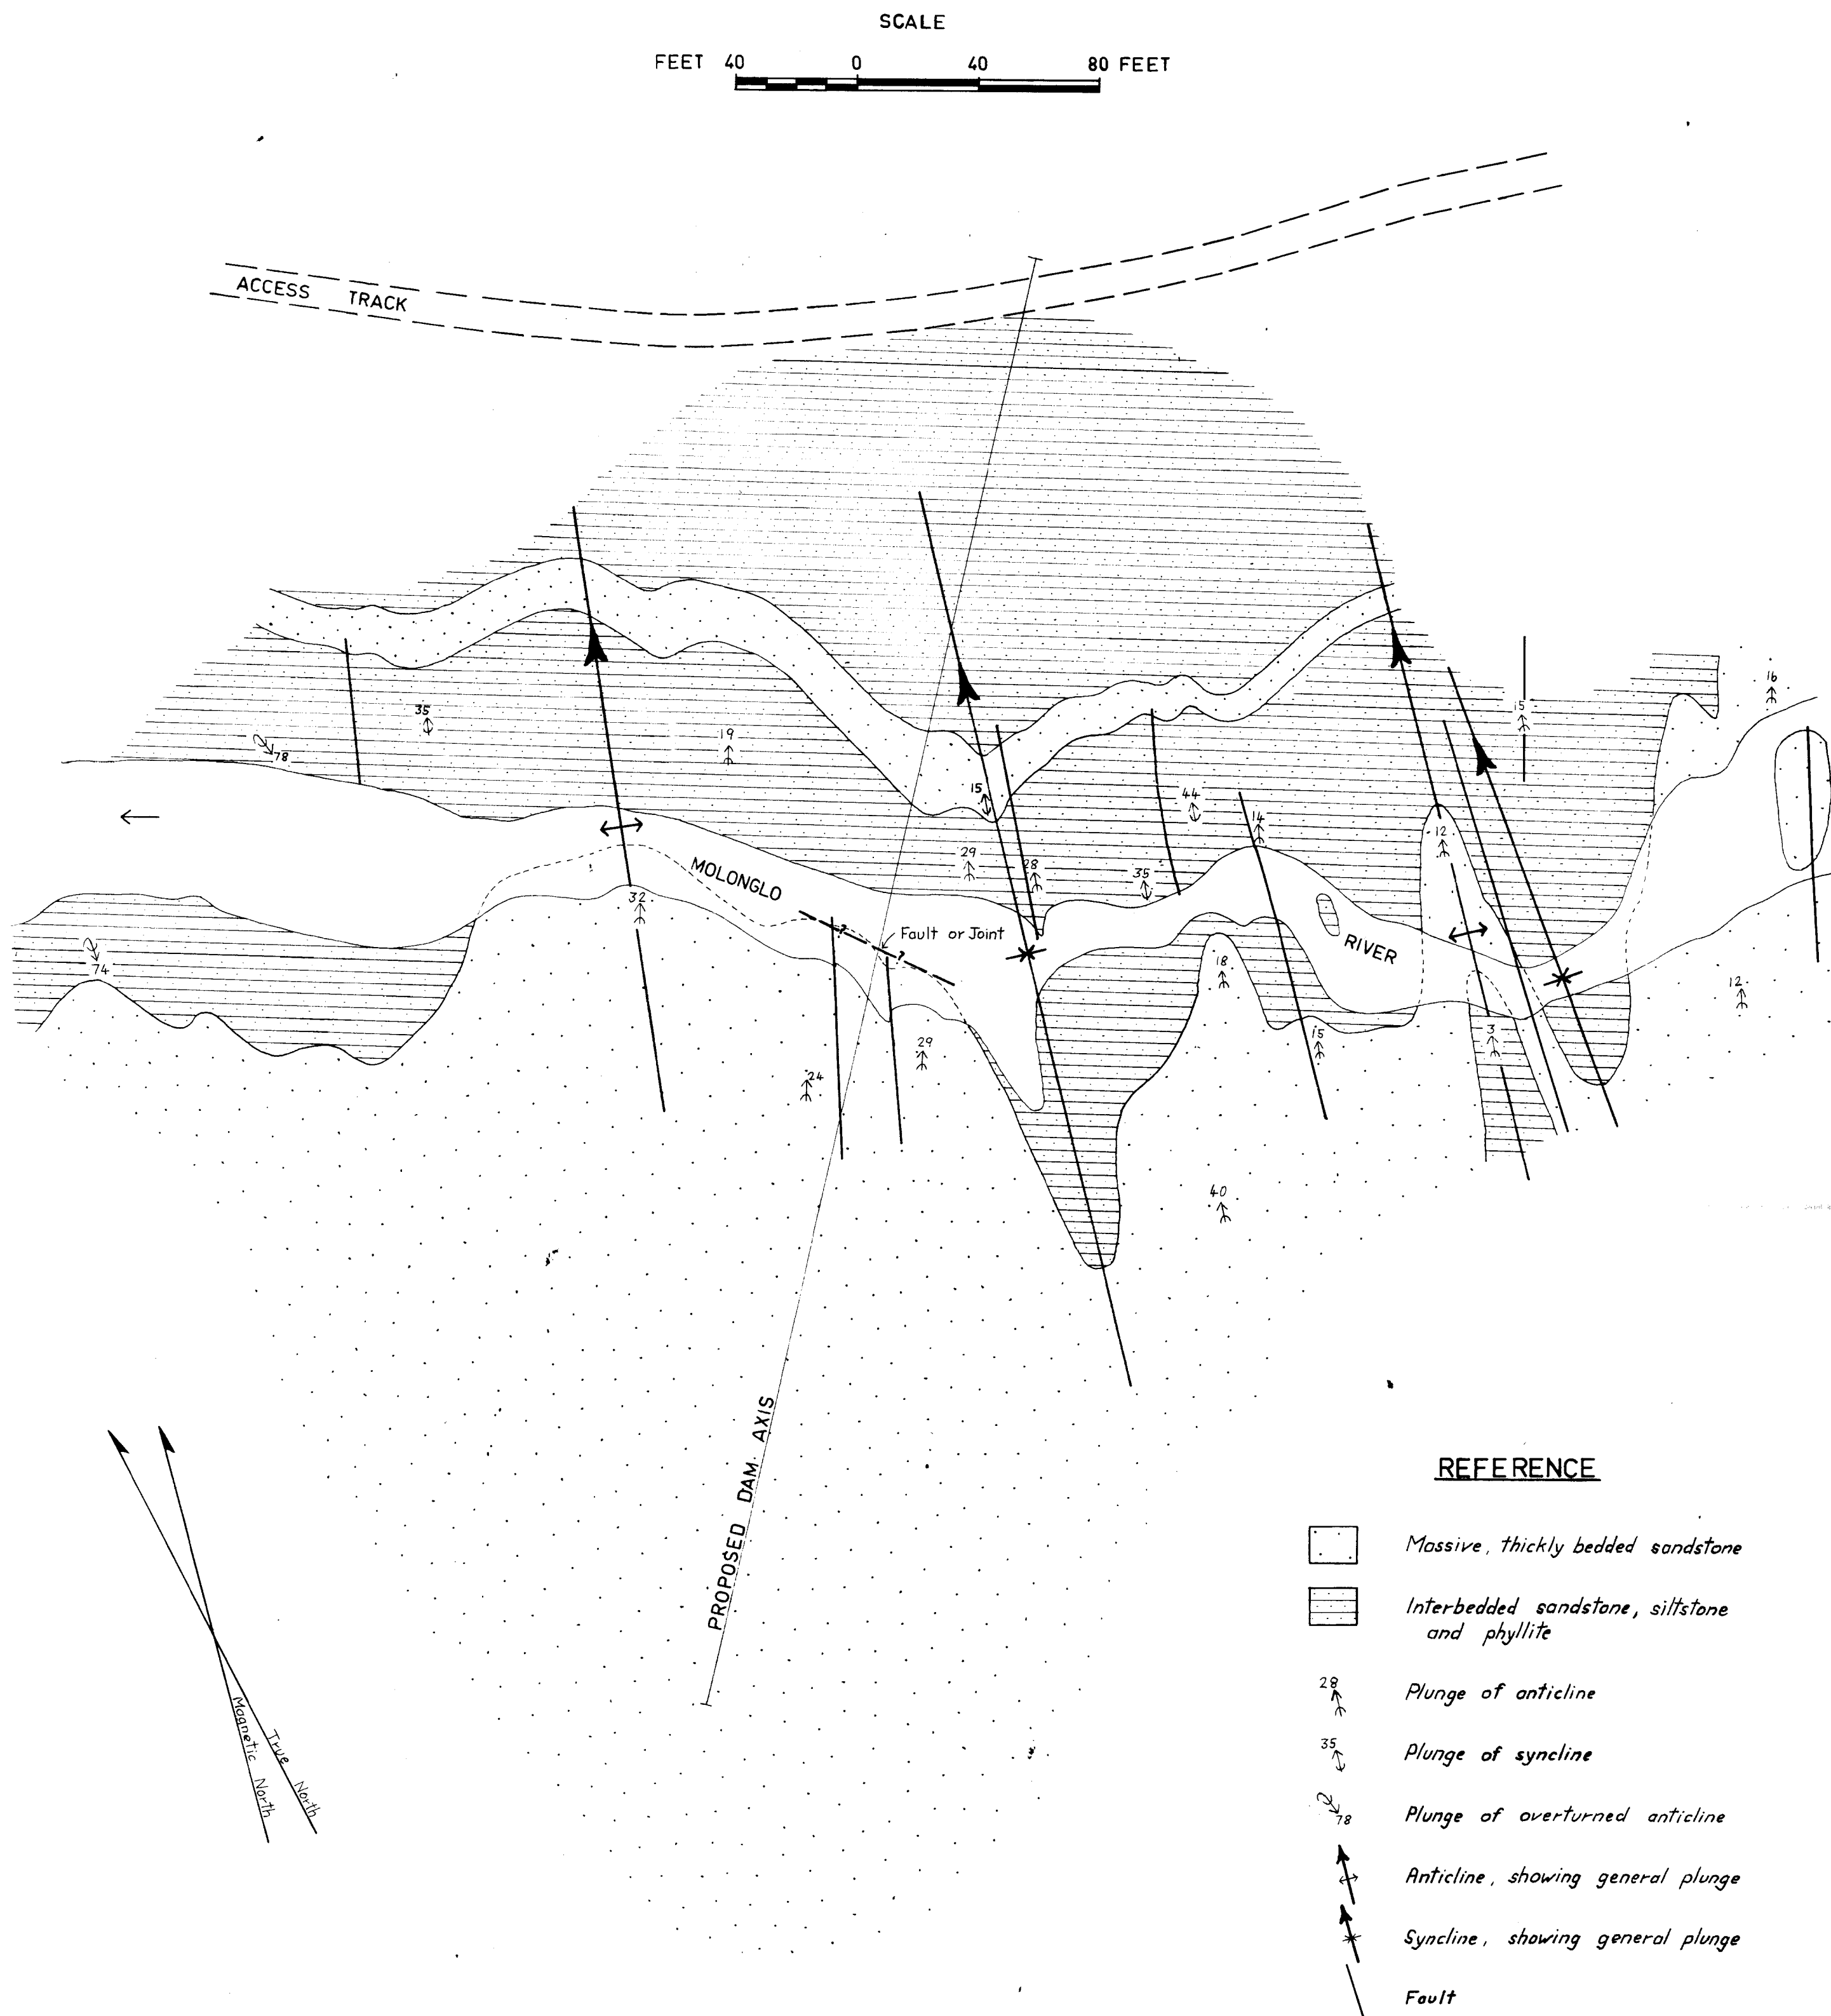
PLATE 7

The rock types at the damsite can be separated, on the basis of lithology and thickness of beds, into two main groups:- massive quartz sandstone in which the beds are 5 or more feet thick; and interbedded sandstone, siltstone and phyllite ranging in thickness from less than an inch to about 2 feet, with occasional beds up to 3 feet thick. The interpreted distribution of these two groups is shown in Plate 7.

The general trend of the fold axes at the damsite is north-north-east as elsewhere in the region. However the plunge and small amplitude of the folds cause the beds to follow an overall east-west trend. The folds are very irregular, both in size and degree of closure. Over nearly all the mapped area at the damsite the folds plunge gently to the north-north-east; axial planes dip steeply to the east. The structure of a particular bed may be likened to a piece of rather irregular corrugated iron sloping gently in the direction of the corrugations (See Plate 7).
