RECORD NO. 1967/115

ST JOHN'S CHURCH, REID, A.C.T.,  
VIBRATION TEST, 1967

*G. HART*

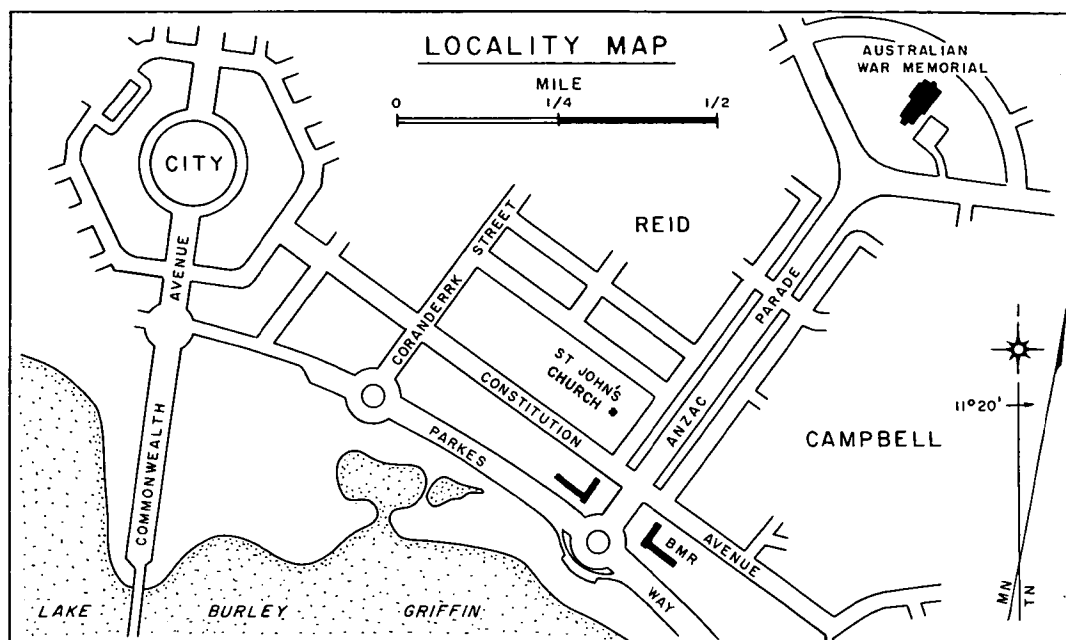
**GROUND LEVEL PLAN**

The church, which is about 140 years old, has developed cracks in some of its walls (Plate 1). The purpose of the test was to find out if bell ringing and organ playing could produce vibrations large enough to be the cause of the damage.

The vibrations caused by the bell and the organ are not expected to cause damage to the church. To explain the cracks in the walls of the church, other causes should be sought.
