RECORDS 1968/88

GEOLOGICAL INVESTIGATION OF TENNENT DAMSITE,
GUDGENBY RIVER, A.C.T. 1966-1967

D.A. Buchhorn

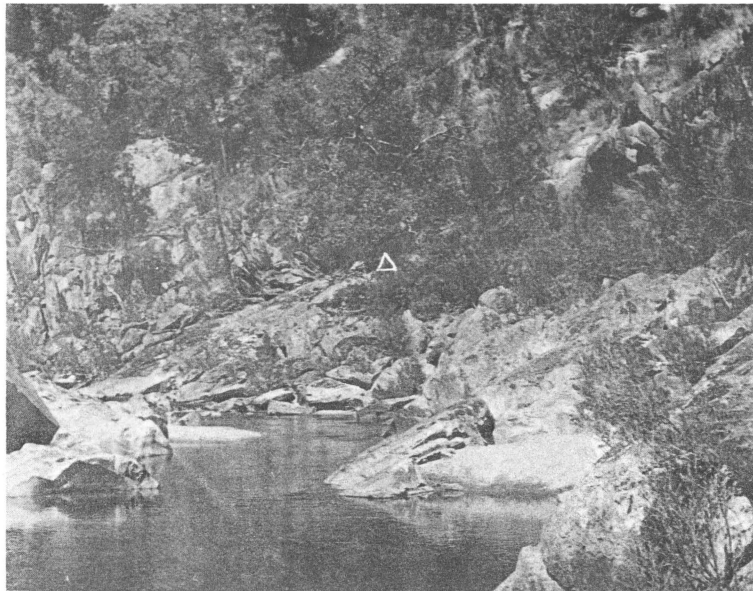
Type 4. Closely-spaced parallel joints, moderate size, within a horizontal zone, and having the orientation of set 3 joints, i.e. strike 152° magnetic and dip 37° east. The joints occur between two horizontal planes about 4 feet apart. An example is shown in Figure 8; the photograph shows how readily the joints are eroded by the river. These joints are exposed in the downstream portion of the gorge between R.L's 1930 and 1955 and have also been found in DG1 between the same elevations. In DG2 a set was found between R.L's 2076 and 2079. The areal extent of a particular zone is large. For example, the zone which has its lower surface at R.L. 1955, is mostly eroded but occurs at E18620/S85300, E18690/S85210 and E18750/S85220 and thus may have had an areal extent of greater than 2600 square feet.

Set 3 joints Strike 152° , dip 37° E. They consist of type 1 and type 4 joints, which are illustrated in Figures 9 and 8 respectively. The type 1 joints of this orientation are believed to be sheeting joints. They occur on the west bank downstream.

Fig. 7. (Above left) From 17750/84250. Road-cutting showing weathering. Note sharp boundary between completely-weathered and unweathered rock, and rounding of the rock-body by weathering. Hammer at left end of boulder gives scale.

Fig. 8. (Above right) From 18740/85200. Multiple joints, analogous to current-bedding: parallel closely-spaced dipping joints restricted to a horizontal zone a few feet thick. In the foreground a horizontal surface representing the lower extremities of these joints ("bottom-set beds"). Hammer gives scale.

Fig. 9. (Left) From near Station S, looking South (upstream). Station K marked. Riverbed and West bank, showing easterly-dipping joints (also shown in fig. 3).

(2) Weathering is initially difficult within the granite and thus tors may be fresh, but surrounded by highly weathered rock. The boundary is commonly sharp, as in the example in Figure 7.
