DEPARTMENT OF NATIONAL DEVELOPMENT

RECORDS 1968/98

GEOLOGICAL INVESTIGATION OF COREE DAMSITE,  
COTTER RIVER, A.C.T., 1967-1968.

D.A. BUCHHORN

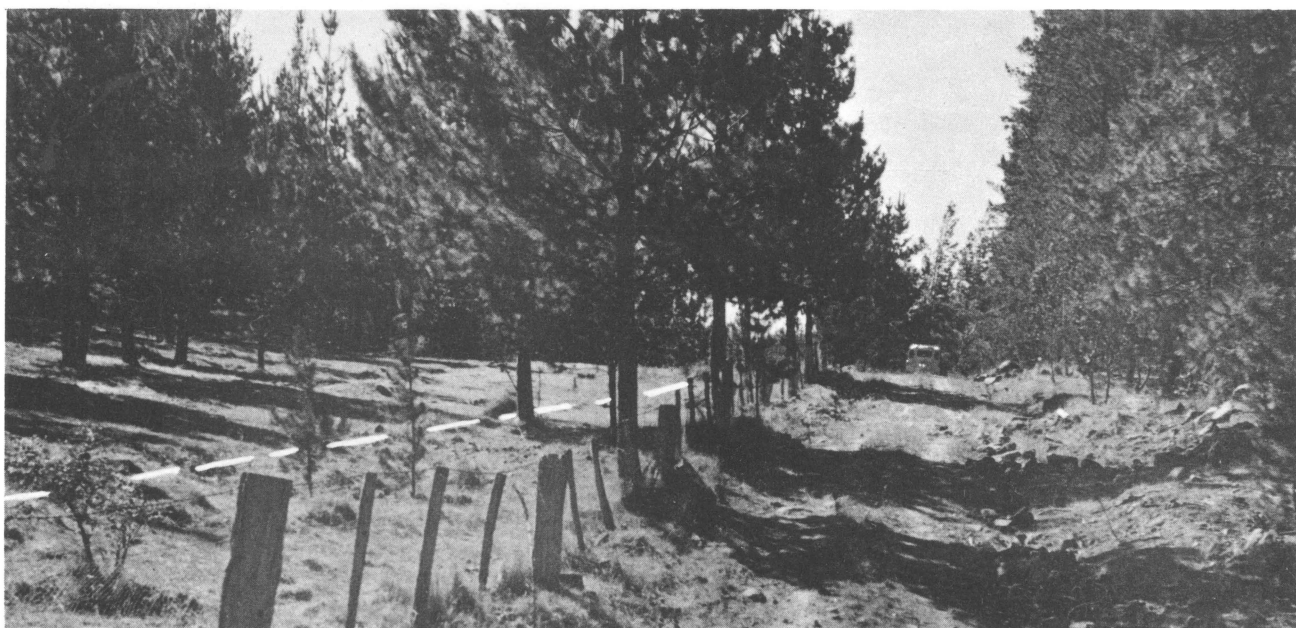
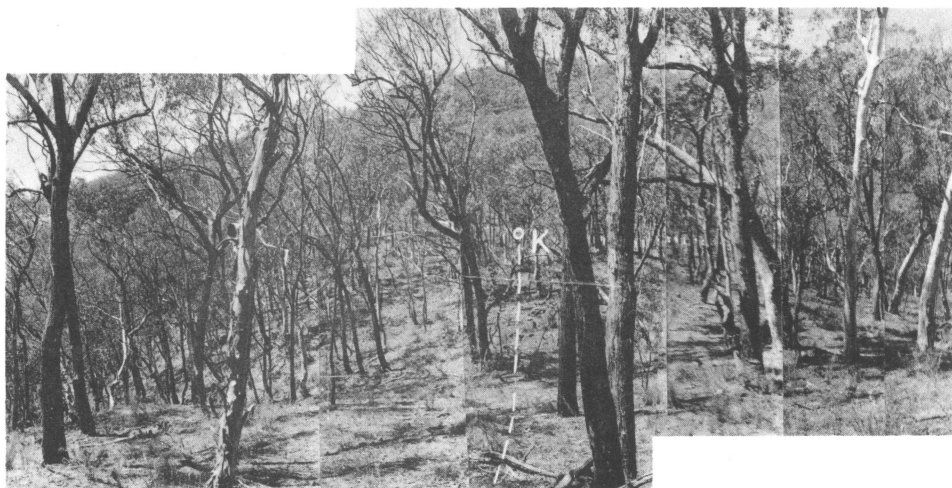
# COREE DAMSITE COTTER RIVER.

Figure 2. (top) Damsite, looking north-west (upstream). Seismic traverse AB, marked, is possible dam axis. A is at R.L. 2066.

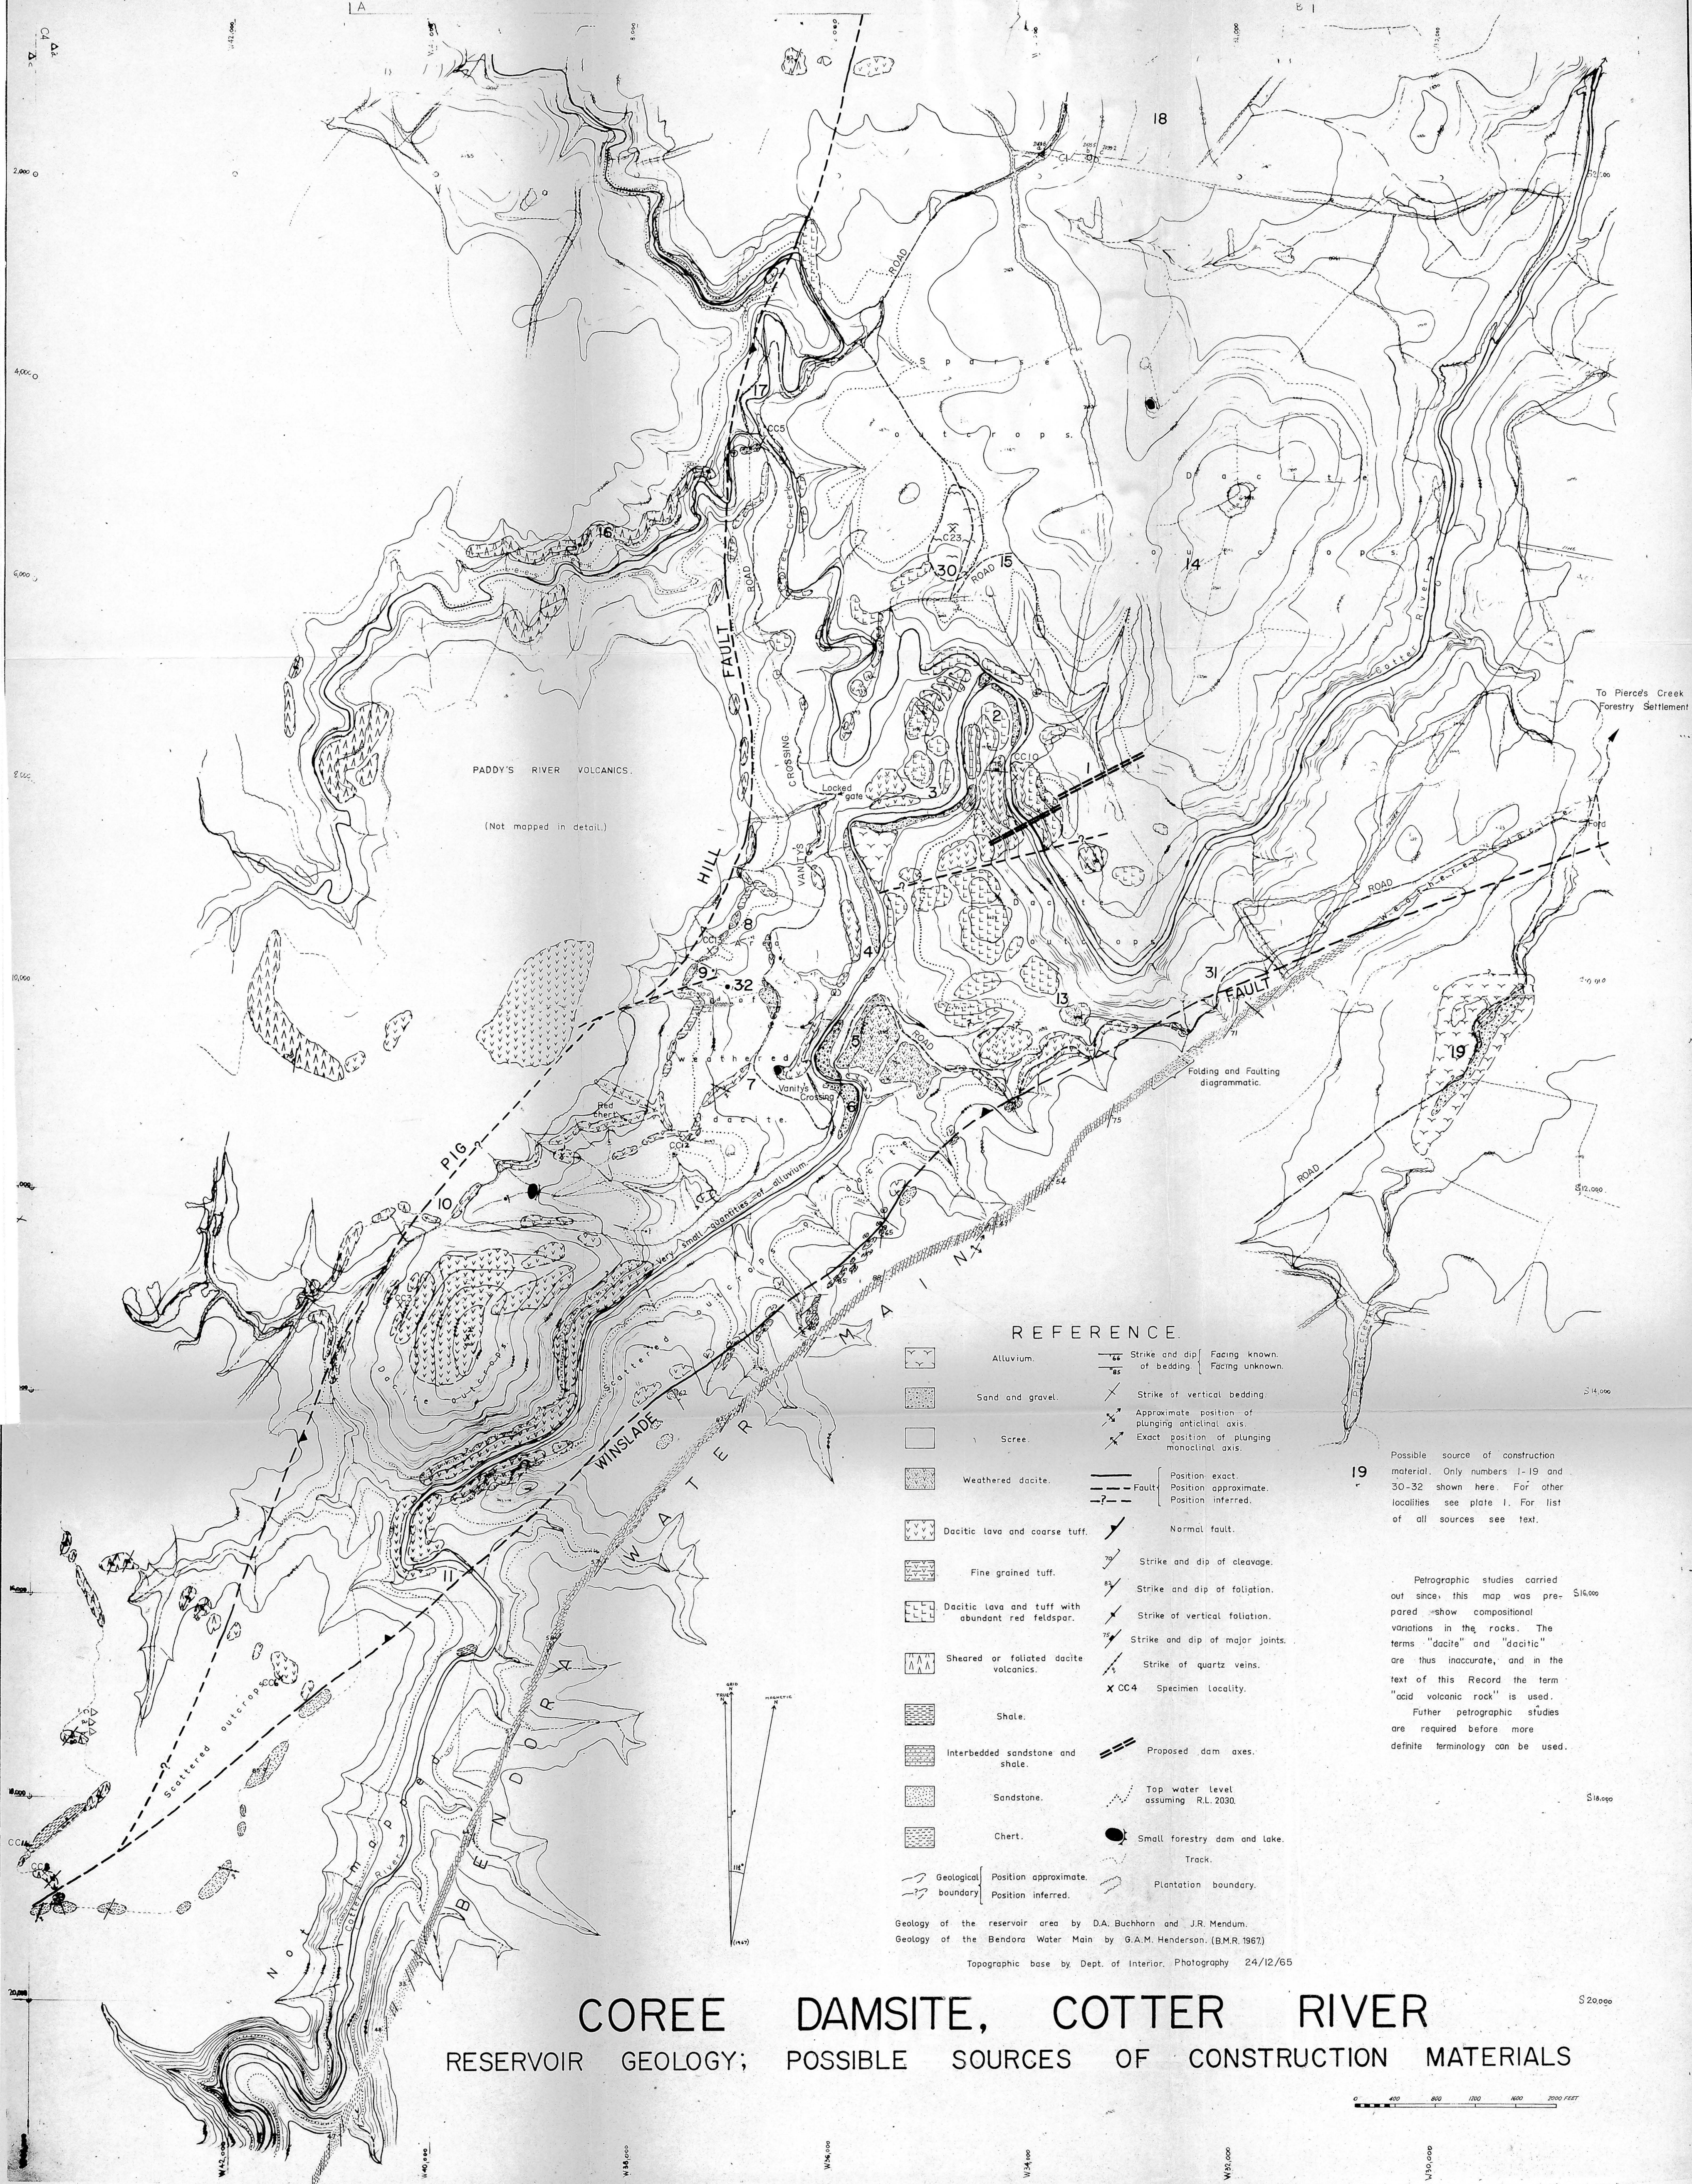
COREE DAMSITE, COTTER RIVER  
RESERVOIR GEOLOGY; POSSIBLE SOURCES OF CONSTRUCTION MATERIALS

(d) Leakage through a suspected fault downstream of the damsite, nearly parallel to the Winslade Fault, and cutting through a meander in the Cotter River (see Plate 2). The possible existence of the fault is inferred from colour changes in the adjoining rock and the alignment of gullies. The possible leakage path at top water level is about 800 feet. Further investigation will be necessary.

(g) Landslides in Ordovician sediments. Scree cover within the reservoir is not very thick and slopes are gently-sloping. Minor slips could occur. Bedding planes in the sediments are possible causes of slips, although there are no soft beds. The beds generally dip towards the river, but in most of the reservoir area they dip at angles greater than  $57^{\circ}$ , steeper than any natural surface. In the upstream part of the reservoir (south-east corner of Plate 2) the bedding dips at lower angles than the natural surface. Field examination of this area in any future investigation is warranted. Slides of a magnitude sufficient to impair the reservoir are not expected.
