**Geological Report on
Site Investigation and Construction
of Corin Dam, Cotter River, A.C.T.**

E.J. Best

Record 1969/111

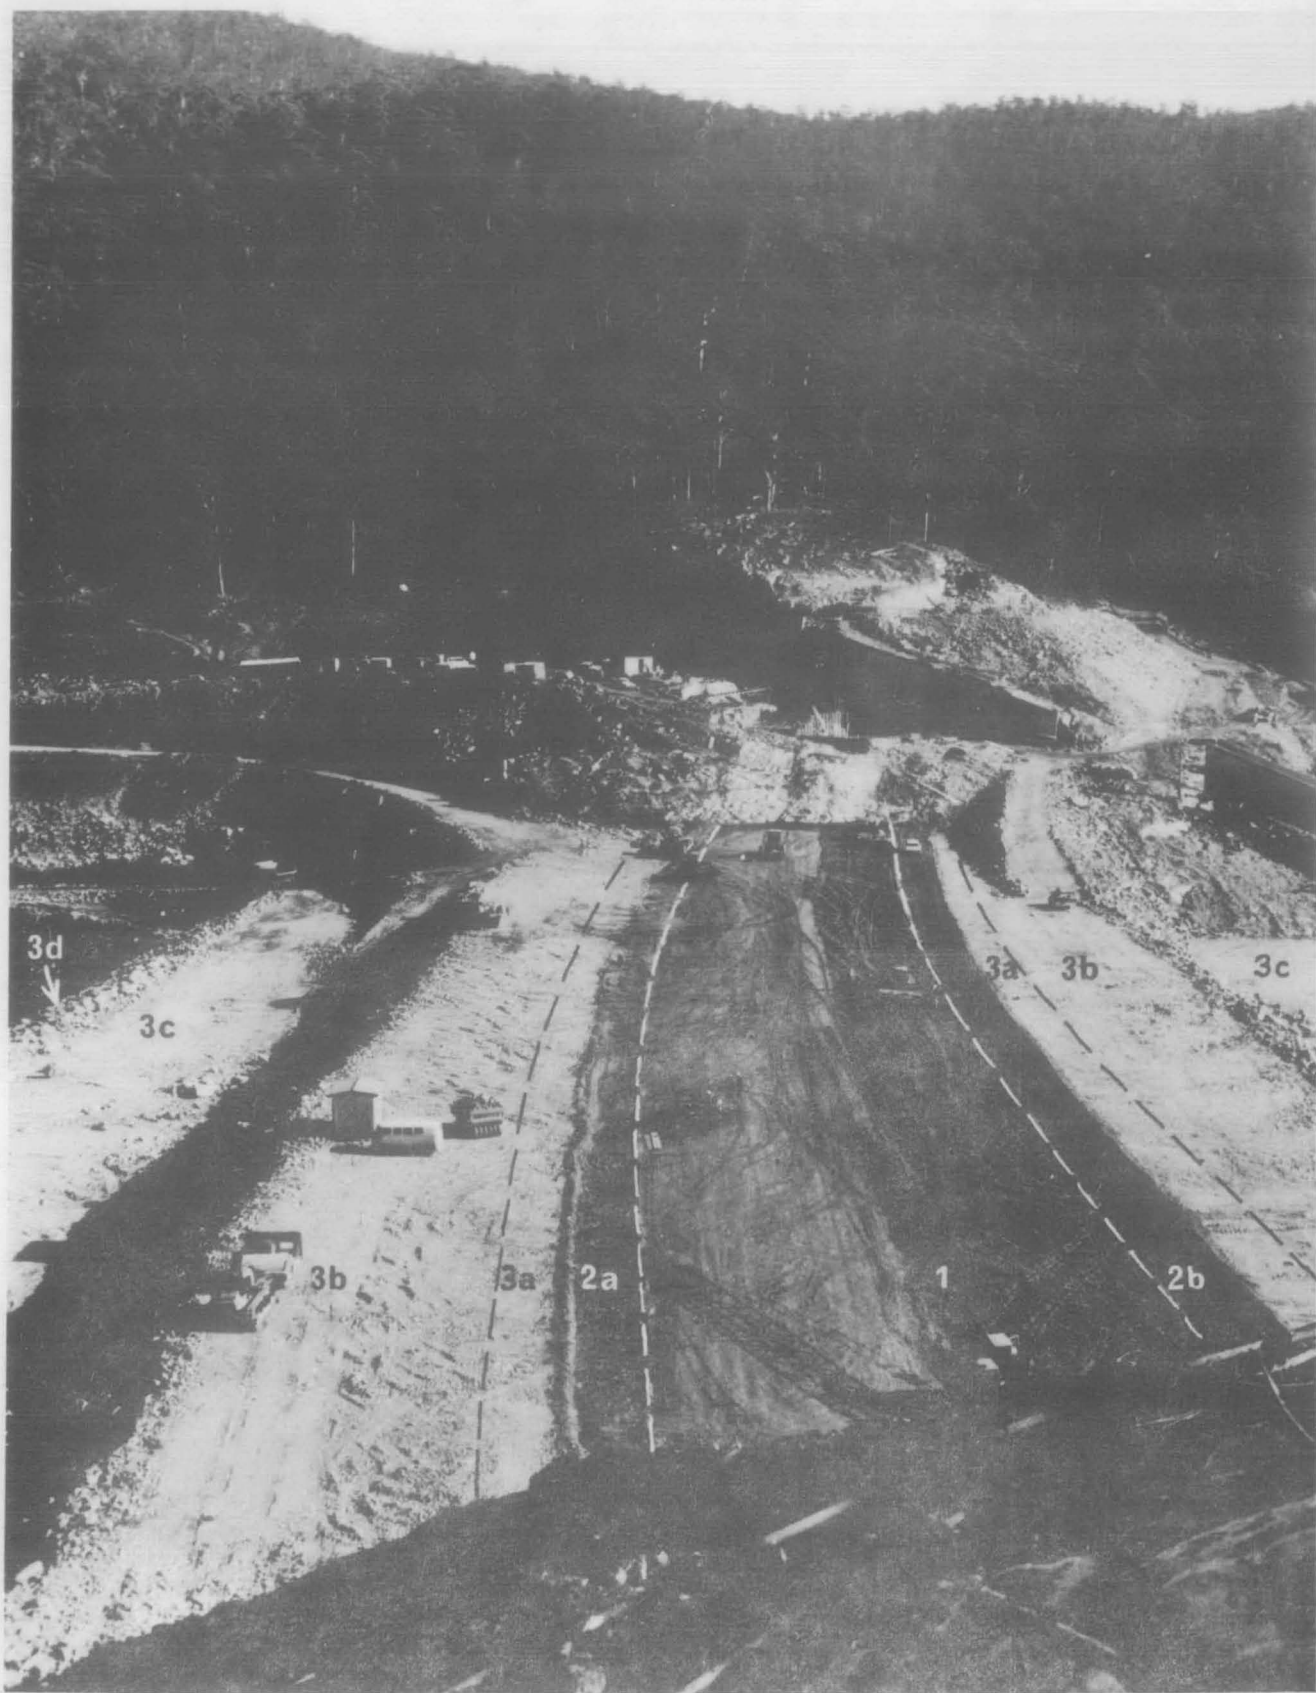
Fig. 3 :- Photograph of the dam during construction showing the zoning of construction materials - see Fig. 2 for descriptions of the various zones. The top of the core zone is at R.L. 3068 feet.

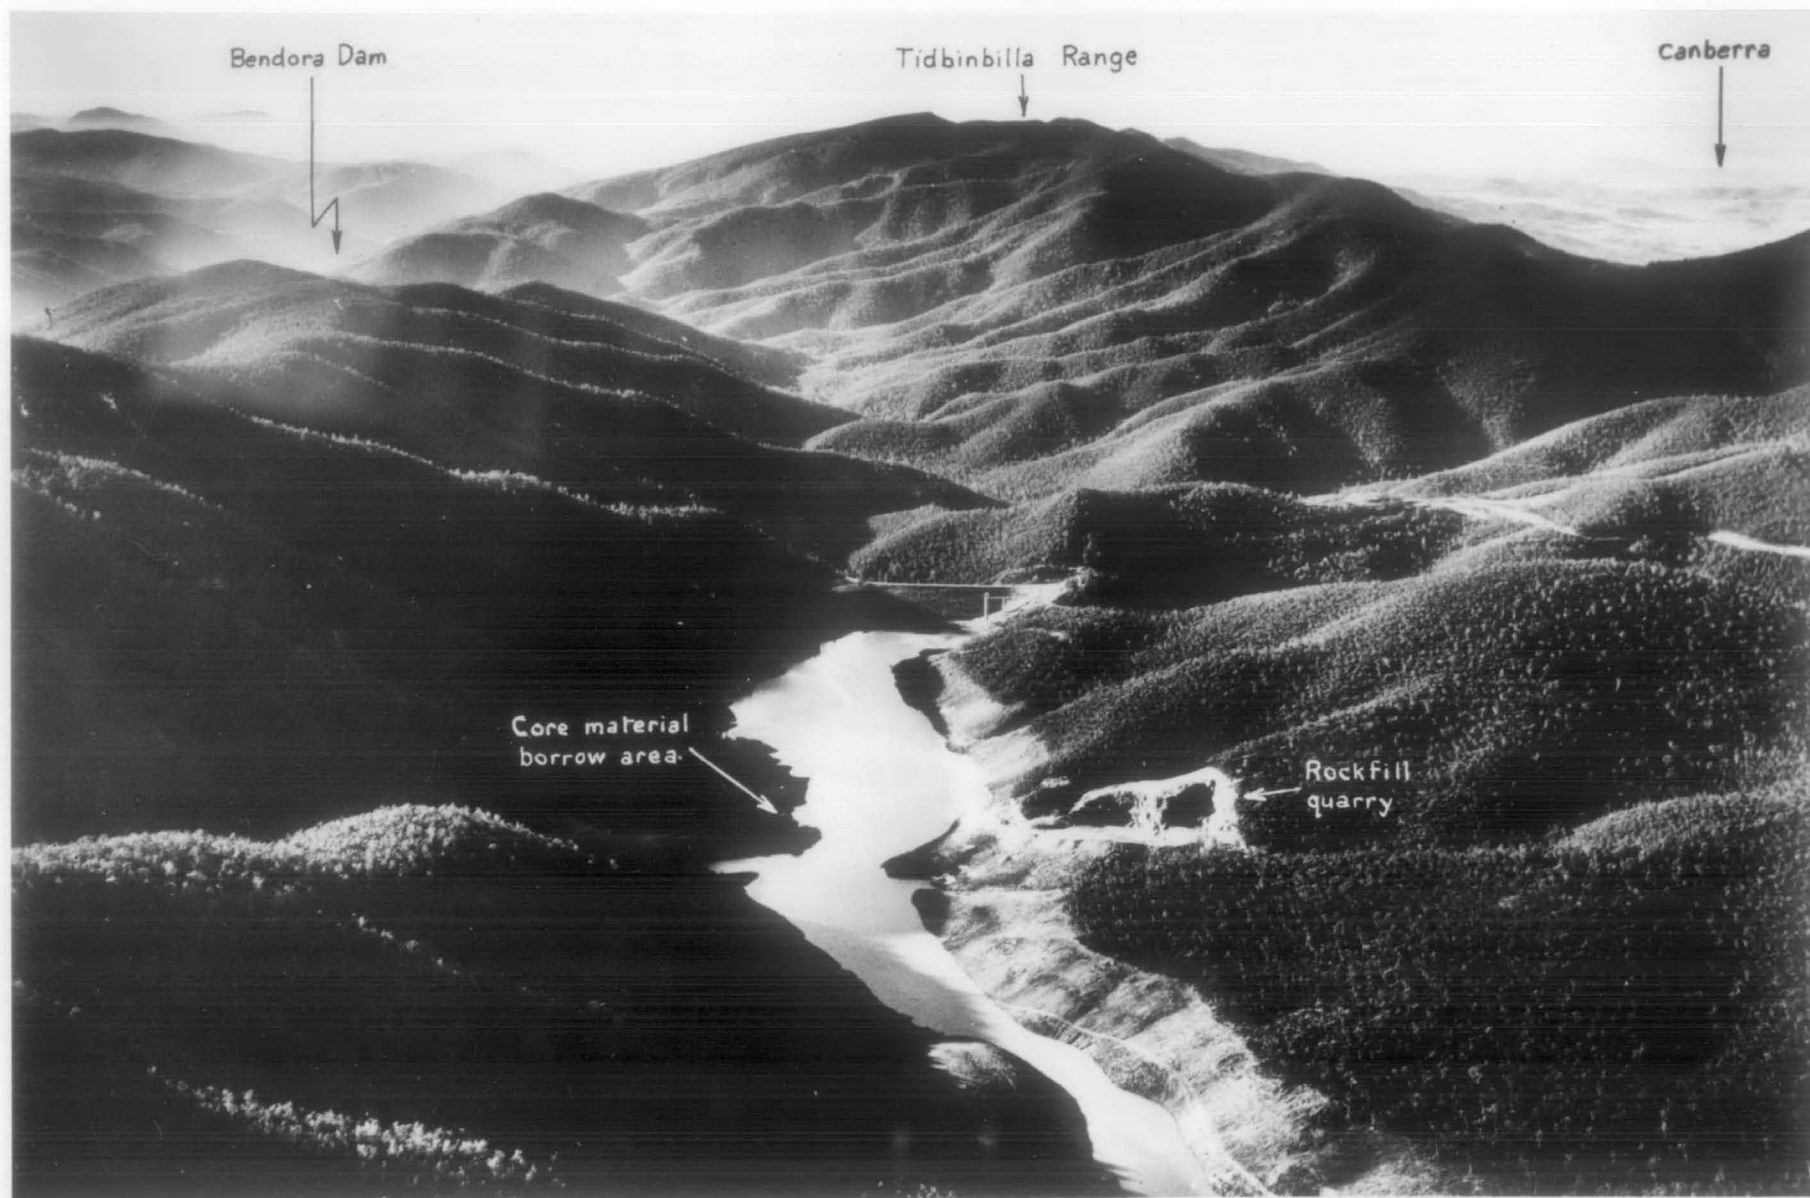
Fig. 4 :- Aerial view of the middle reaches of the Cotter valley, showing the change to a youthful river valley with overlapping spurs immediately downstream of Corin Dam. The Tidbinbilla Range is of probable Lower Silurian sediments which dip gently to the west - note the dip slope towards the Cotter River from the highest peak (Mt Tidbinbilla).

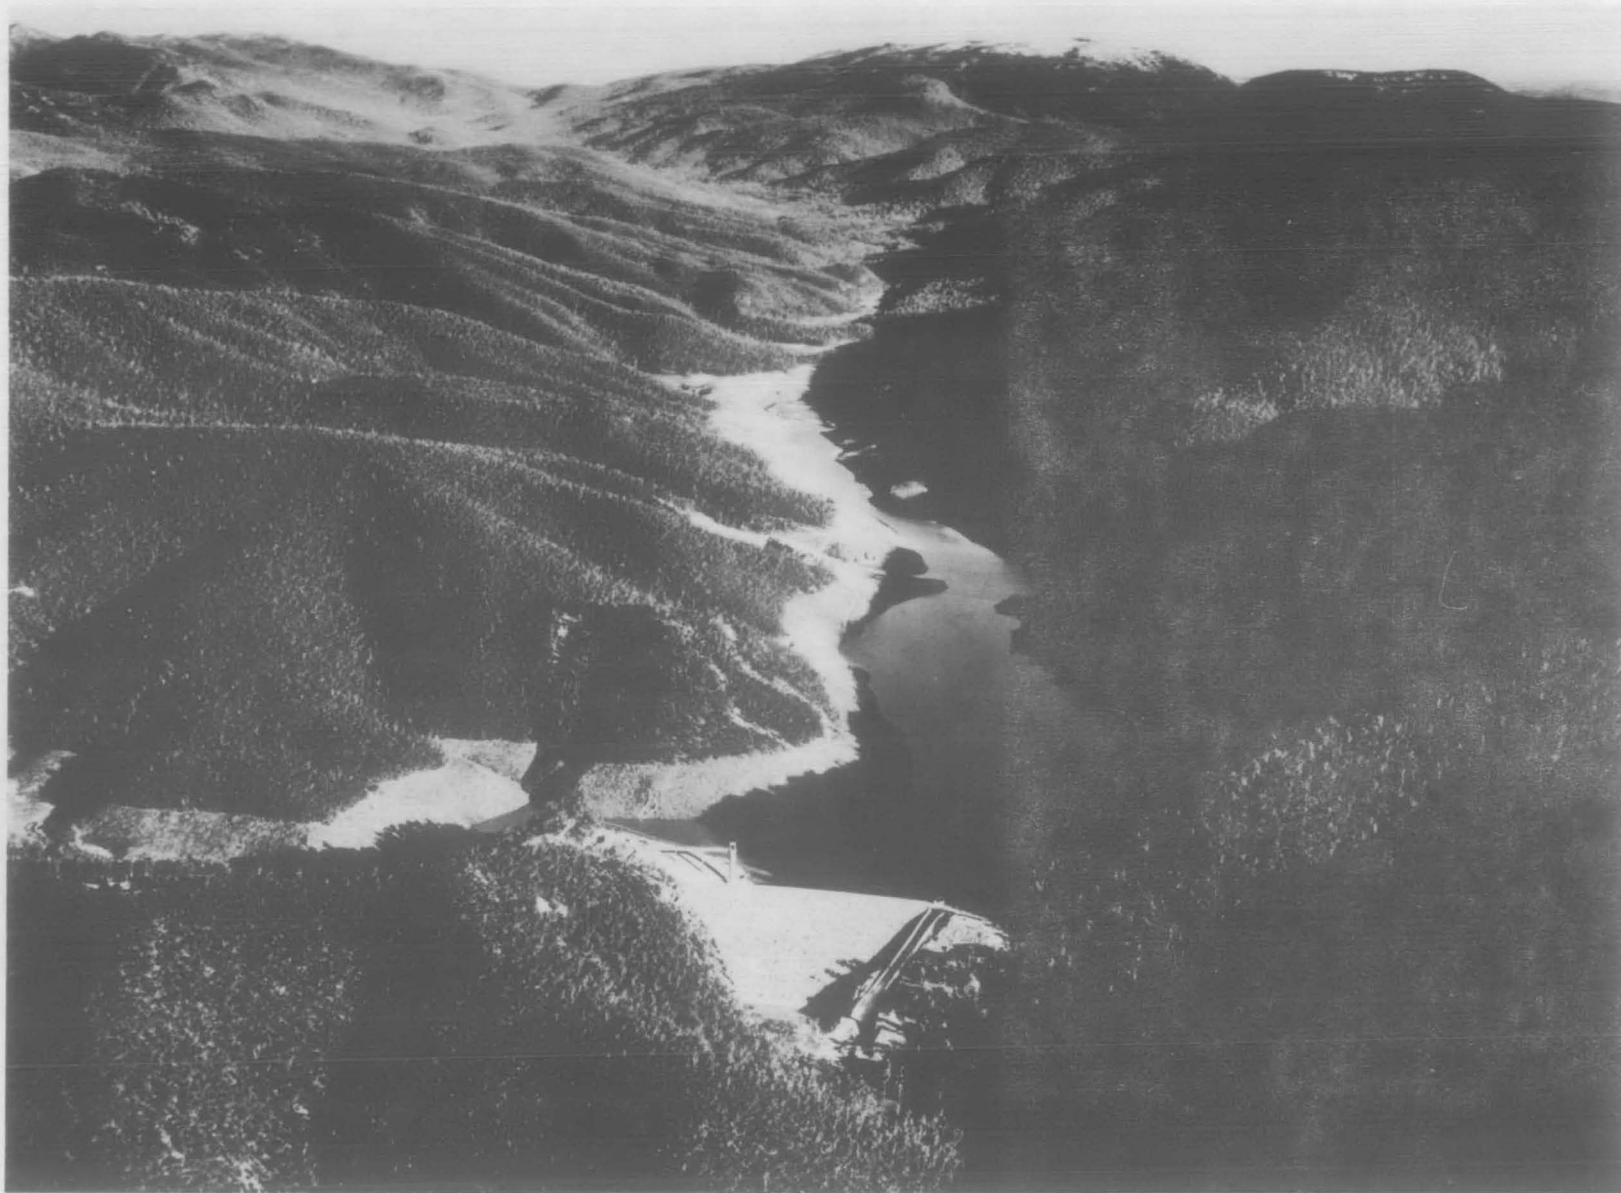
Fig. 5 :- Aerial view of the upper Cotter valley showing Corin Dam and reservoir area 3 months after plugging of the diversion tunnel. Note the subdued topography and gentle slopes in the granite at the head of the catchment area.

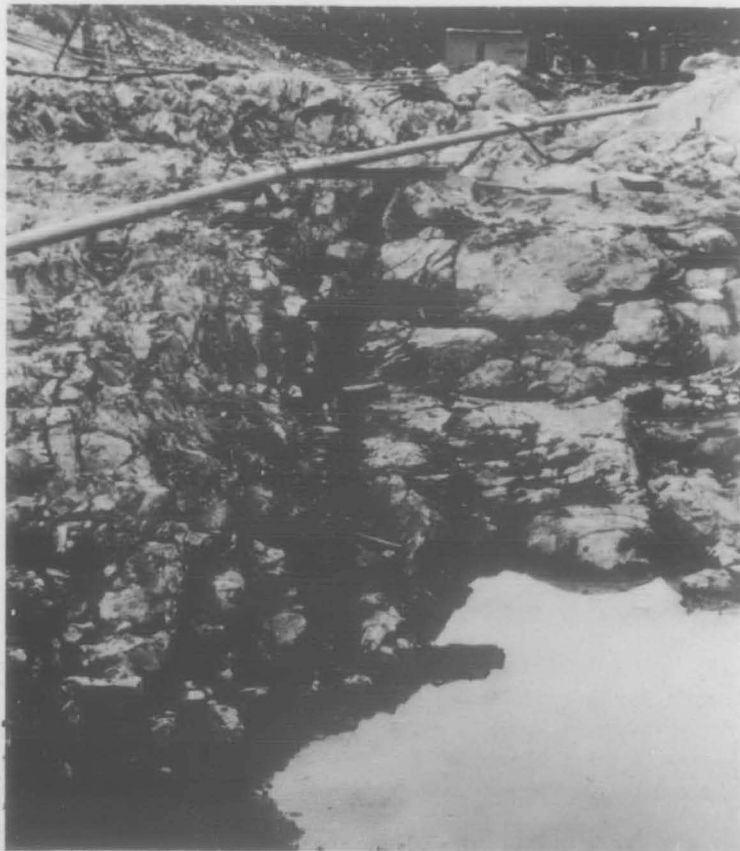
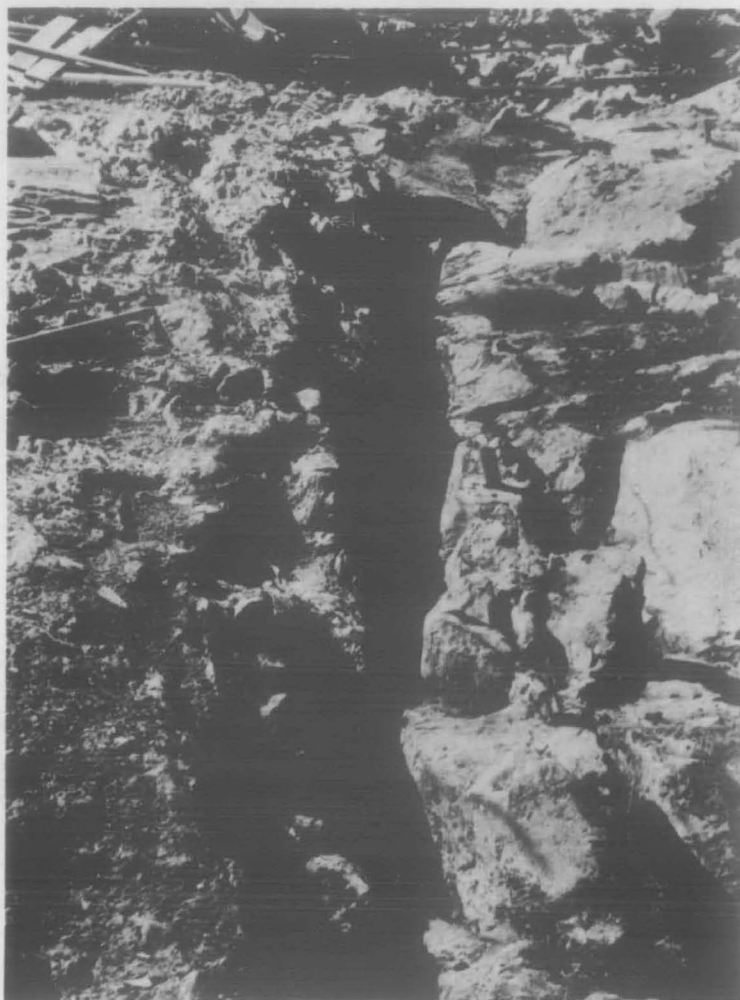
Fault E is the actual trace of the displacement which was predicted as a result of the site investigation; it is, in fact, 30 feet west of its predicted position. The fault is near-vertical, and consists of a zone of crushed rock, ranging in width from 2 to 12 inches, which contains a few impersistent clay seams. Although the fault zone is rather narrow (see Fig. 12), the displacement along it must be considerable, as the rock sequences on either side of the fault are quite dissimilar. To the east, a sequence of thickly-bedded silicified sandstone is overlain by interbedded siltstone and sandstone, and underlain by sandstone with interbeds of siltstone and sandstone with silty laminae; this suggests that the thickly bedded sandstone, which is about 90 feet thick, is the same sequence as the quartzite exposed at the upstream and downstream ends of the spillway excavation. If this is so, the vertical displacement on fault E is about 150 feet, with downthrow to the west.

Fig. 12 :- Views of Fault E exposed in the valley floor core zone foundations. The top view shows the fault after sluicing of the bedrock surface; the bottom view shows the extent of excavation for concrete dental treatment. Approximate co-ordinates of the centres of both views are 540 E, 985 N.

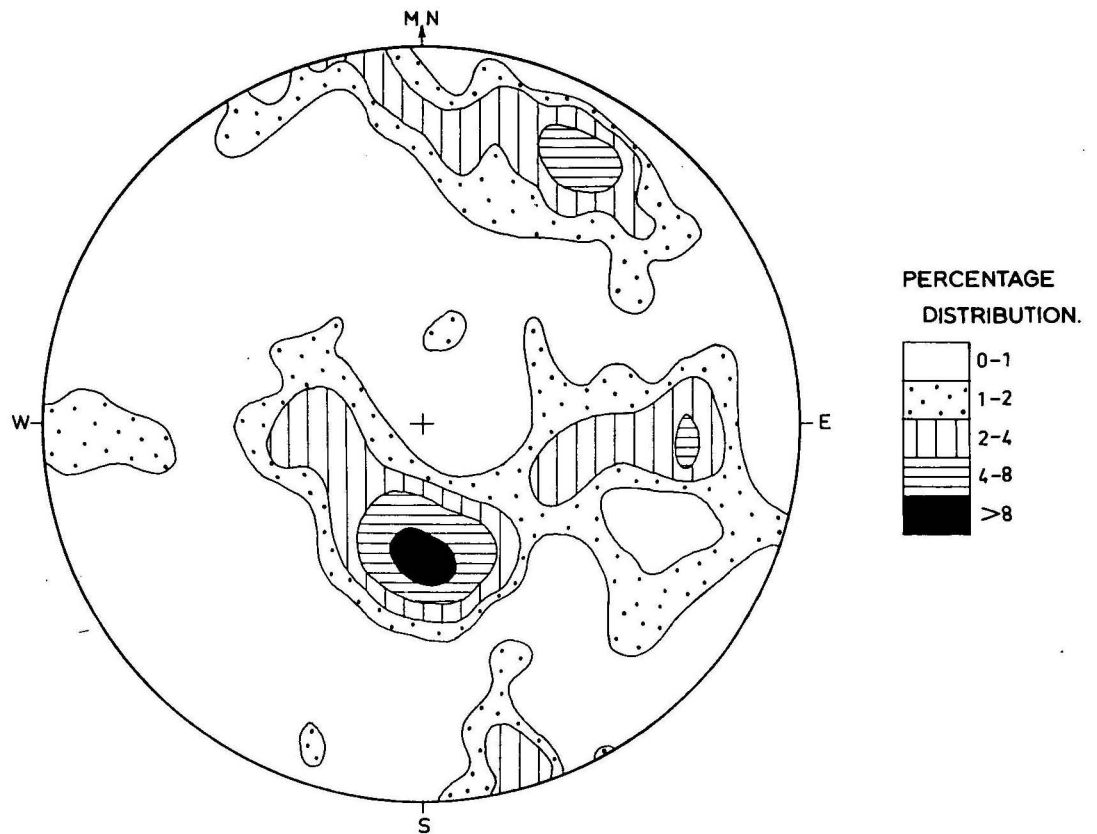
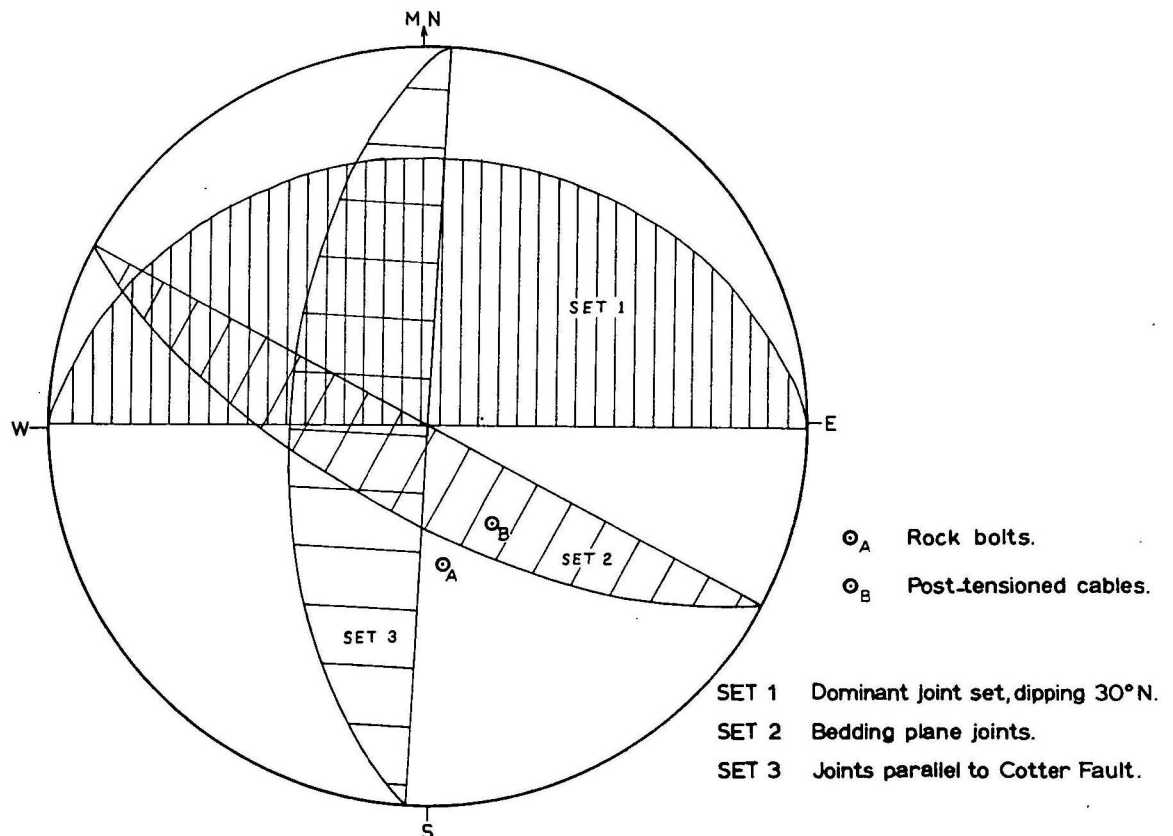
Fig. 17 :- Joint stereograms of spillway crest foundations.

- (a) Contoured stereogram of poles to 200 measured joint planes.

- (b) Stereographic plot of dominant joint sets, together with adopted orientations of crest rock bolts and post-tensioned cables.

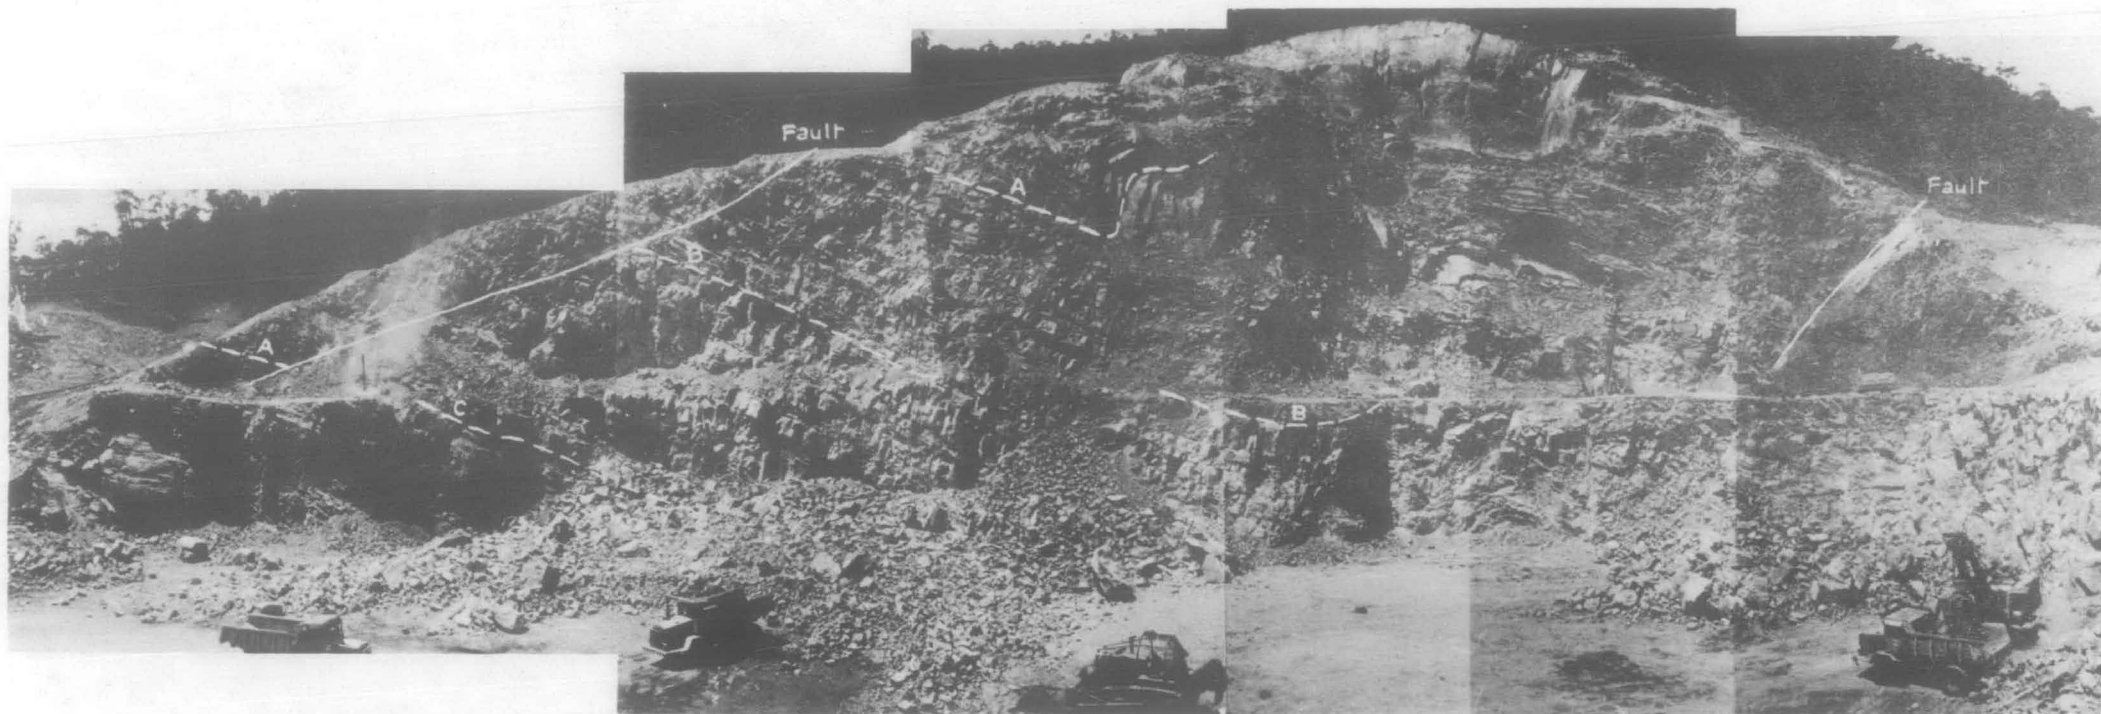
Fig. 21 :- Panoramic view of the quarry looking east from the ridge of quartz porphyry left along the western quarry boundary. The structure and geological succession are indicated by annotations - see Plate 14 for the reference. This panorama was taken at a late stage of the quarry development, and working of the fifth bench is well-advanced.

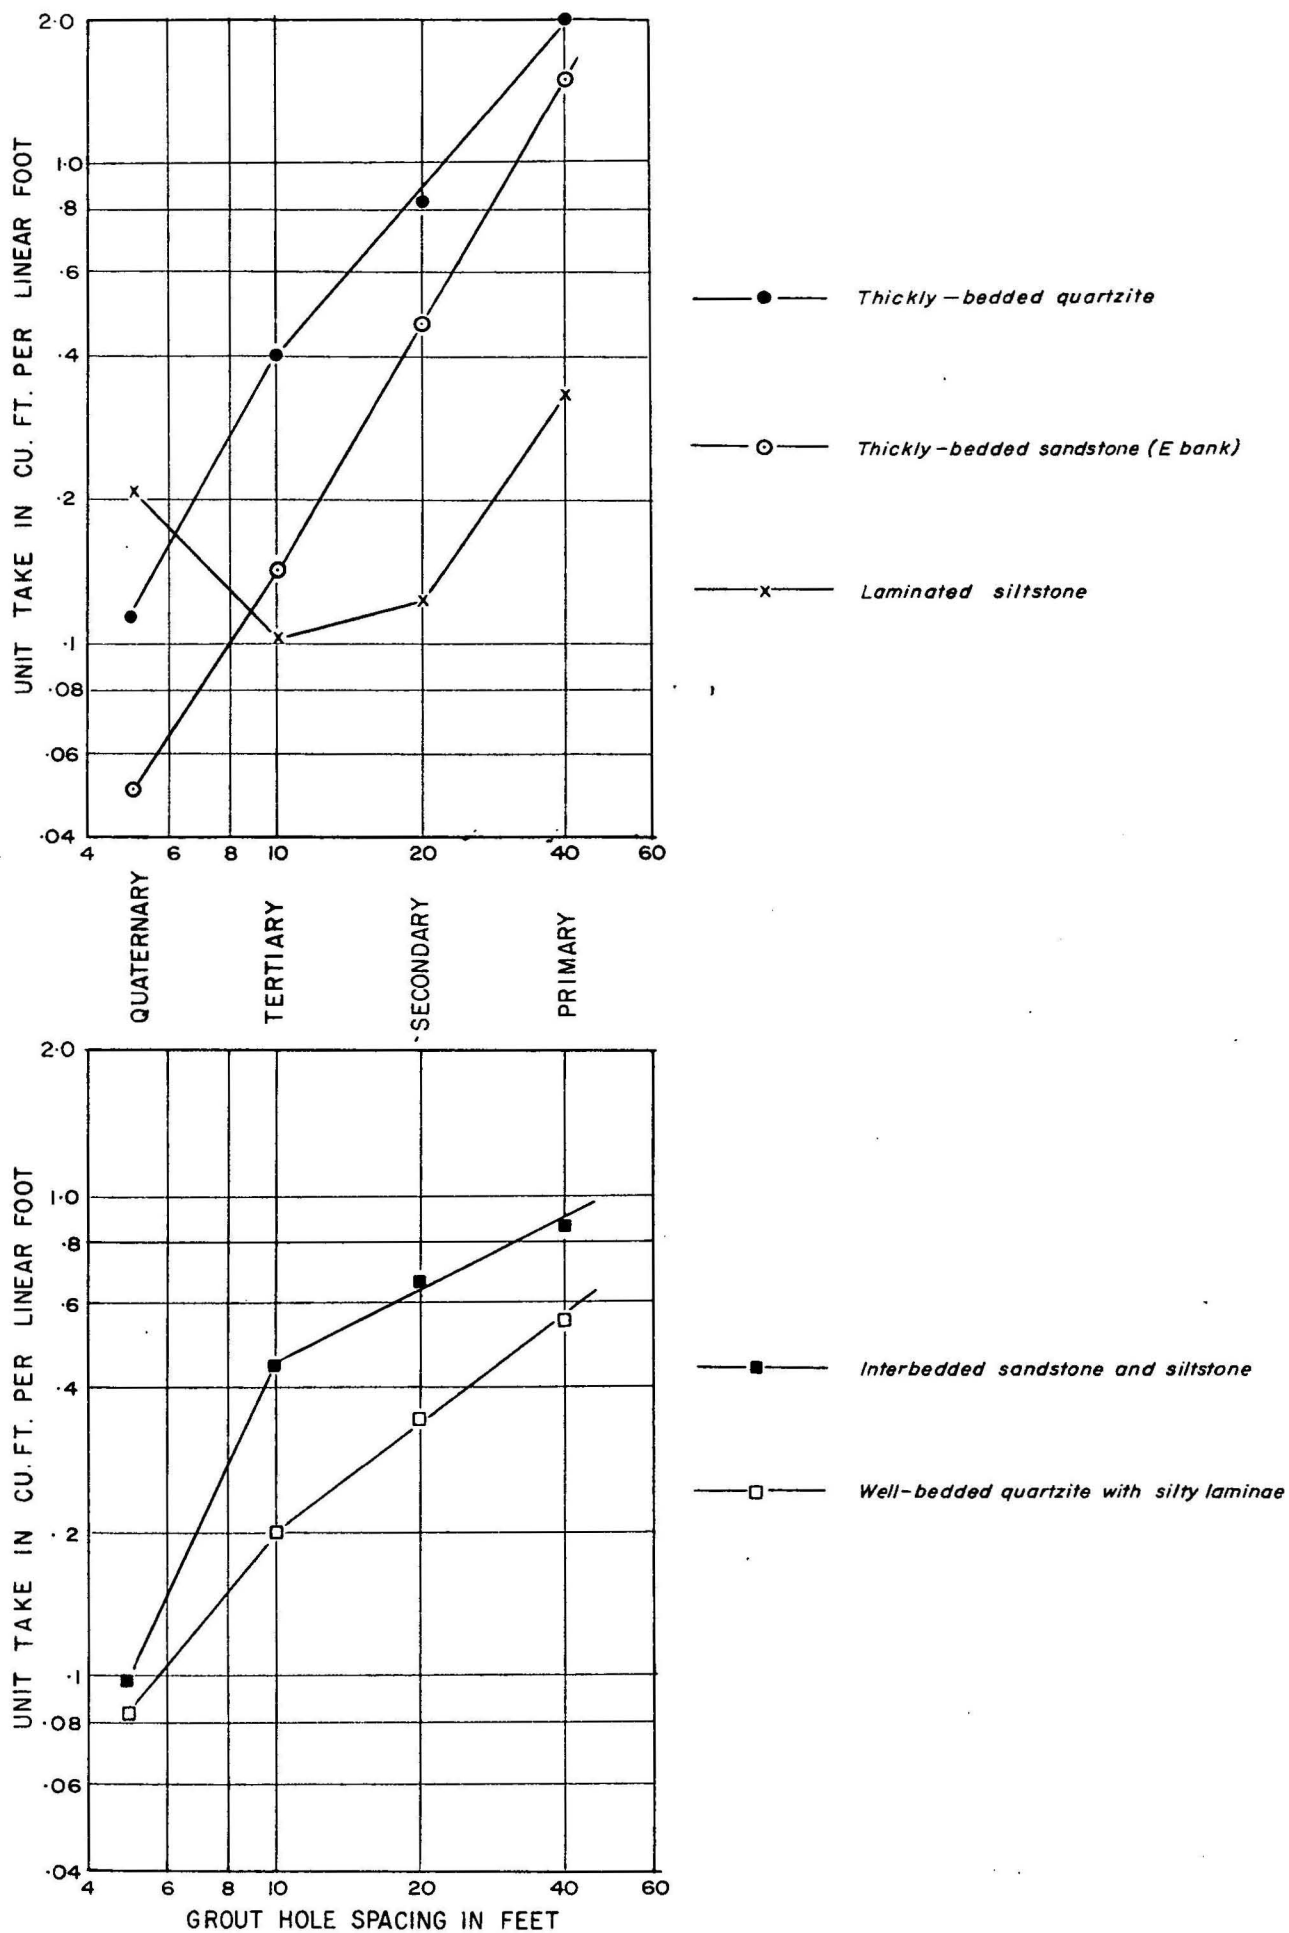
The results (Fig.22 and Table above) together show that, by Grant's criteria, an effective grout curtain has been constructed at Corin Dam.

Fig. 22 Correlation of unit takes during curtain grouting with hole spacing for different foundation rock types

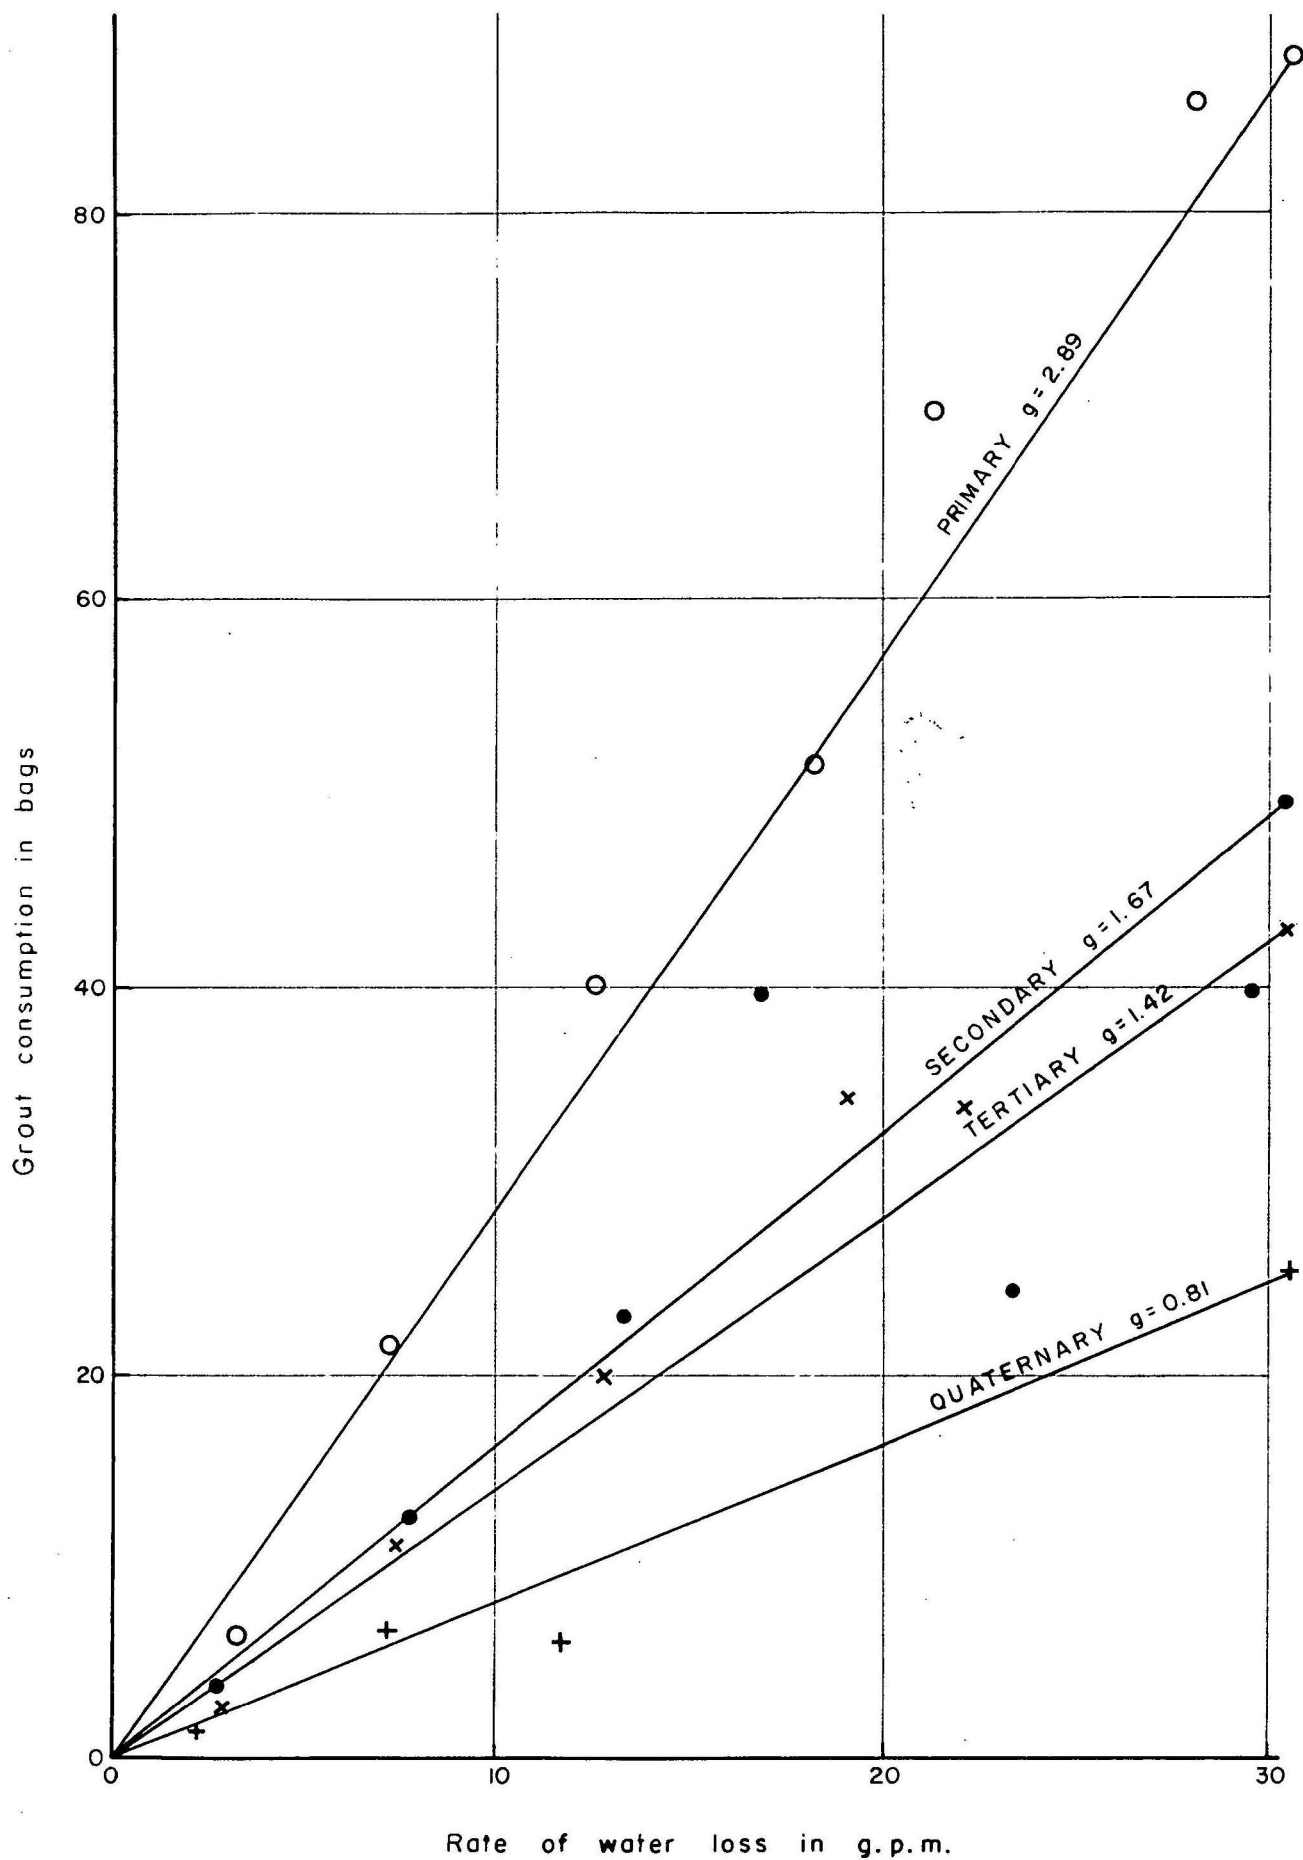
The curtain below the core zone was the first area analysed by this method. To start with, the four closure phases of grouting were considered separately. The plot of average grout take against average rate of water loss for the primary holes was close to a straight line, and although the plots for secondary, tertiary and quaternary holes were more scattered, a linear relationship was apparent, particularly if the high water loss values were ignored (see Fig. 23).

Fig.23:— Correlation of grout consumption in curtain holes with water test results.

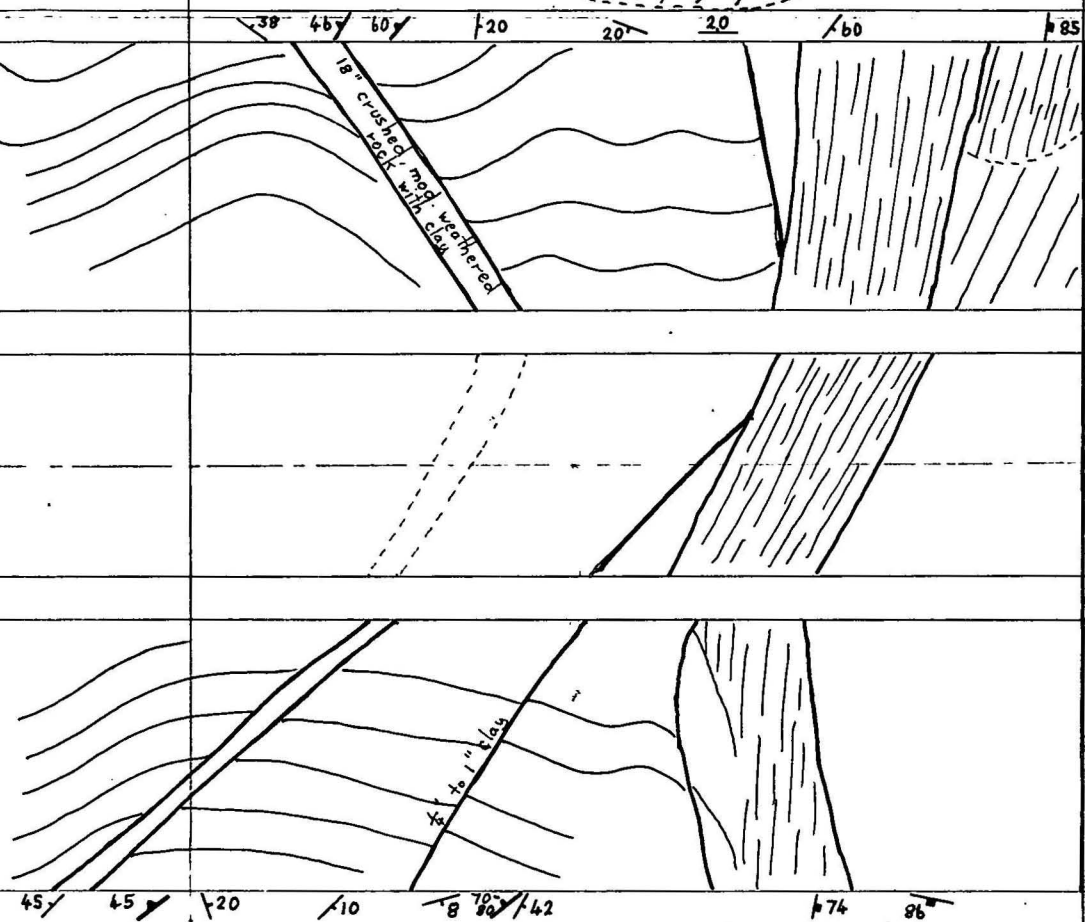
FACE AT STN. 00+50

Bedding planes most prominent partings.
Direction of bedding variable due to folding.
Bedding planes spaced 6" to 2 feet apart and
surfaces generally weathered.

Faults: ① 40°-60° to tunnel and dipping 45°-60° west
② 45° to tunnel and dipping 70°-80° west

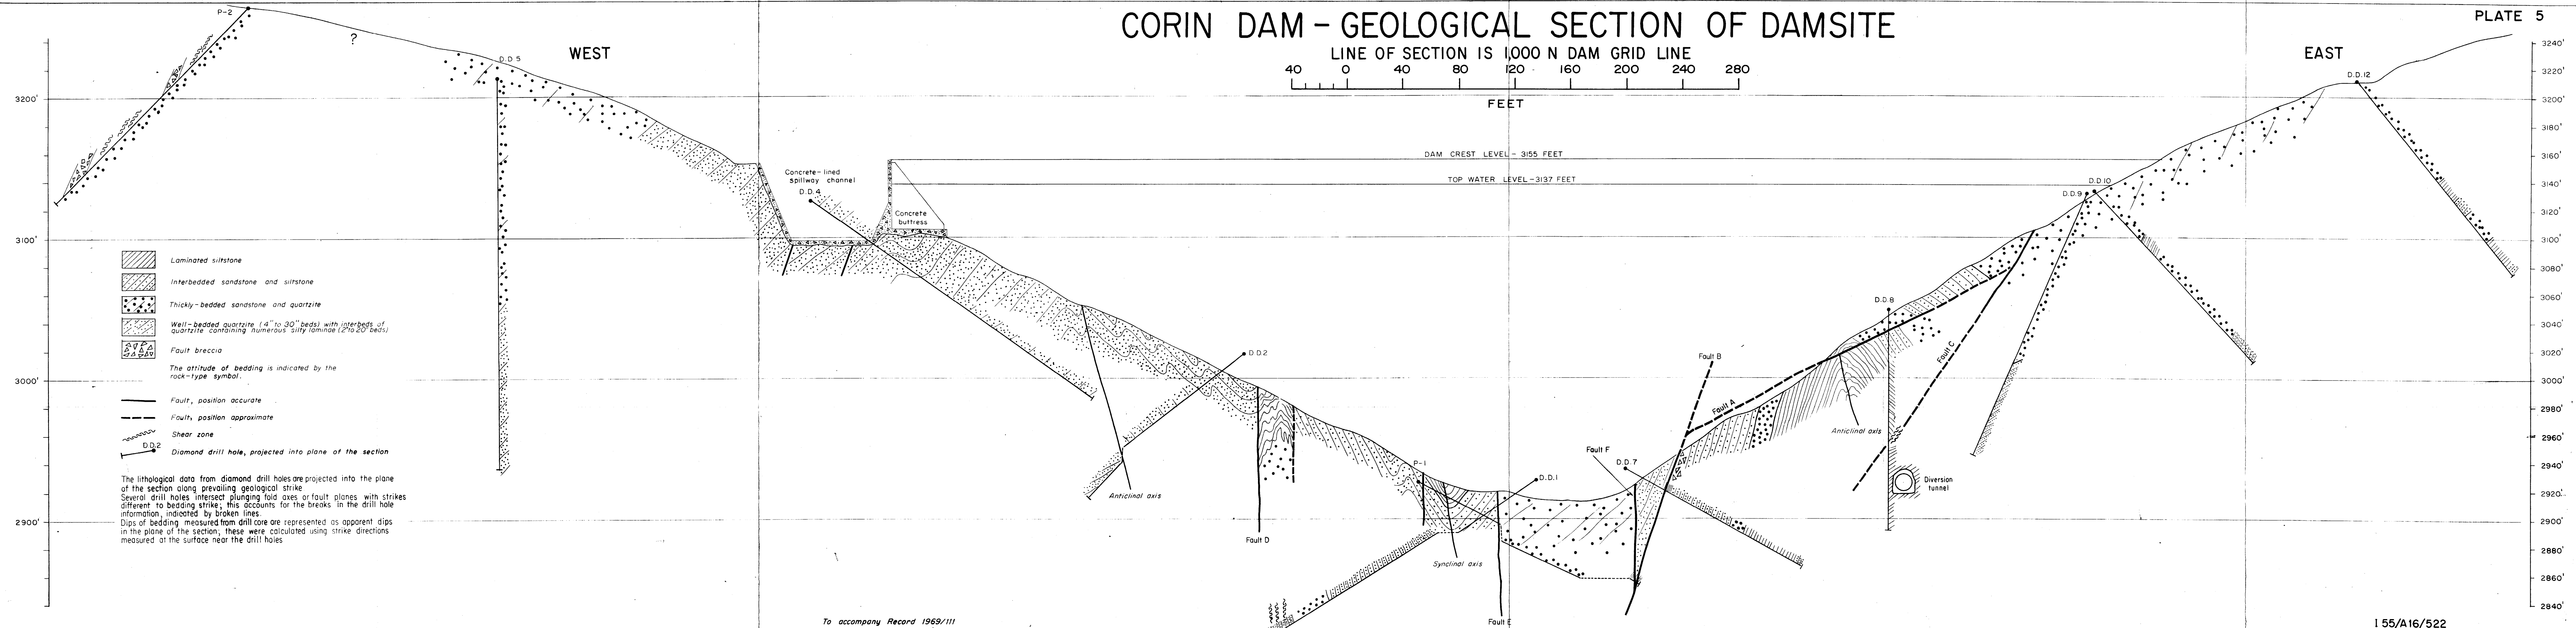
PLATE 5

Two of the major faults exposed on the east bank of the dam foundations can be correlated with faults mapped in the tunnel. The 60° fault which crops out high on the eastern foundations (fault C in Plate 5) correlates with a 6-inch zone of crushed rock and clay which was exposed in the tunnel between chainages 545 and 572 feet; the rock on both sides of the fault at tunnel level is fresh laminated siltstone. The 40° fault on the east bank (fault A) is correlated with a prominent contact between sandstone and siltstone which was exposed between chainages 480 and 510 feet. Although a significant fault was not evident, the contact cuts across the bedding, dips at 35° to 40° to the south-west, and is on the projected strike line of fault A at tunnel level.
