**Geological Report on
Site Investigation and Construction
of Corin Dam, Cotter River, A.C.T.**

E.J. Best

Record 1969/111

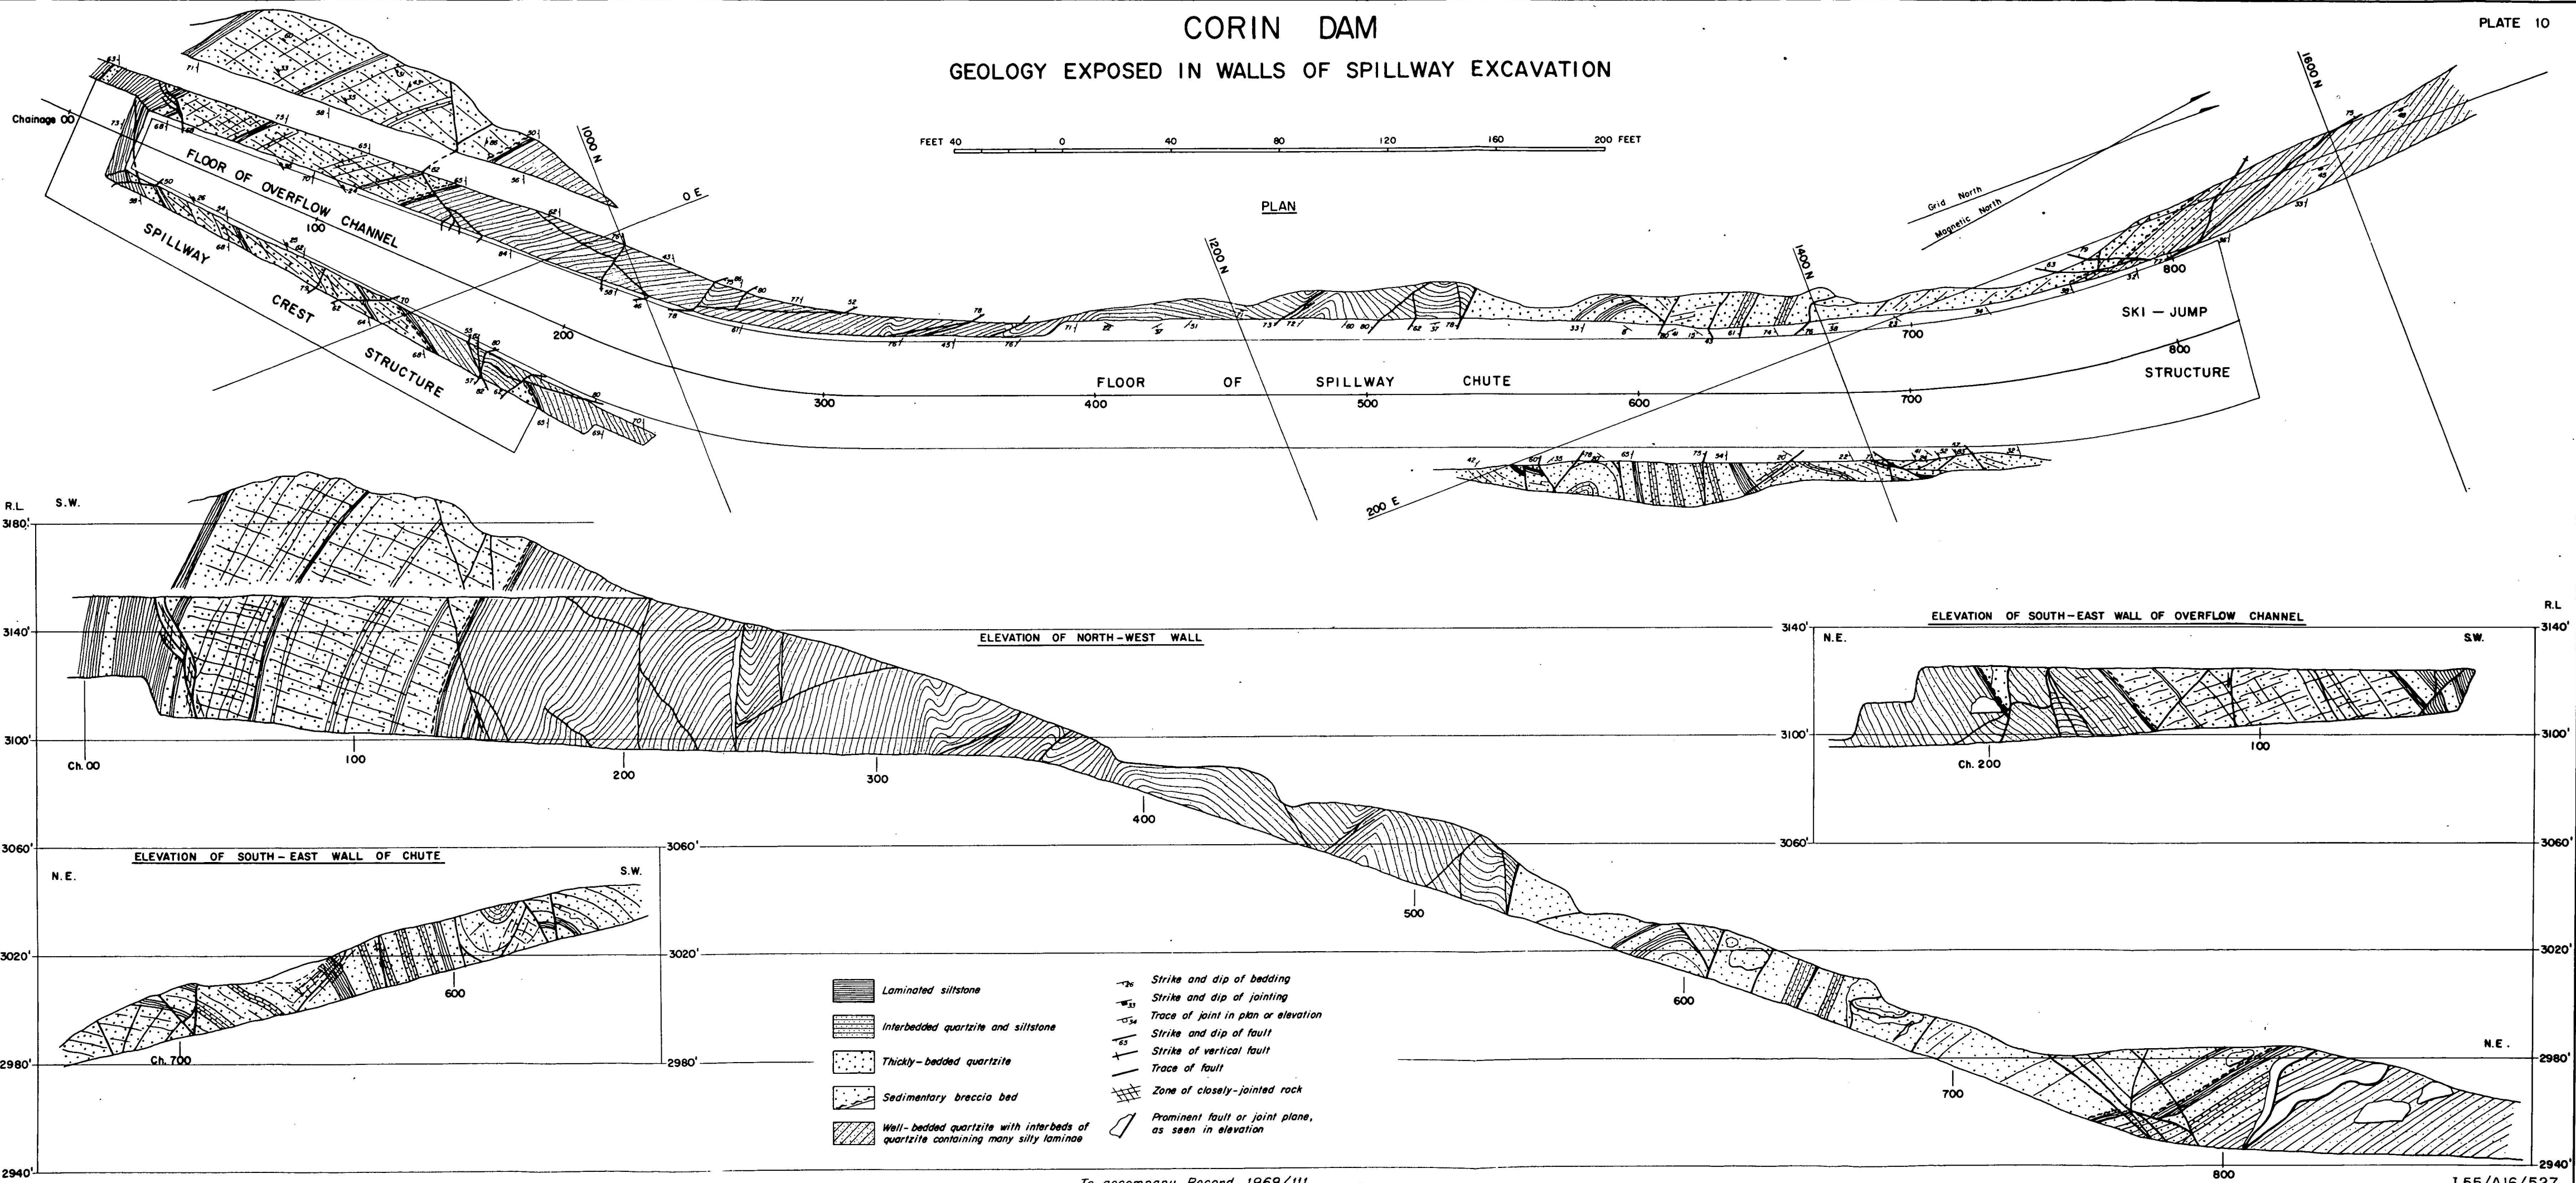
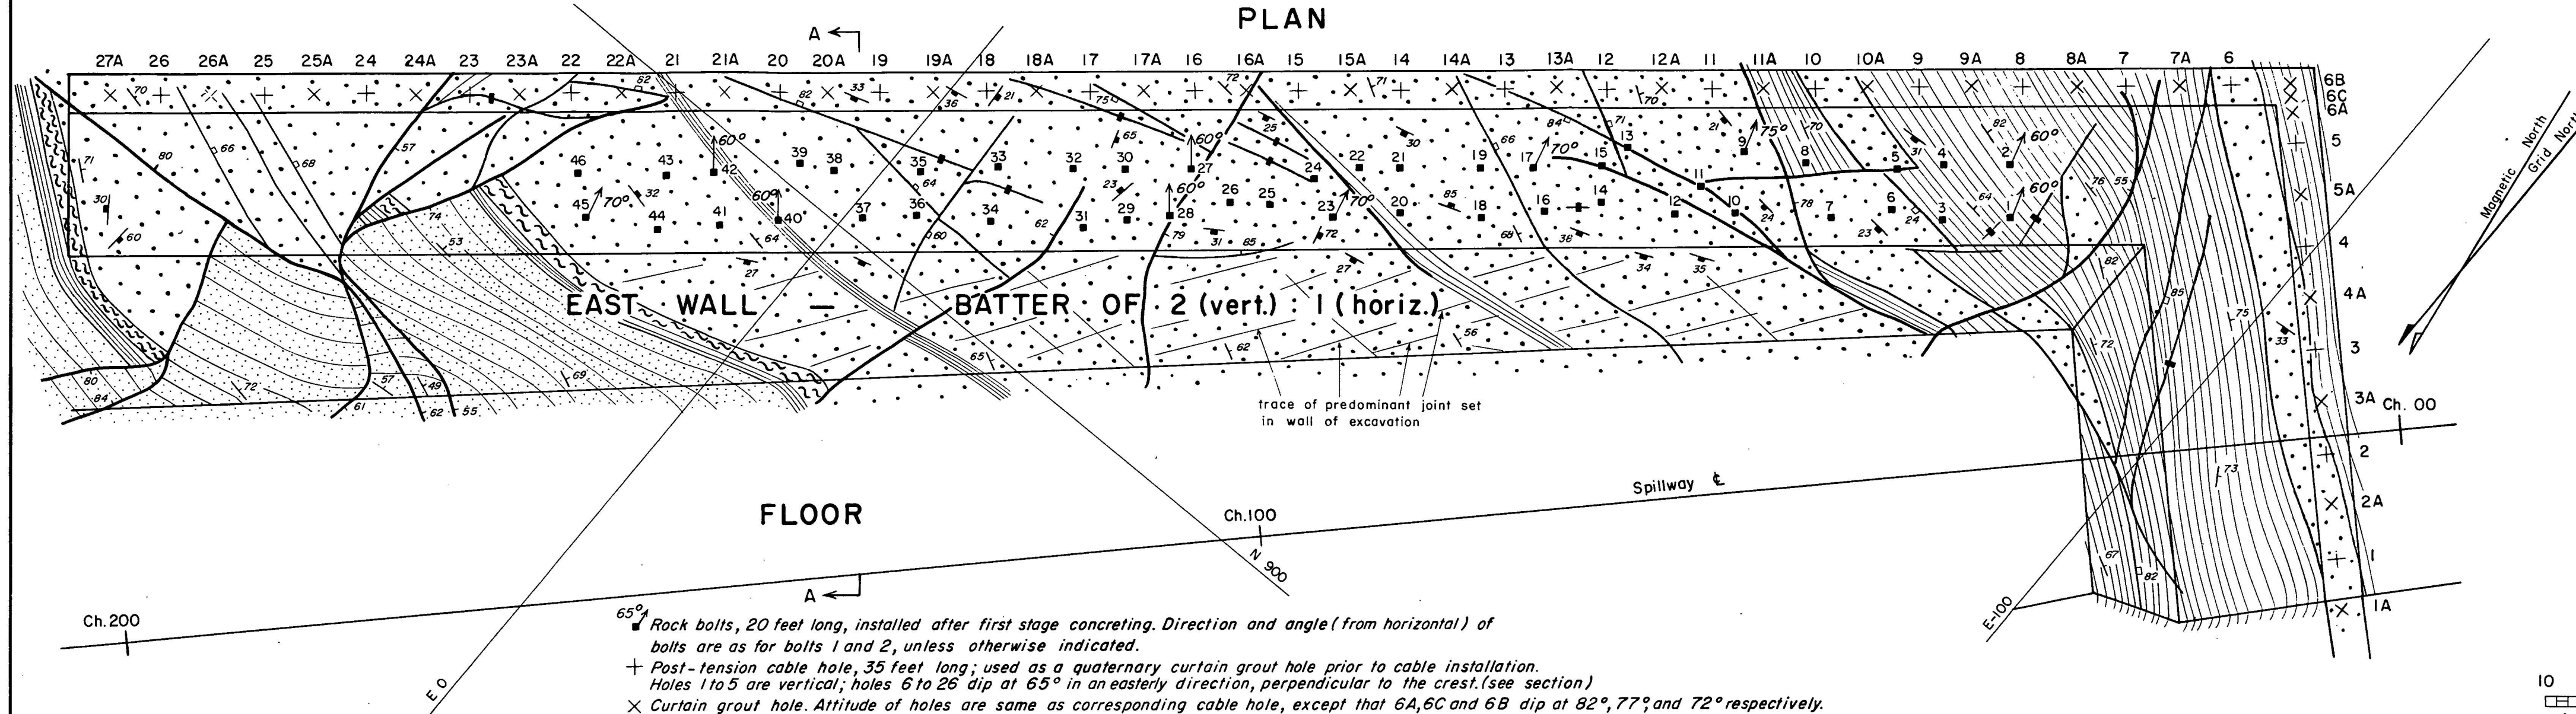
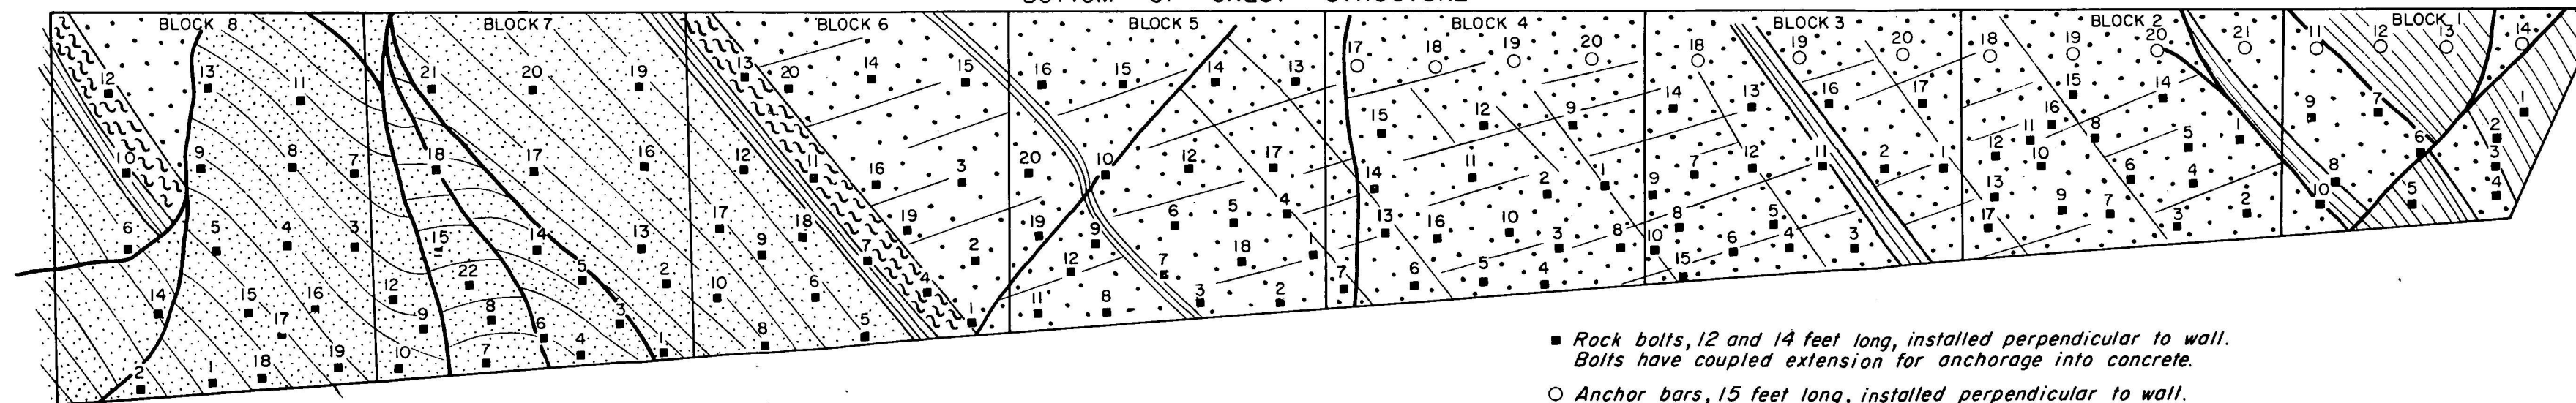
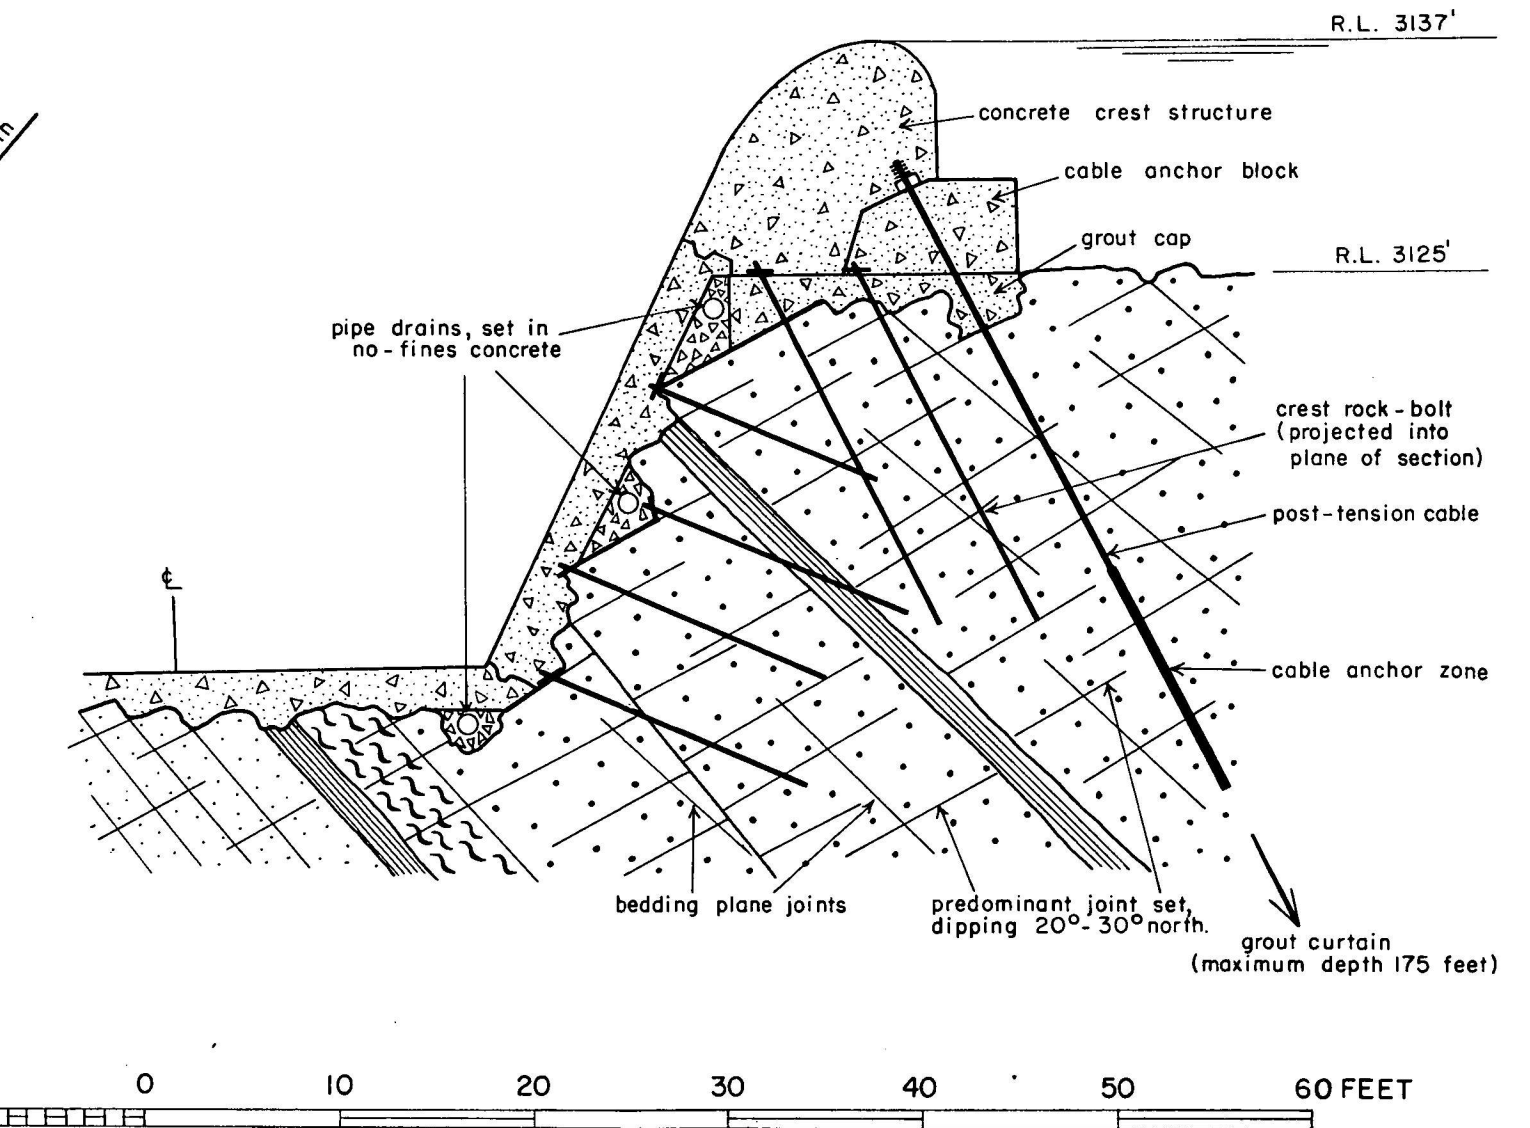
PLATE 11

The orientation finally adopted for the 26 post-tensioned cables was virtually dictated by attitude of the adverse joint set, combined with the position of the bedrock surface downhill from the crest area. On the one hand, the joint set dictated that the cables should be angled at 65° or less from the horizontal in a downhill direction; on the other hand, the holes had to be as steep as possible, so that the anchorage zones are not too close to the bedrock surface. It was therefore decided that the collars of the cable holes should be located as originally planned, but that the orientation of the holes should be changed from vertical to 65° in a direction normal to the line of holes and downhill; inspection of the joint stereogram showed that this orientation is not near-parallel to any joint sets (see Fig. 17). The cables are 35 feet long, have an anchorage zone $12\frac{1}{2}$ feet long, and were tensioned to 50 tons before final grouting of the cable holes. A concrete anchor block was constructed along the crest before installation of the cables, and after tensioning, testing and grouting, the third and final stage of the concrete crest was placed (see section in Plate 11).

As an added precaution, the stability of the crest foundations was further increased by the installation of 135 grouted rock bolts in the wall of the channel excavation below the crest. The bolts are all 12 or 14 feet long, and replace a similar number of proposed 15-foot long anchor bars in the original design. However, whereas the anchor bars would have been installed on a regular pattern, the rock bolts were located according to the rock conditions exposed in the wall. The programme of rock bolting in the wall is shown in the elevation in Plate 11, and the attitude of these bolts in relation to jointing and bedding is illustrated in the section through the crest.

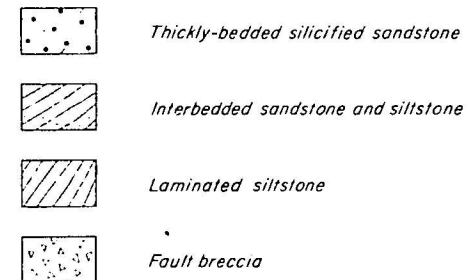
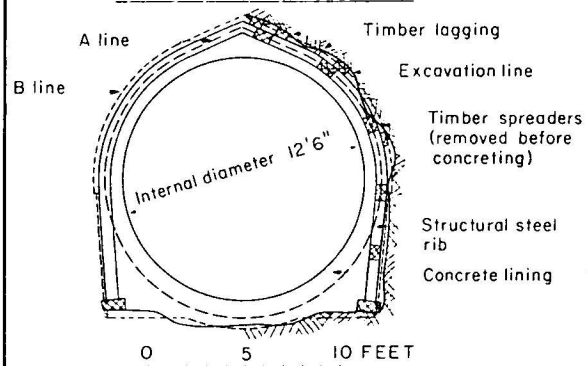
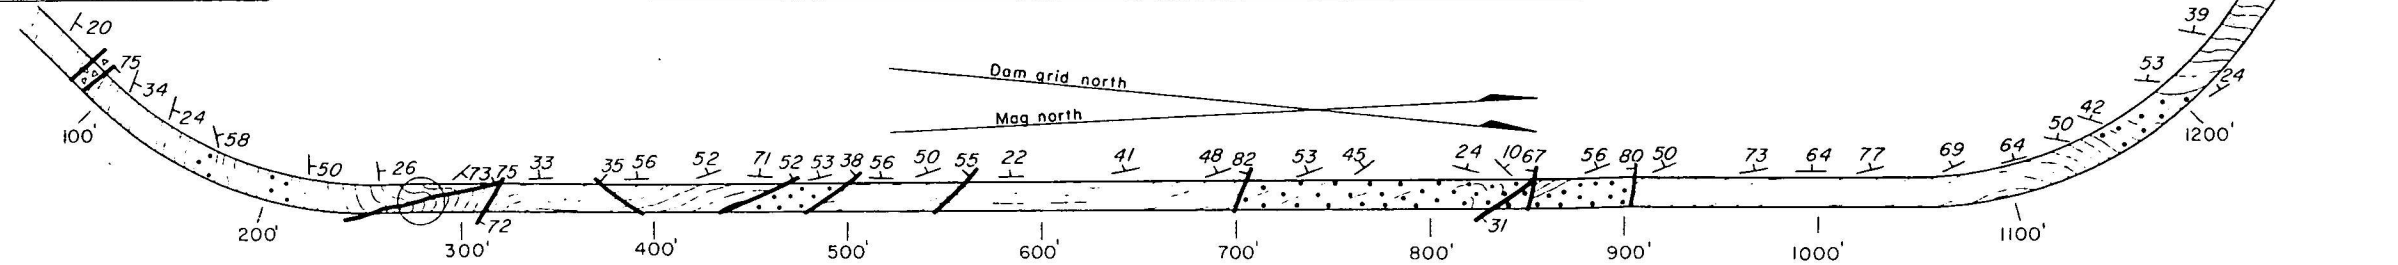
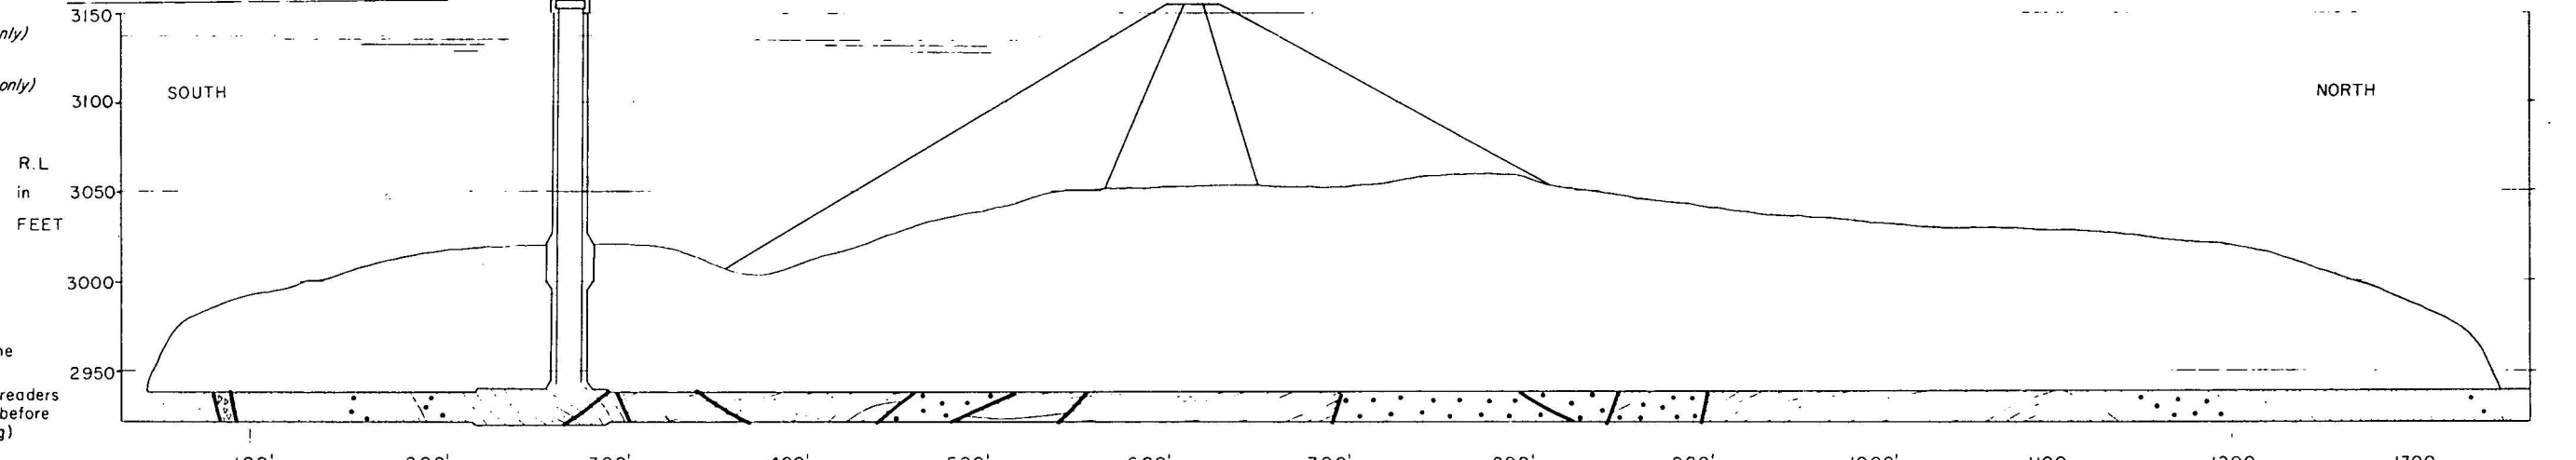
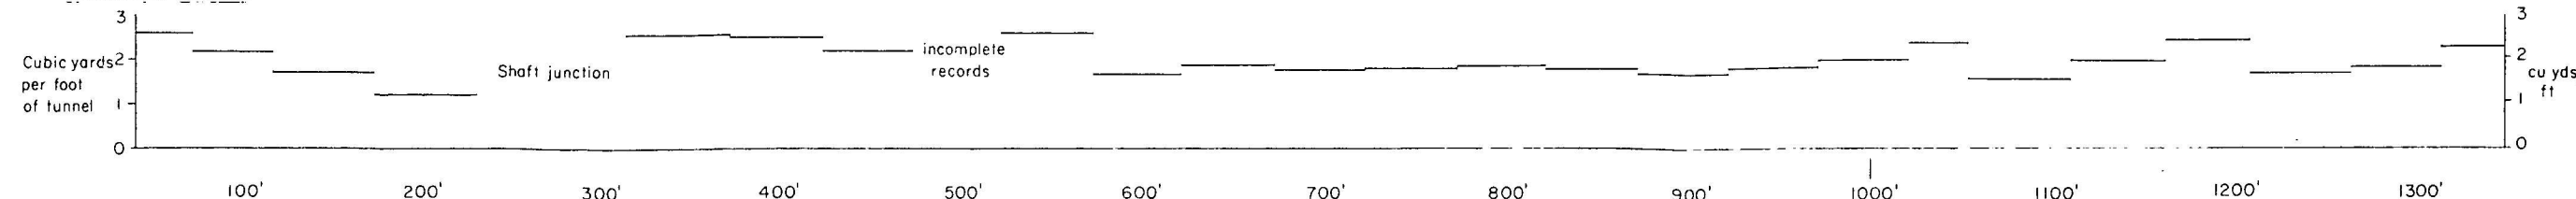
PLATE 13

The engineering geology of the tunnel is summarised in Plate 13, which shows graphically the geological conditions encountered and their relationship to engineering factors, such as drive rate, support, amount of explosives used, and overbreak.

The calculated values of overbreak are shown in Plate 13 (the units are cubic yards per foot of tunnel). High values were obtained between chainages 314 and 572 feet, where the tunnel intersects a number of faults striking nearly parallel to the tunnel alignment, and also in two sections towards the outlet end of the tunnel. From chainage 1021 to 1054 feet, a prominent joint set dipping 45° north-east was noted on the tunnel log as causing considerable overbreak, and this is reflected in the calculated value. The other tunnel section with high overbreak, between chainage 1163 and 1210 feet is excavated in openly-jointed sandstone which is affected by several minor faults.

2. The lack of contrast in the assessment of rock classification is brought out in Plate 13 by showing the plot of rock classification which would require the support actually used (dashed line). This plot shows that the rock condition as noted on the tunnel logs generally shows better quality rock than is indicated by the support actually used. In fact, the only areas where the assessed rock condition is significantly lower than the condition indicated by actual support occur in the sections of the tunnel not supported by steel sets; this indicates that the geologist's assessment of rock condition is generally conservative. On the basis of the actual rock classification and the geological logs, only about 250 feet of tunnel required support with steel sets.

3. The contrast between the sections of tunnel supported by steel sets and the virtually unsupported sections should be indicated by substantially lower explosive charges being required to blast each foot of tunnel in rock so openly-jointed and faulted that steel sets are required. This contrast is not at all evident in the explosive charge plot in Plate 13.

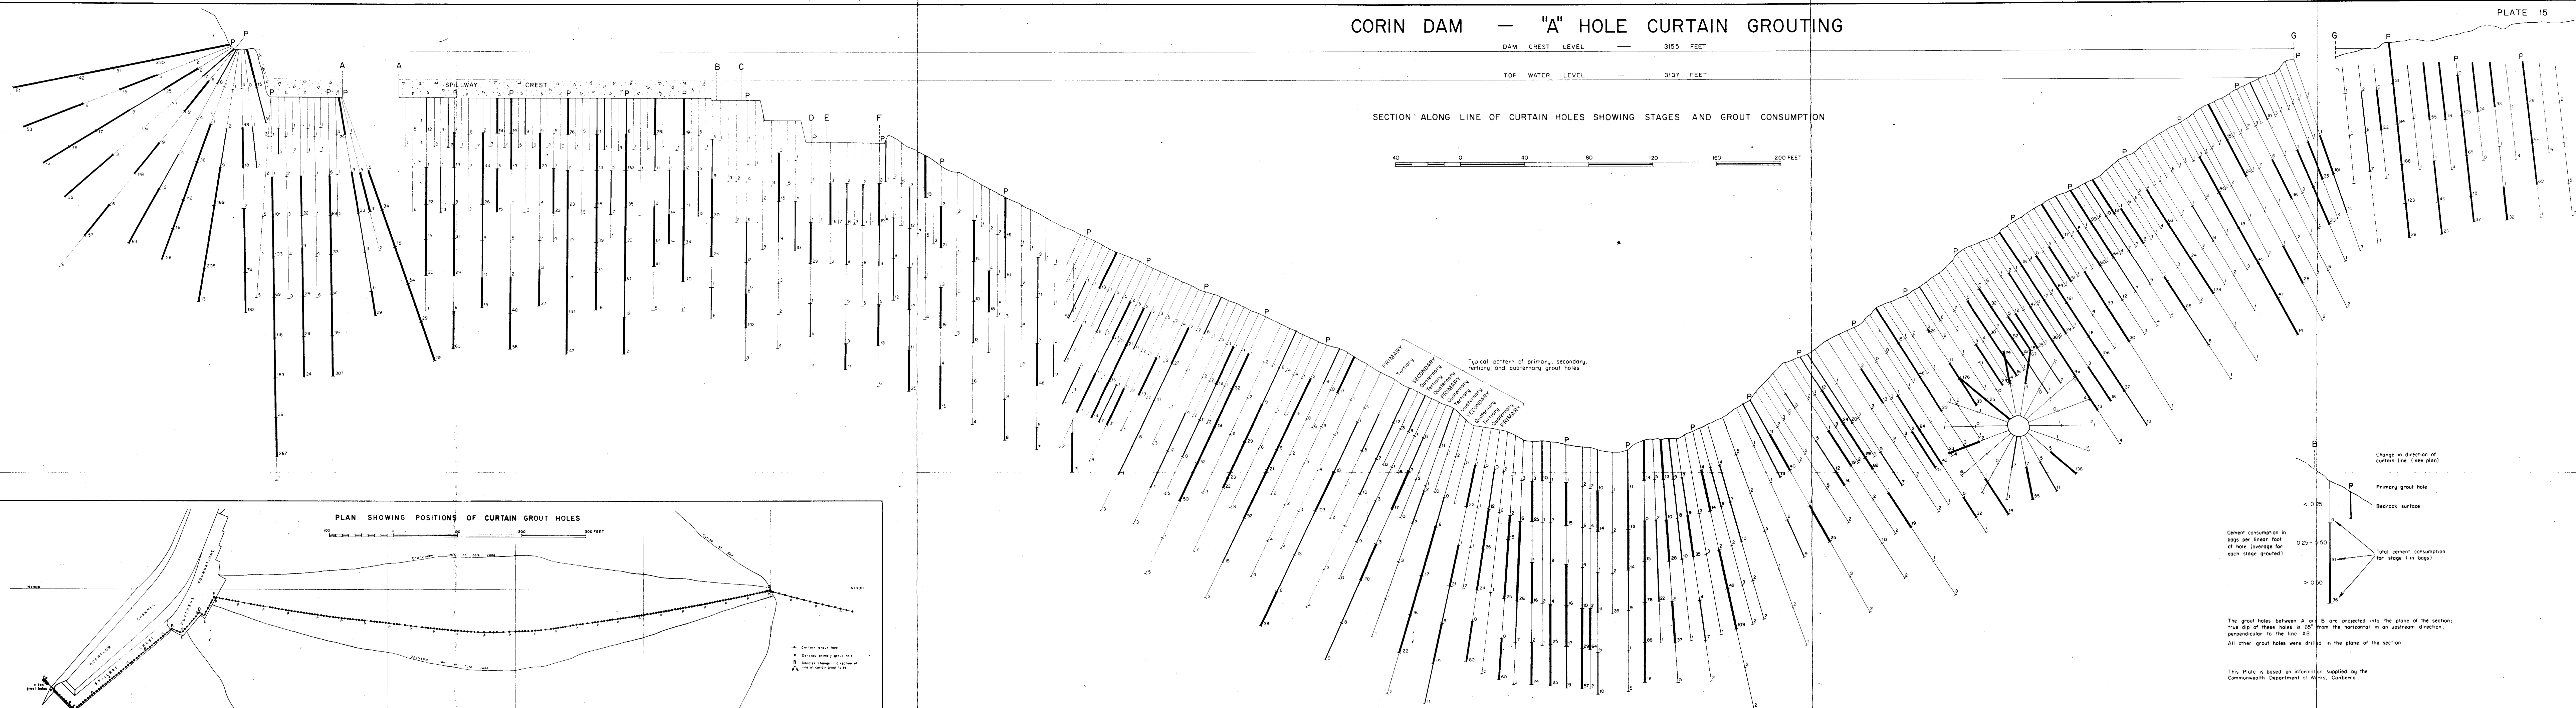
SECTION ' ALONG LINE OF CURTAIN HOLES SHOWING STAGES AND GROUT CONSUMPTION

It can be seen that the closure ratios range between 0.08 and 0.37, with an average for the entire curtain of 0.19; this indicates that the closure pattern has been effective in progressively filling fissures with grout.
