DEPARTMENT OF  
MINERALS AND ENERGY

# BUREAU OF MINERAL RESOURCES, GEOLOGY AND GEOPHYSICS

Record 1971/52

GOOGONG DAM SITE - QUEANBEYAN RIVER N.S.W. -  
FEASIBILITY INVESTIGATIONS 1970 and 1971

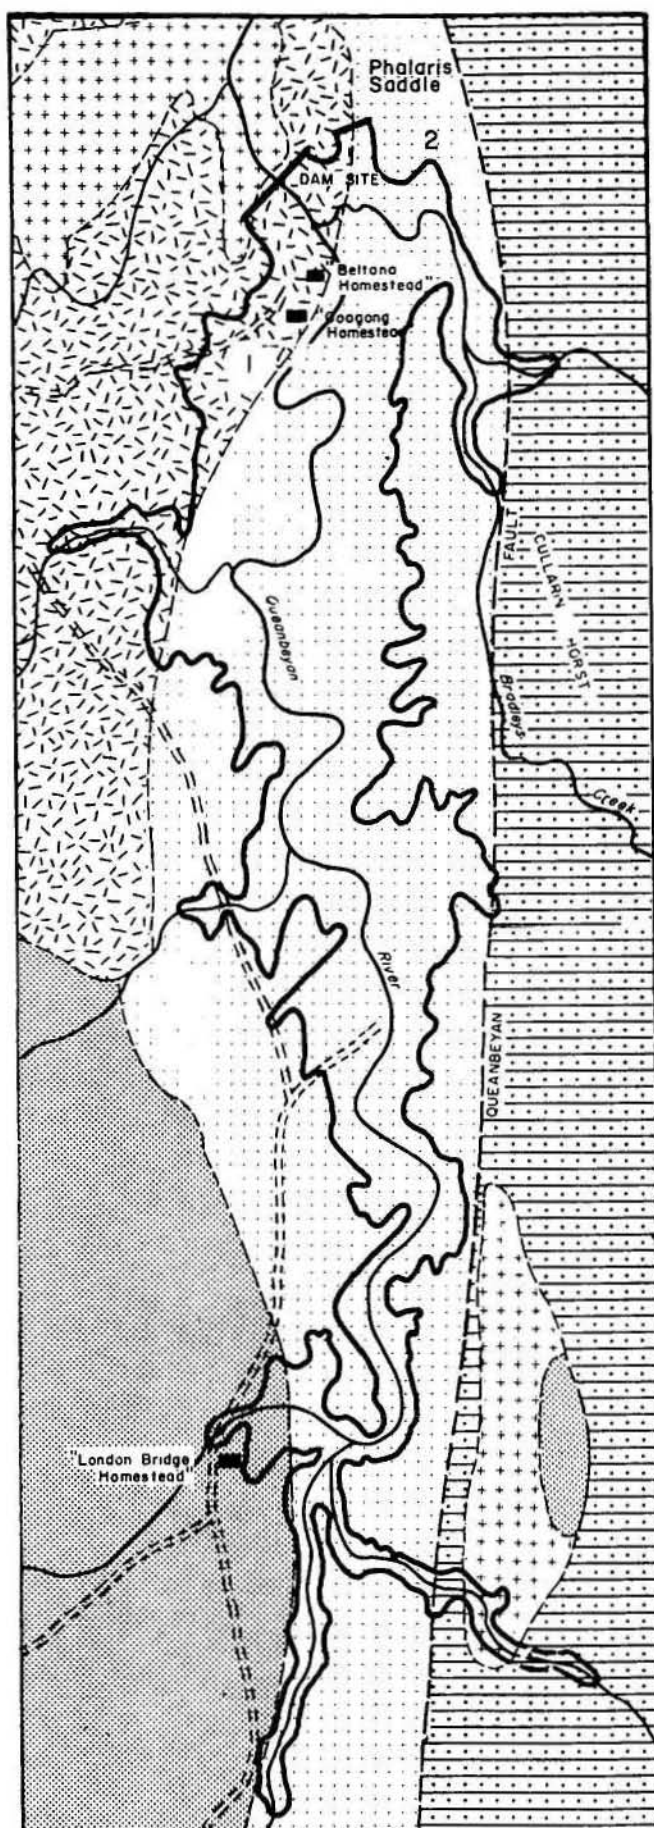
FIGURE 2

The dam site and the storage area lie in a belt of Palaeozoic metasediments and volcanics intruded by granite and porphyry (Fig. 2).

Southwest of Googong Homestead an alternative quarry site can possibly be developed in case the spillway/quarry design does not prove feasible. The site ('1' on Fig. 2) is a steep cliff on the left bank of the river cut in a low hill immediately south-west of Googong Homestead. The bulk of the rock of this hill consists of hard, silicified dacite with little cover of scree and soil. From outcrops it was concluded that the rock is fresh or slightly weathered at the surface or very shallow depth. Interbedded with dacite are slate lenses, which could prove to be so large or numerous as to render the site unsuitable.

A short survey was made of the availability of earth material near the dam site. The most promising borrow area is marked by '2' on Figure 2. The material is deposited in a narrow valley east of the Phalaris Saddle, bounded on the west by the Queanbeyan Fault. The Cullarin Horst is the source area of most of the earth deposits in the valley. The Central Testing and Research Laboratories (CTRL) of CDW carried out a seismic refraction survey in this area; auger holes were drilled and some backhoe pits were dug by the same organization. The material was also tested by CTRL. A report on these investigations is being prepared by CTRL.

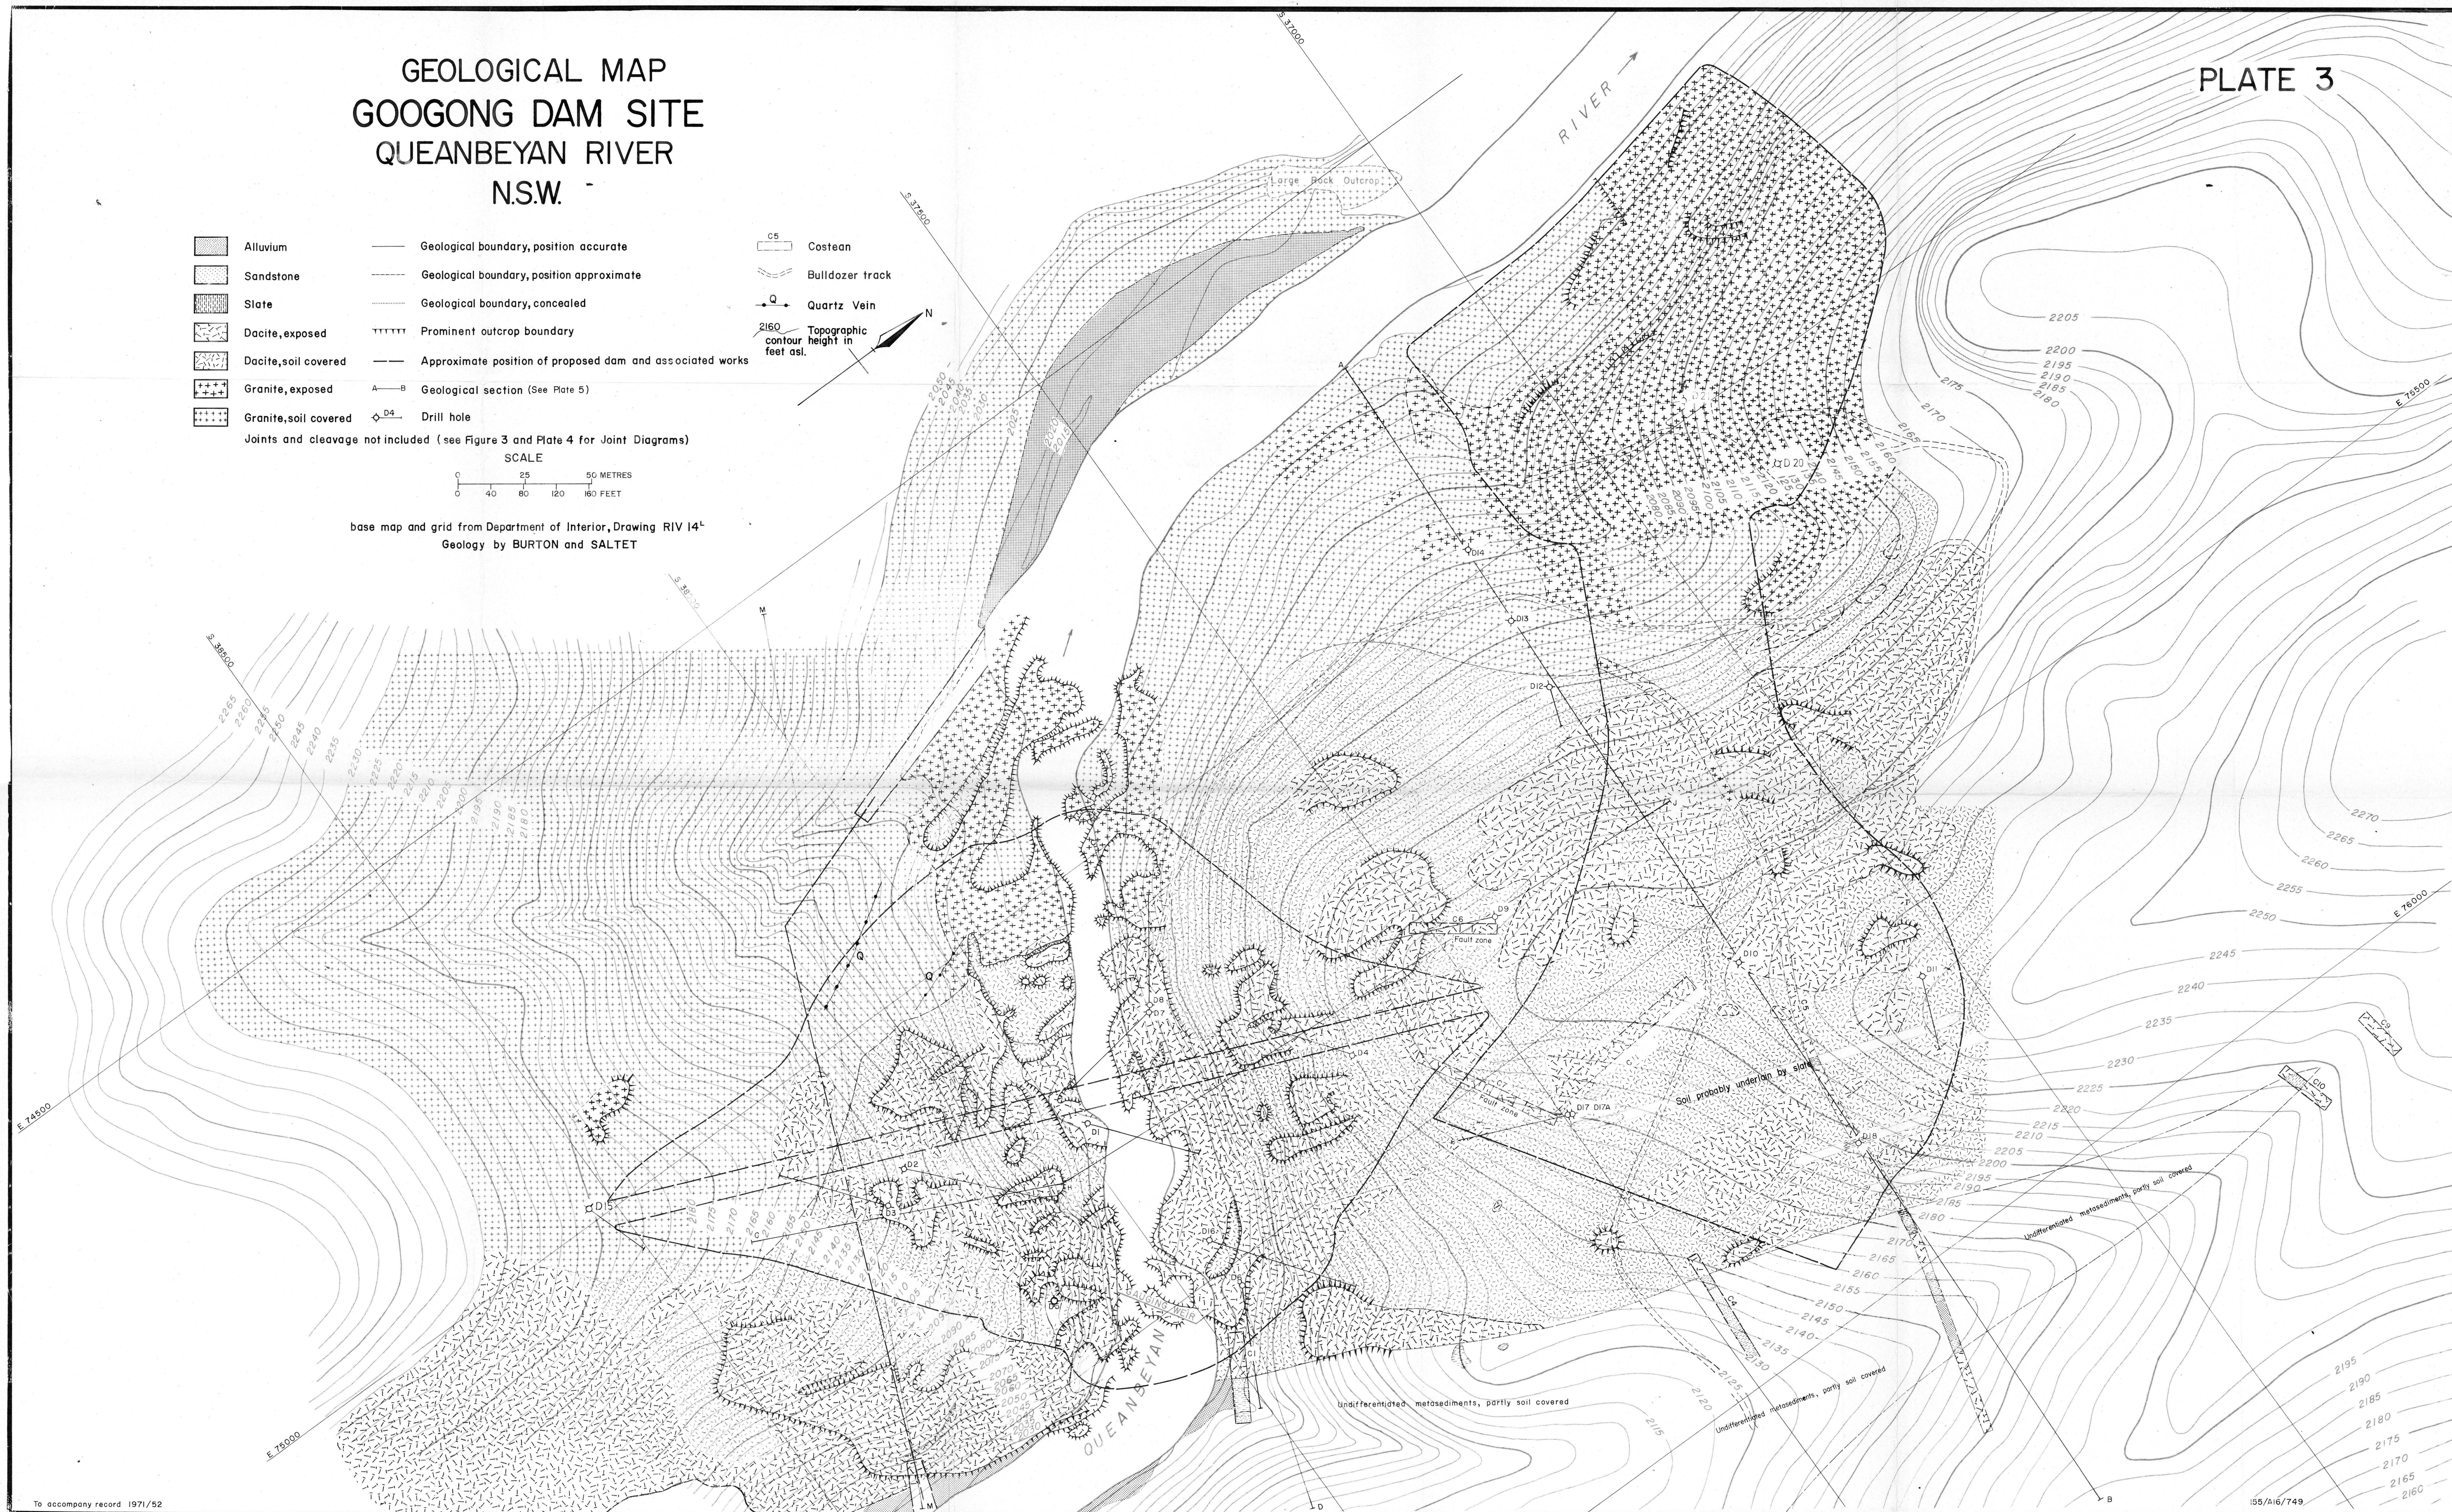
PLATE 3

The country rock at the Googong dam site and immediate environs consists of vertical beds of dacite and metasediments (Colinton Volcanics). The volcanics are intruded by the Googong Granite of Upper Silurian to Middle Devonian age. The dacite forms the largest part of the foundations of the dam (Plate 3); the granite underlies a small part only of the proposed dam on the left bank and river section and the lower part of the spillway. Some metasediments occur in the easternmost part of the proposed spillway area on the right bank, and warrant close attention.

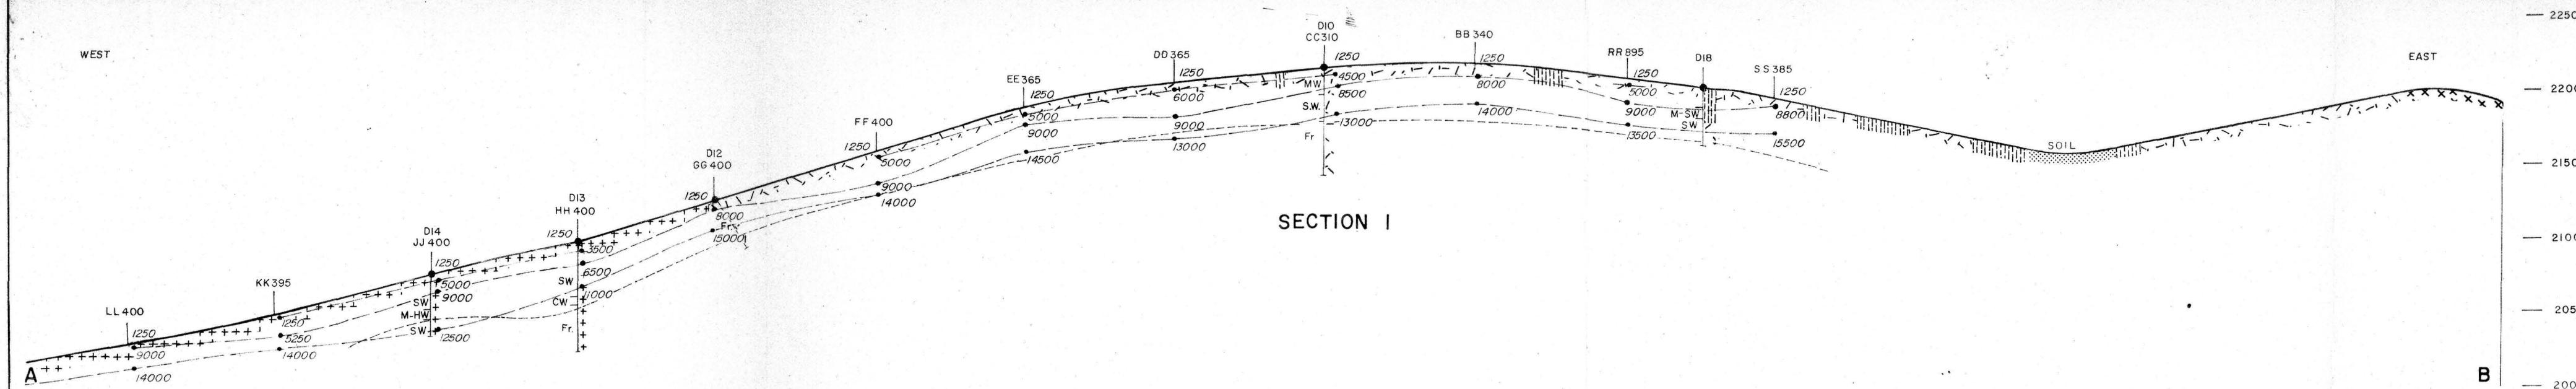
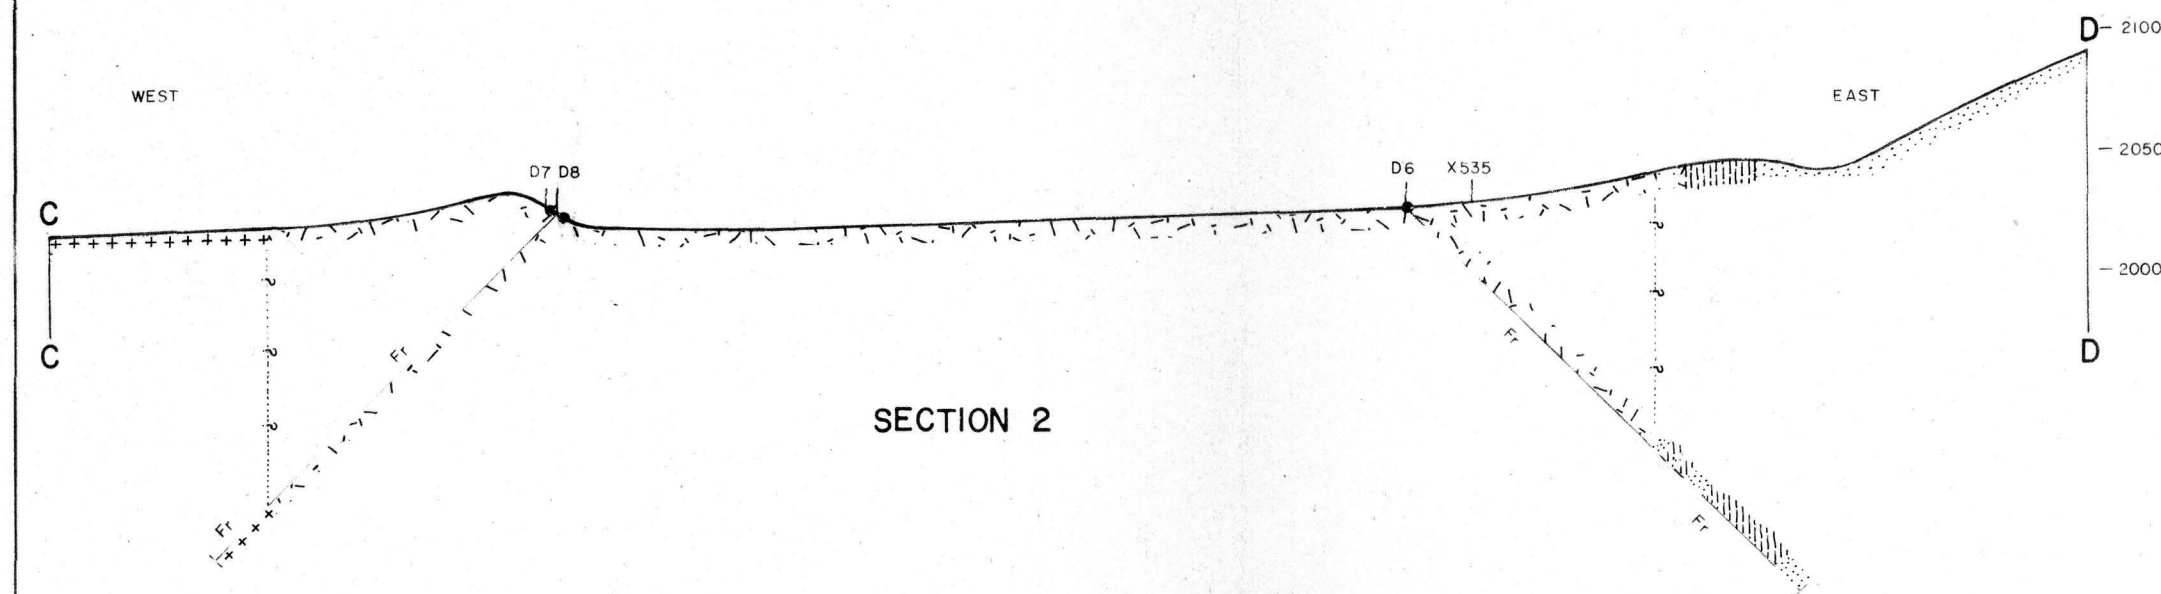
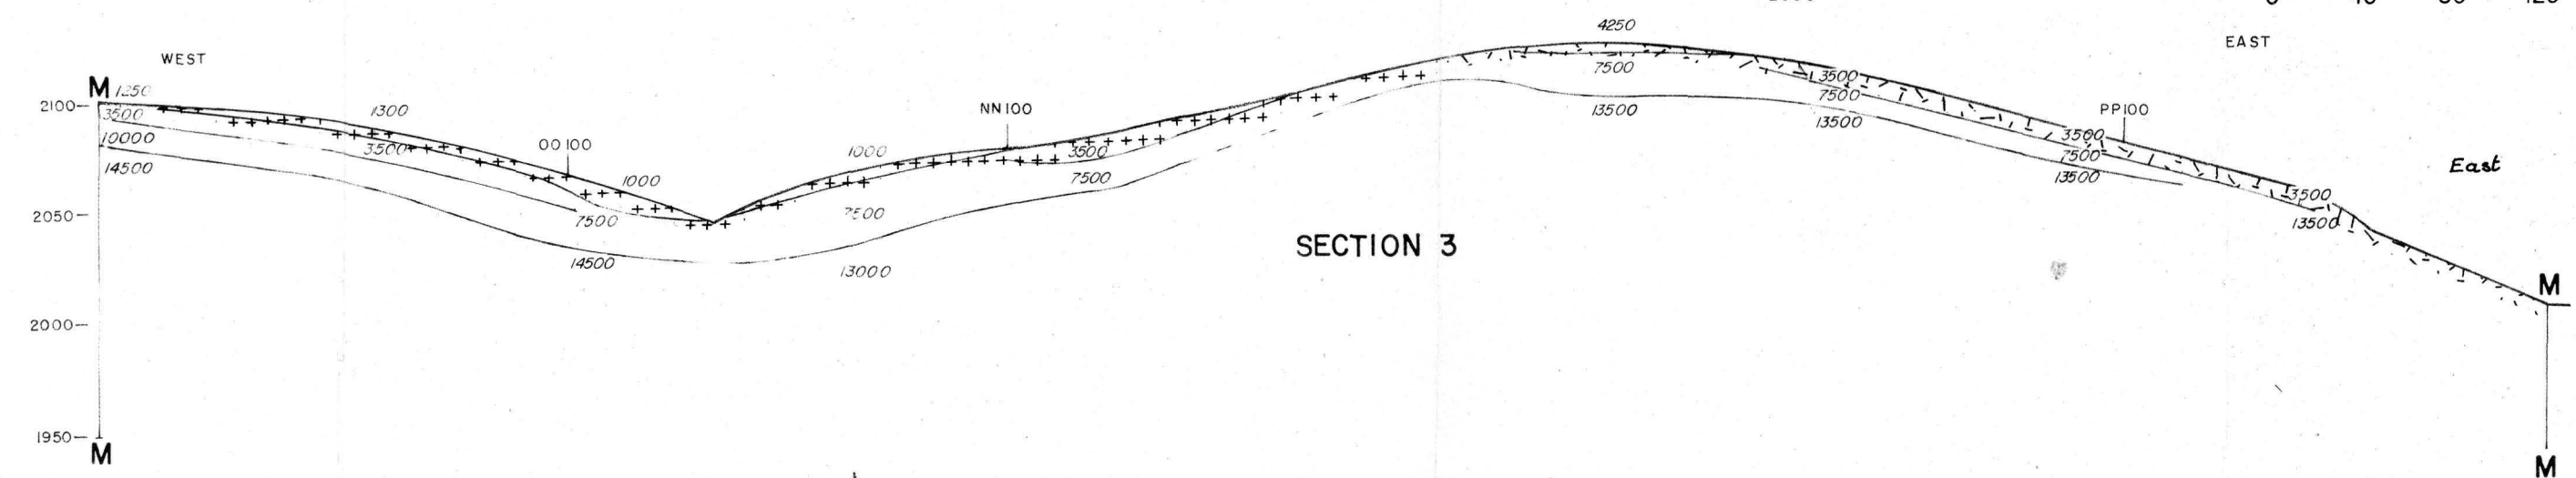
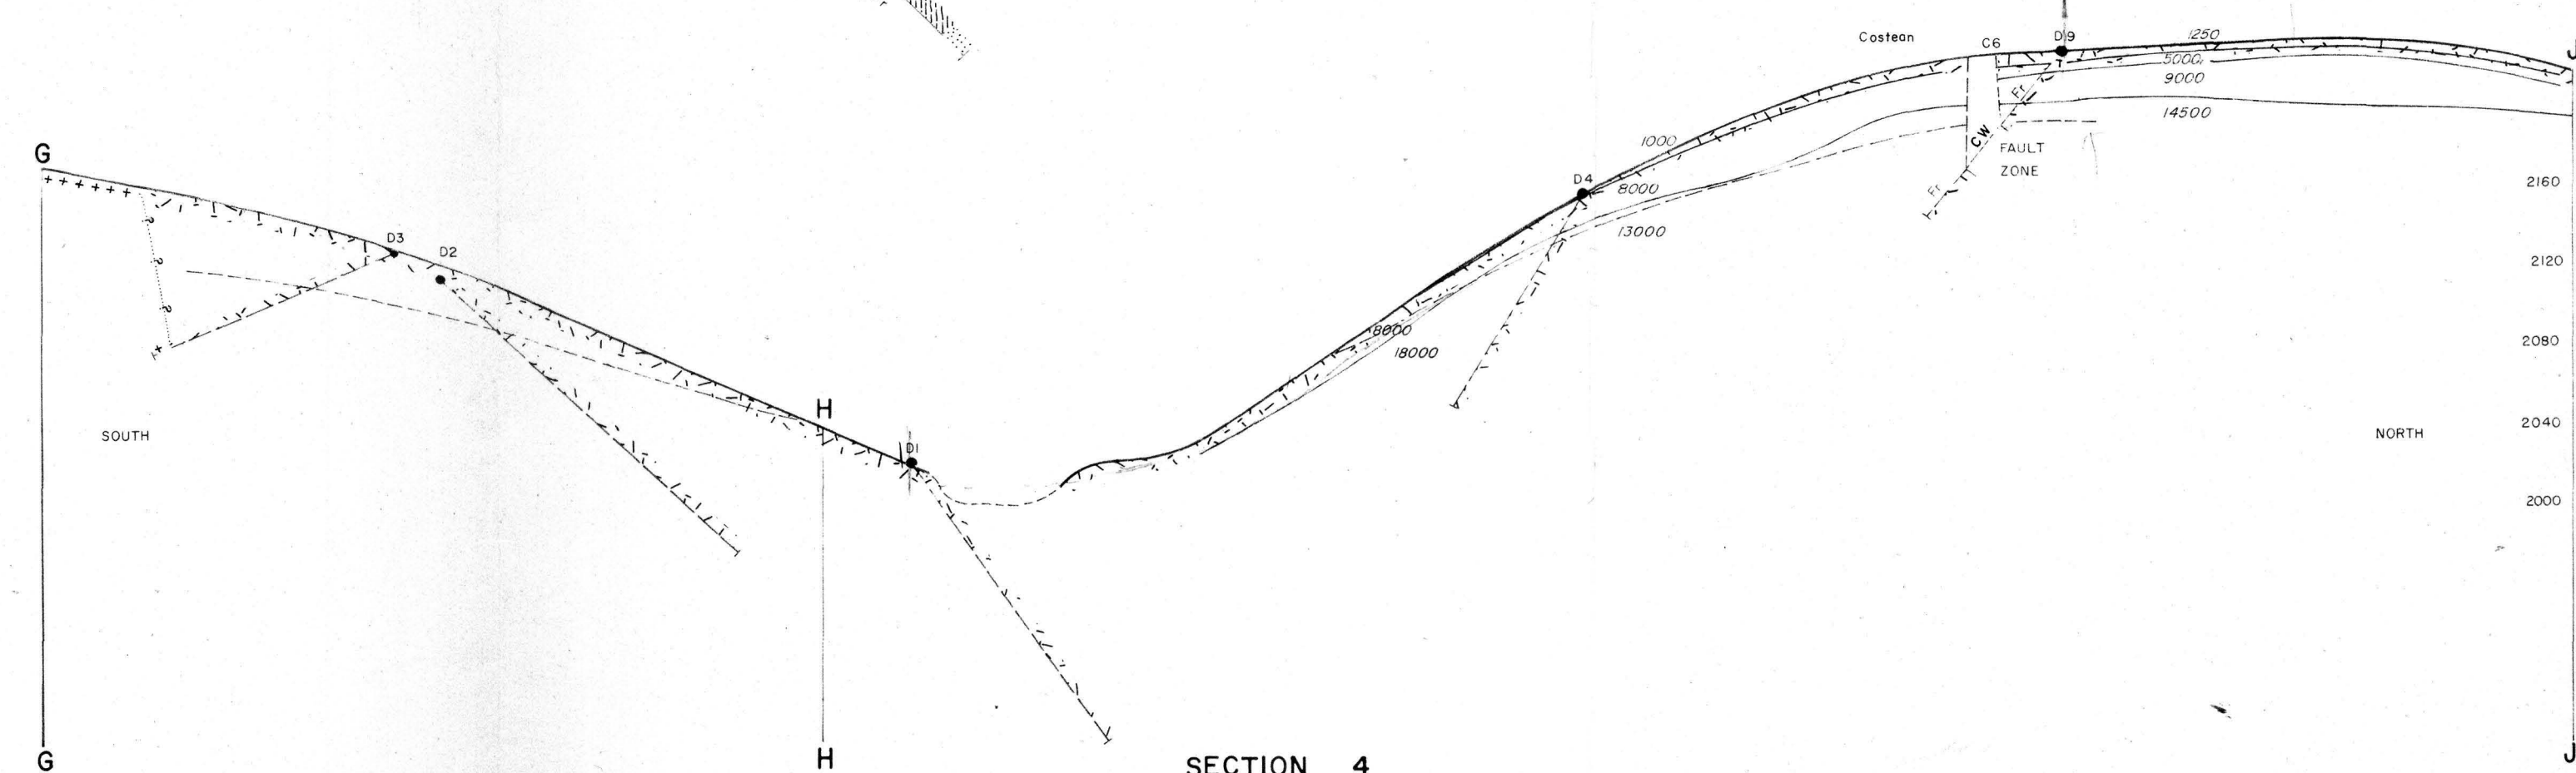
PLATE 5  
**GOOGONG DAM SITE**  
**QUEANBEYAN RIVER**  
**N.S.W.**

CGG carried out a seismic refraction survey at the dam site. Traverses totalled 9300 feet, with geophone spacings of 10 feet. Section 1 (Plate 5) enables us to correlate the seismic markers with five drillholes; from this and general knowledge of the geology at the dam site it can be concluded that the seismic markers correspond in the following way to the weathering profile in the dacite.
