DEPARTMENT OF  
MINERALS AND ENERGY

Record 1971/110

ZINC POLLUTION IN THE MOLONGLO RIVER SYSTEM

A.D. Haldane

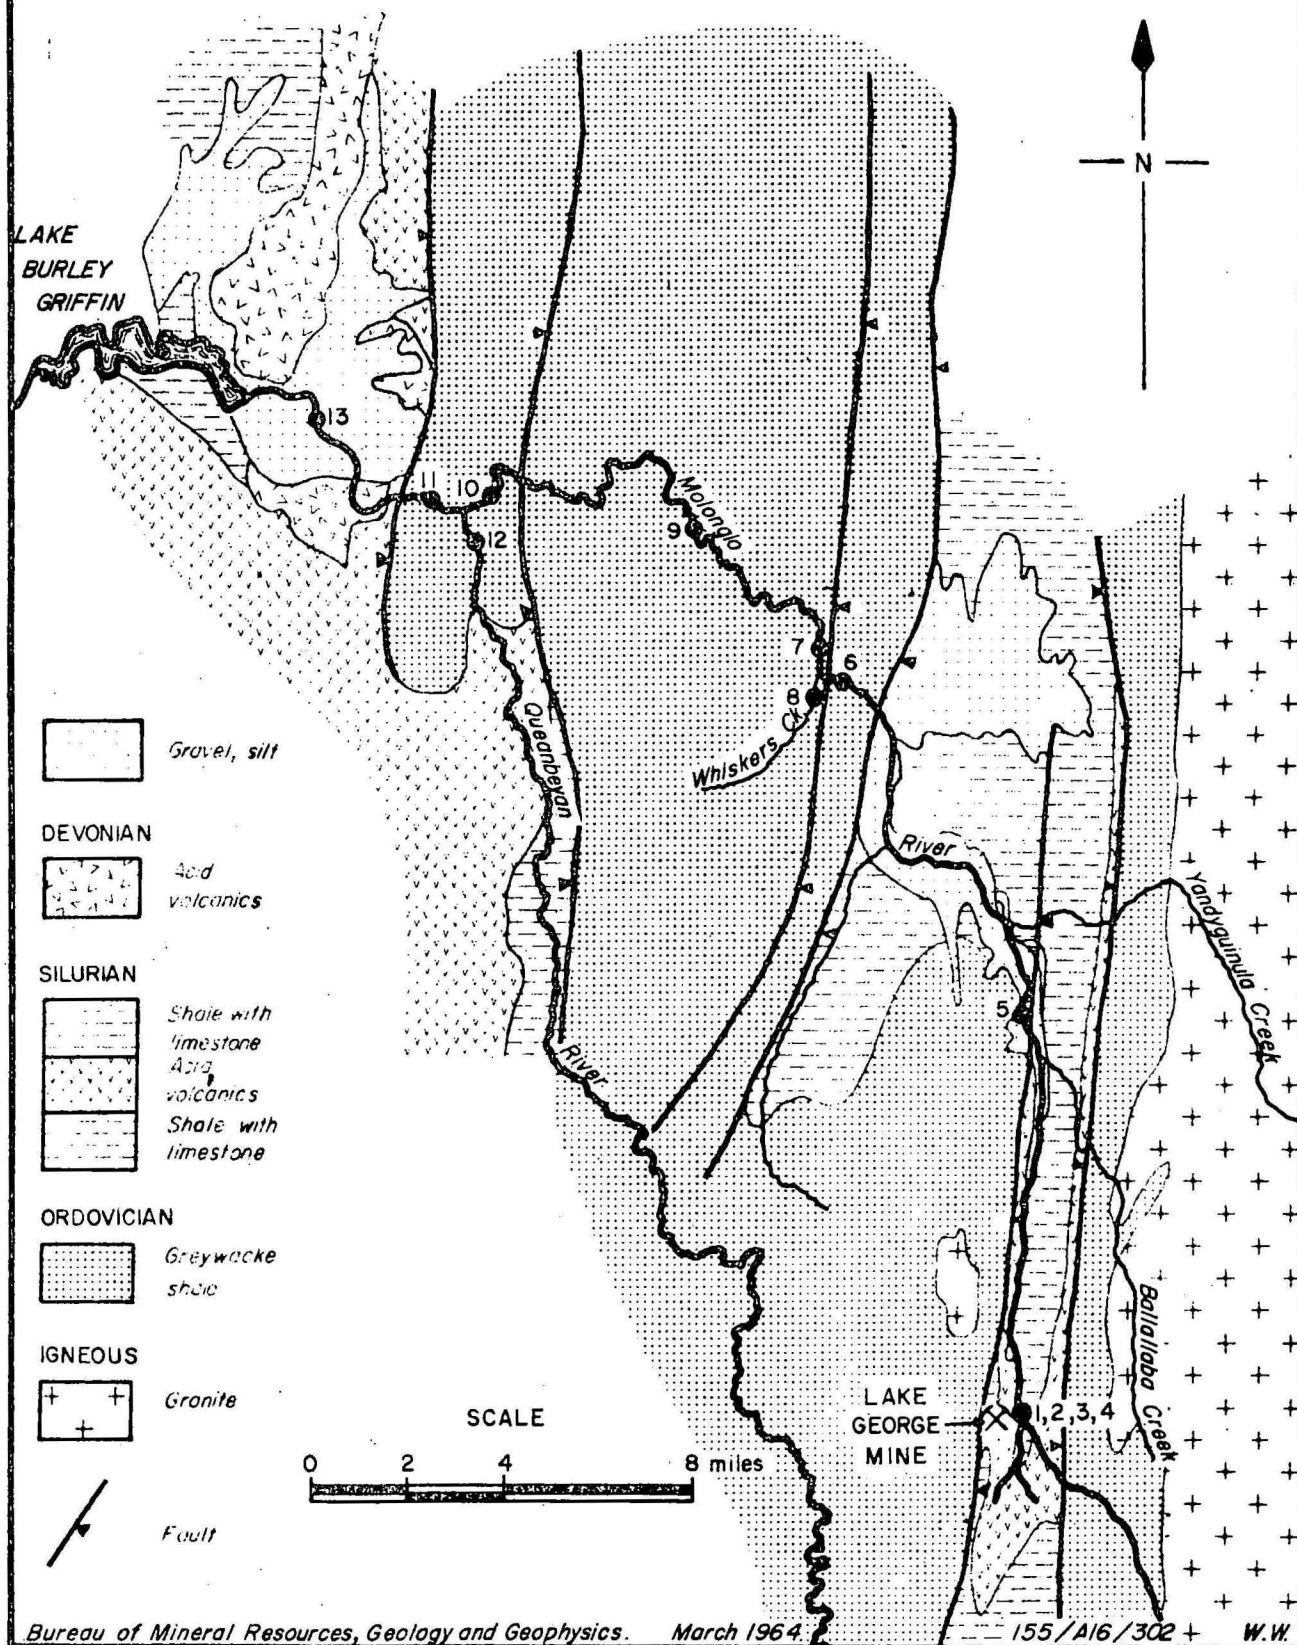
**Fig. 1 MOLONGLO RIVER AREA**  
**(SAMPLING STATIONS & GEOLOGY)**

The Molonglo River rises in New South Wales about 52 km south-south-east of Canberra at an elevation of about 1200 m. The course of the river as far as Lake Burley Griffin and the location of sampling points are shown in Figure 1. About 11 km downstream, the river flows through the town of Captains Flat where the abandoned Lake George Mine is located.

River. Suspended material was subsequently deposited as far downstream as Sutton Road Bridge (Site 10, Fig. 1). Vegetation was destroyed along the Molonglo valley, particularly between Sites 5 and 6 (Fig. 1). This is considered to be due mainly to soluble sulphates and associated acidity. Some of the affected areas have not yet recovered fully.

Semiquantitative field testing in July 1959 showed no zinc or copper in the Molonglo waters above Captains Flat. At the same time zinc and copper were found in water draining from the mine via Copper Creek and zinc was detected in river water as far downstream as Site 10. Zinc was also detected in alluvium along the river course between Sites 5 and 6. Subsequent investigation confirmed the presence of zinc in the flanking alluvium from 3 km downstream of Lake George Mine to Site 10 at Sutton Road Bridge.
