Record 1973/24

GEOLOGICAL INVESTIGATIONS TENNENT DAMSITE,  
A.C.T. 1970

G.A.M. Henderson

Tennent Damsite on the Gudgenby River, 32 km south of Canberra, is one of two alternative sites for Canberra's next major water supply dam. The other site is on the Queanbeyan River at Googong. Tennent Damsite was investigated initially during 1966-1968, and further investigations were carried out during 1970. The damsite is situated in a gorge on the Gudgenby River; the river valley widens upstream to the south to provide a suitable reservoir. The entire reservoir area lies within granitic rocks - Tharwa Adamellite in the north and Clear Range Granodiorite in the south. The meridional-trending Murrumbidgee Fault lies about 1.5 km east of the damsite.

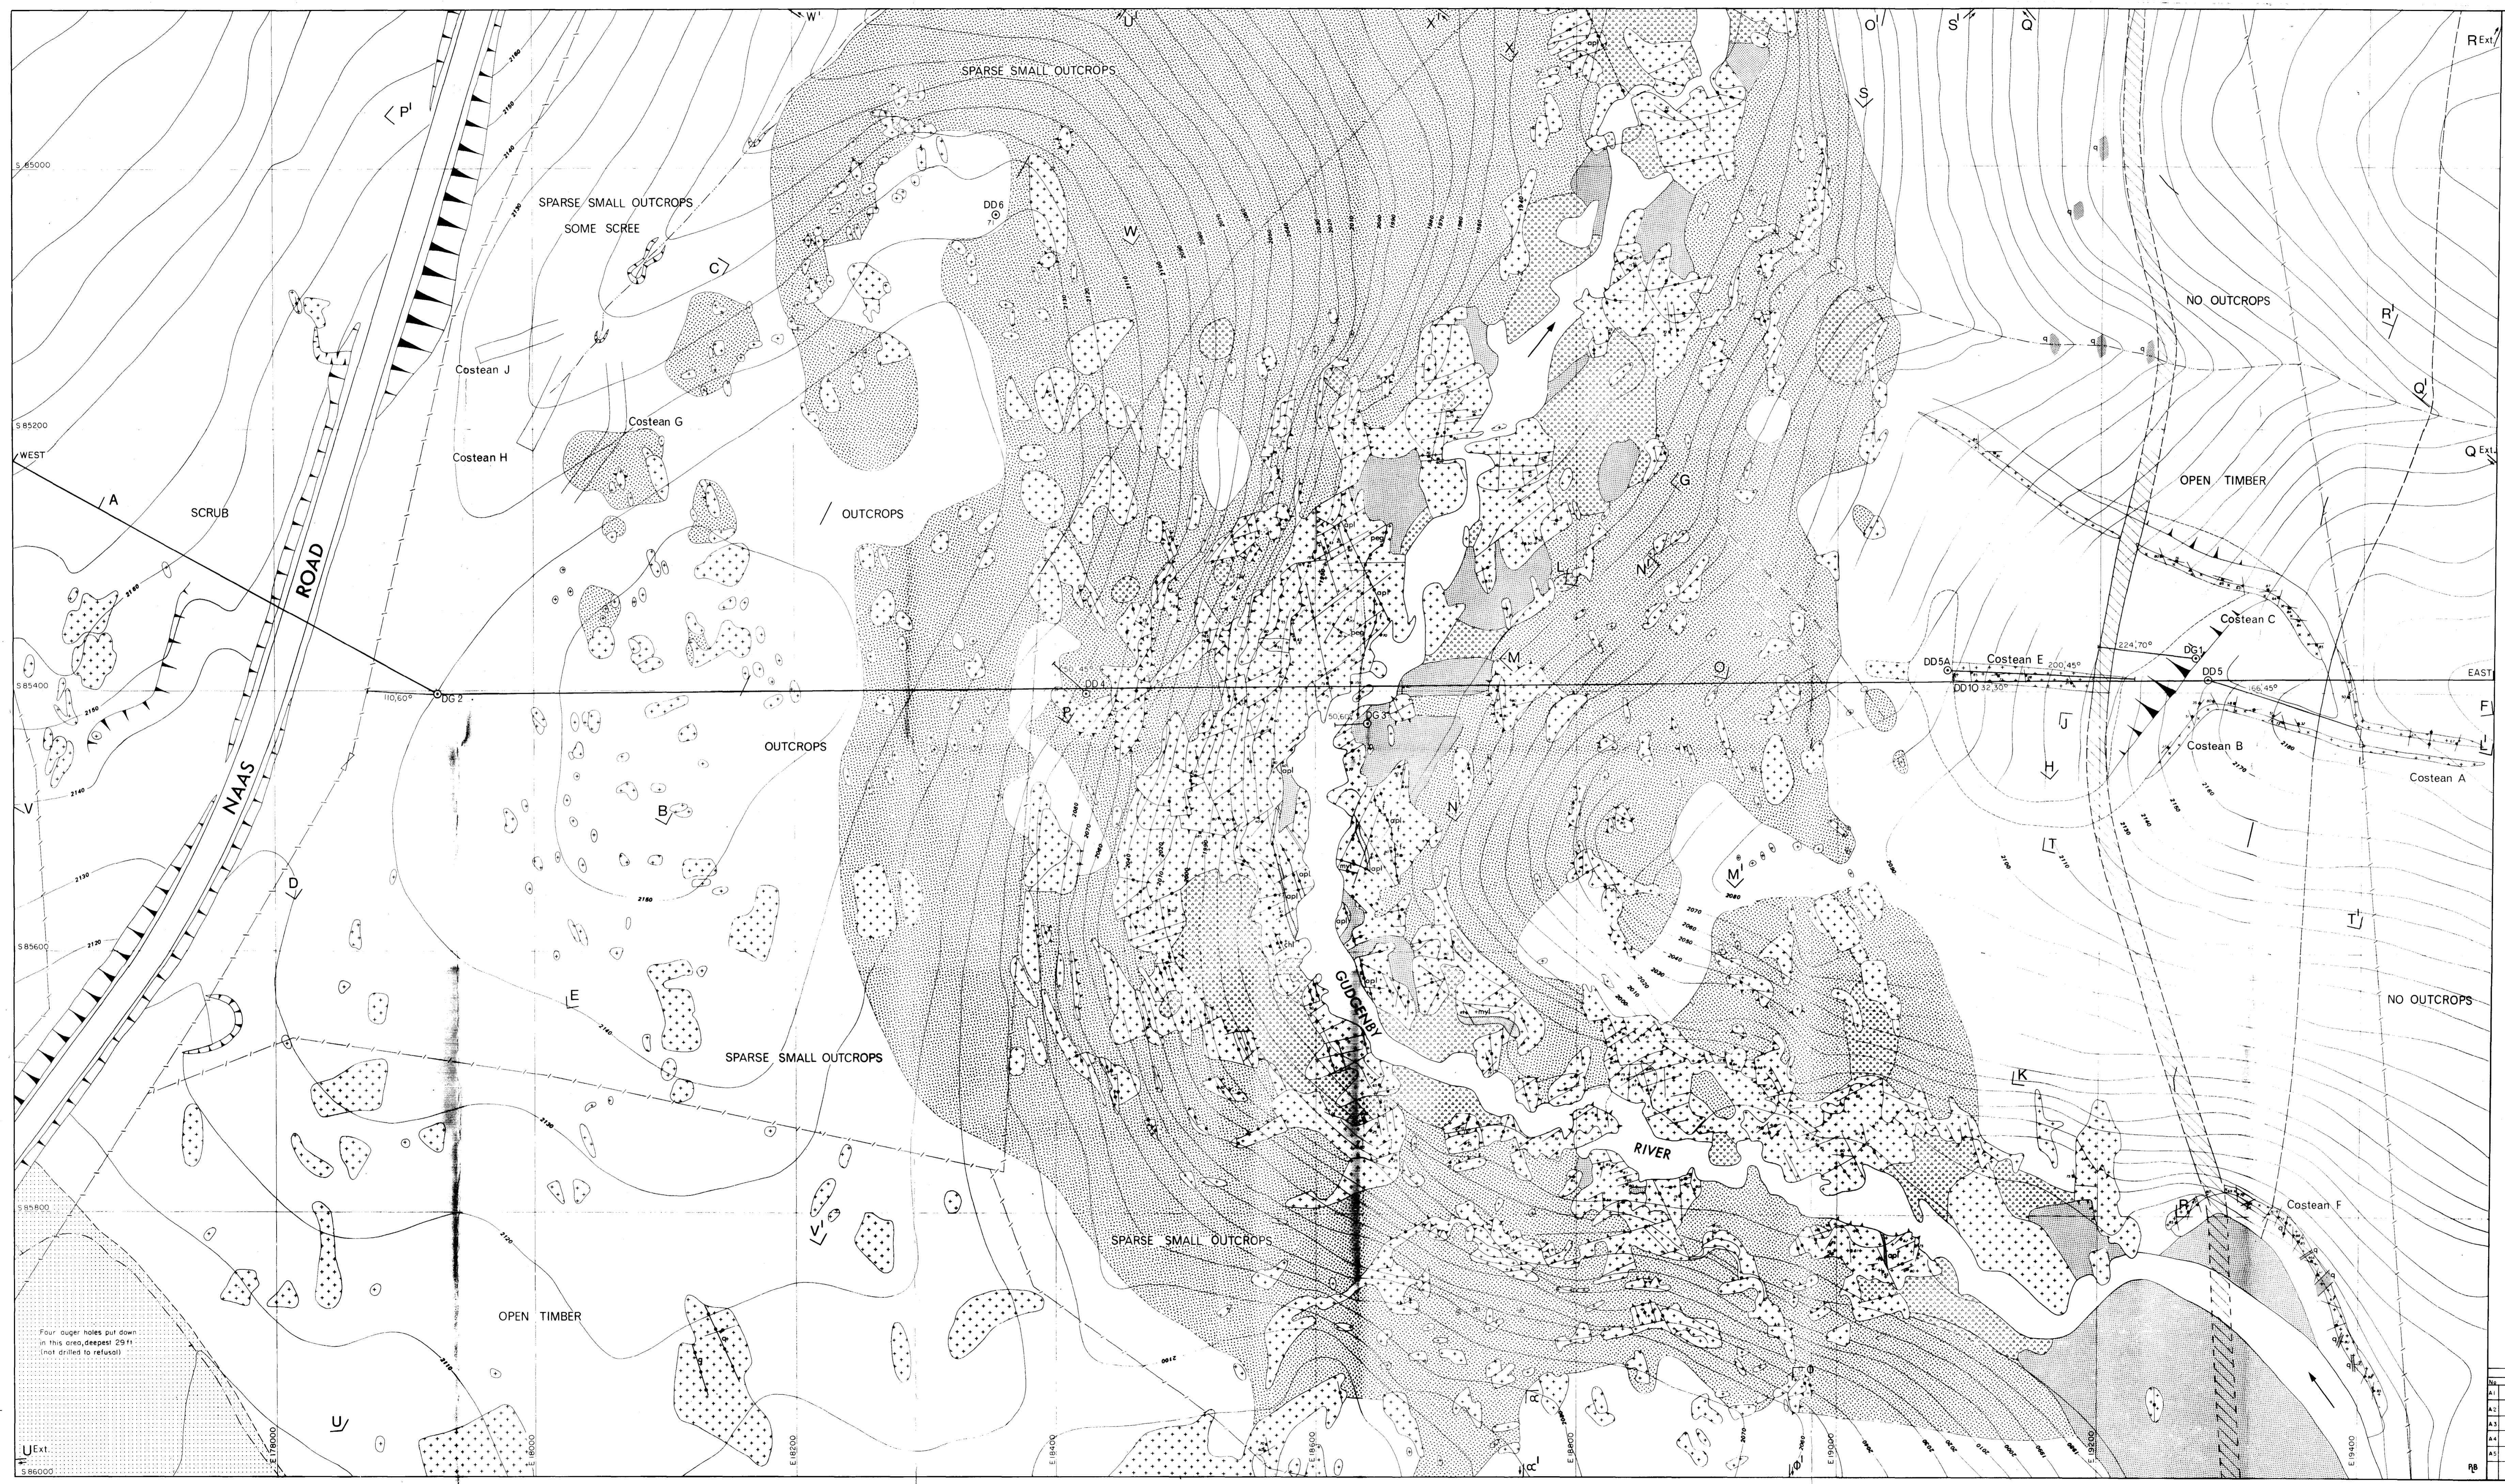
The weathering pattern at the damsite is related mainly to the presence or absence of strong shearing. Thus for the purposes of this discussion the damsite area is divided into a western zone which includes the unsheared grey adamellite found on the west abutment, in the river bed and on the lower part of the east abutment, and an eastern zone which includes the sheared pink and grey adamellite on the upper part of the east abutment. The zones are shown on Plate 2.

Preliminary designs by CDW (October 1970) envisage an earth and rockfill dam about 67 m high with a curved axis as shown on Plate 2. The following notes outline the foundation preparation and treatment that will be required before placement of the dam.

Before laying the earth-core and filter zone, all soil and highly to completely weathered rock should be removed, and the surface of the sound rock cleaned of loose material with a high-pressure water jet. On the lower part of the west abutment and along the river overburden, not more than about 50 cm thick covers fresh rock. In much of this area large rock outcrops are present and only the removal of loose boulders will be required. On the upper part of the west abutment the seismic results indicate that soil and highly to completely

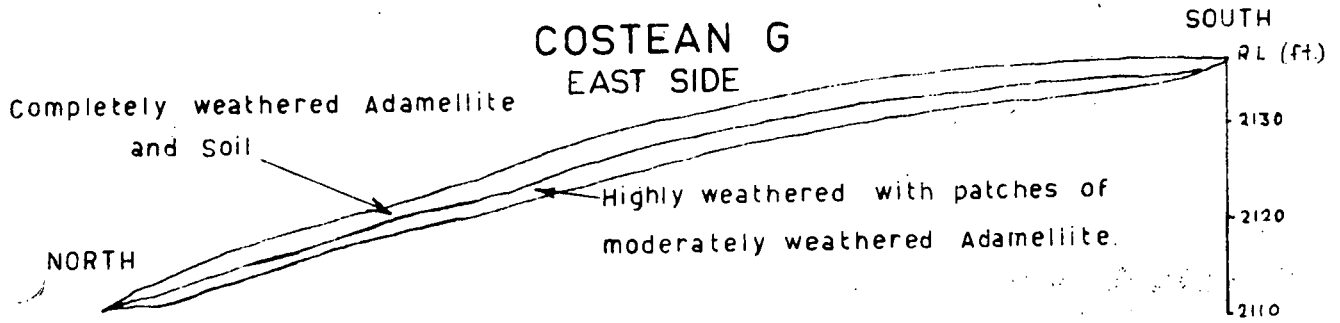
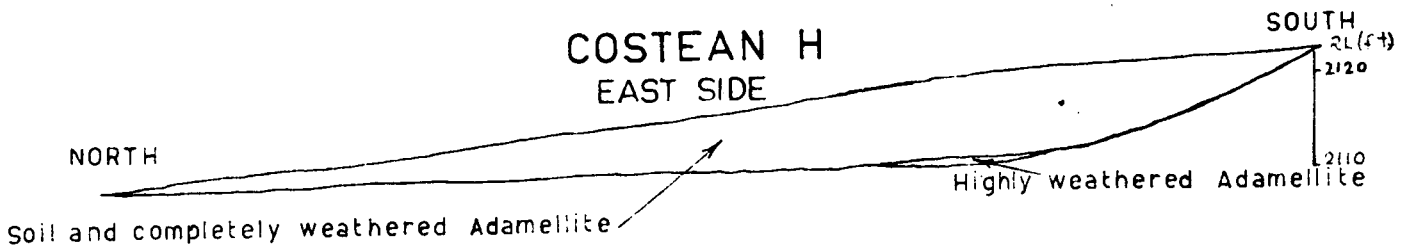
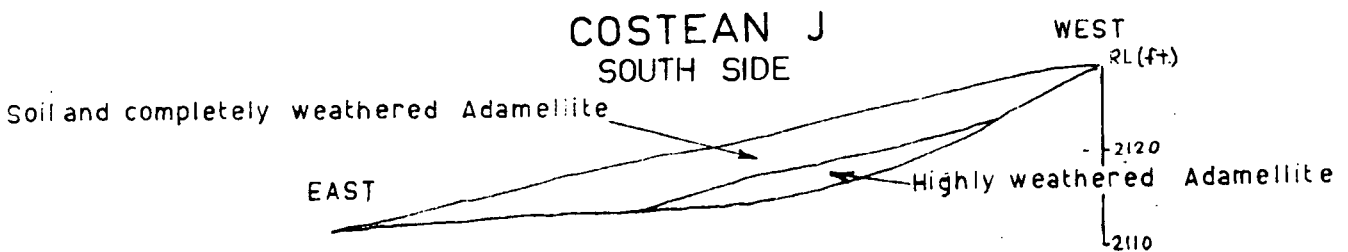
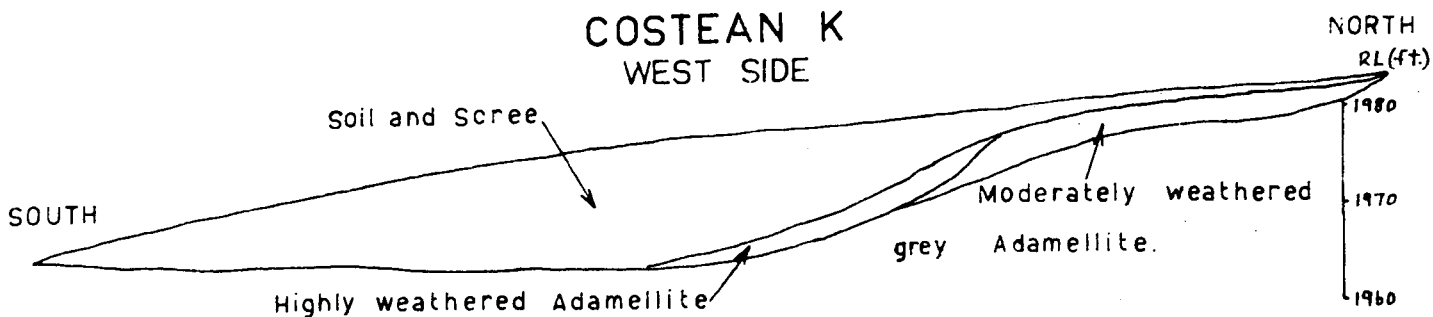
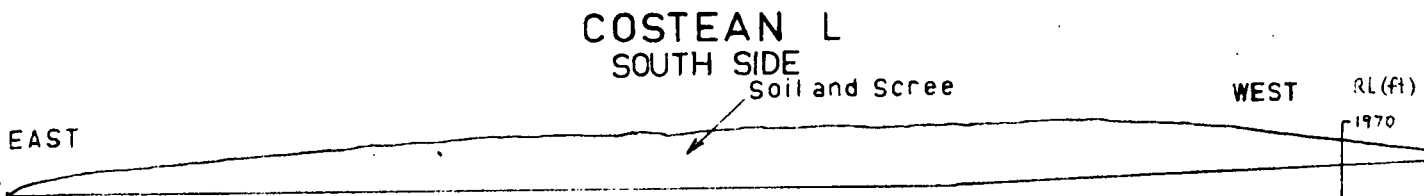
# GEOLOGICAL LOGS OF COSTEANS ON WEST BANK.

Despite the zones of deep weathering observed in some drill holes the general depth of highly to completely weathered rock in the western zone is not great. Table 1 shows the depth of weathering in the drill holes on the west abutment and in the river bed. The holes are listed in order of increasing RL of the drill hole collar to show a general tendency towards increased depth\* of weathering with height above river level. This feature is also apparent on the cross-section (Plate 4) which is derived from both the drilling and seismic results. Additional information on depths of weathering near the surface in the western zone was obtained from costeans G, H, J, K, and L.
