DEPARTMENT OF
NATIONAL RESOURCES

Record 1977/18

PRELIMINARY GEOLOGICAL INVESTIGATIONS OF TENNENT DAM SITES
2 AND 3, GUDGENBY RIVER, A.C.T., 1975

R.C.M. Goldsmith and G. Briscoe

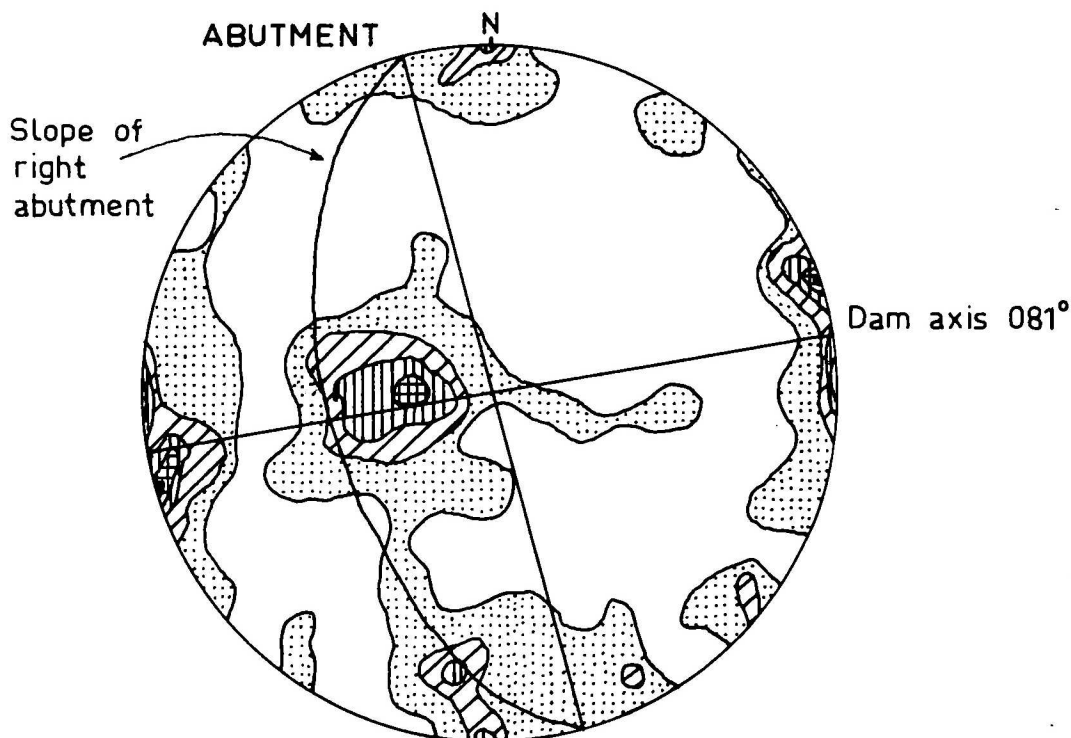
B. 108 JOINTS IN UNSTABLE GROUND OF RIGHT
ABUTMENT

Stability of right abutment. The right abutment is stable from about stn 400 to 500 m but to the west of Stn 400 a 10 m cliff marks the backwall of a slip plane. A combination of toppling, and sliding failure, has resulted in an unstable zone (60 x 80 m in area) of transported material with rotated blocks of rock, scree, and soil (Fig. 4).

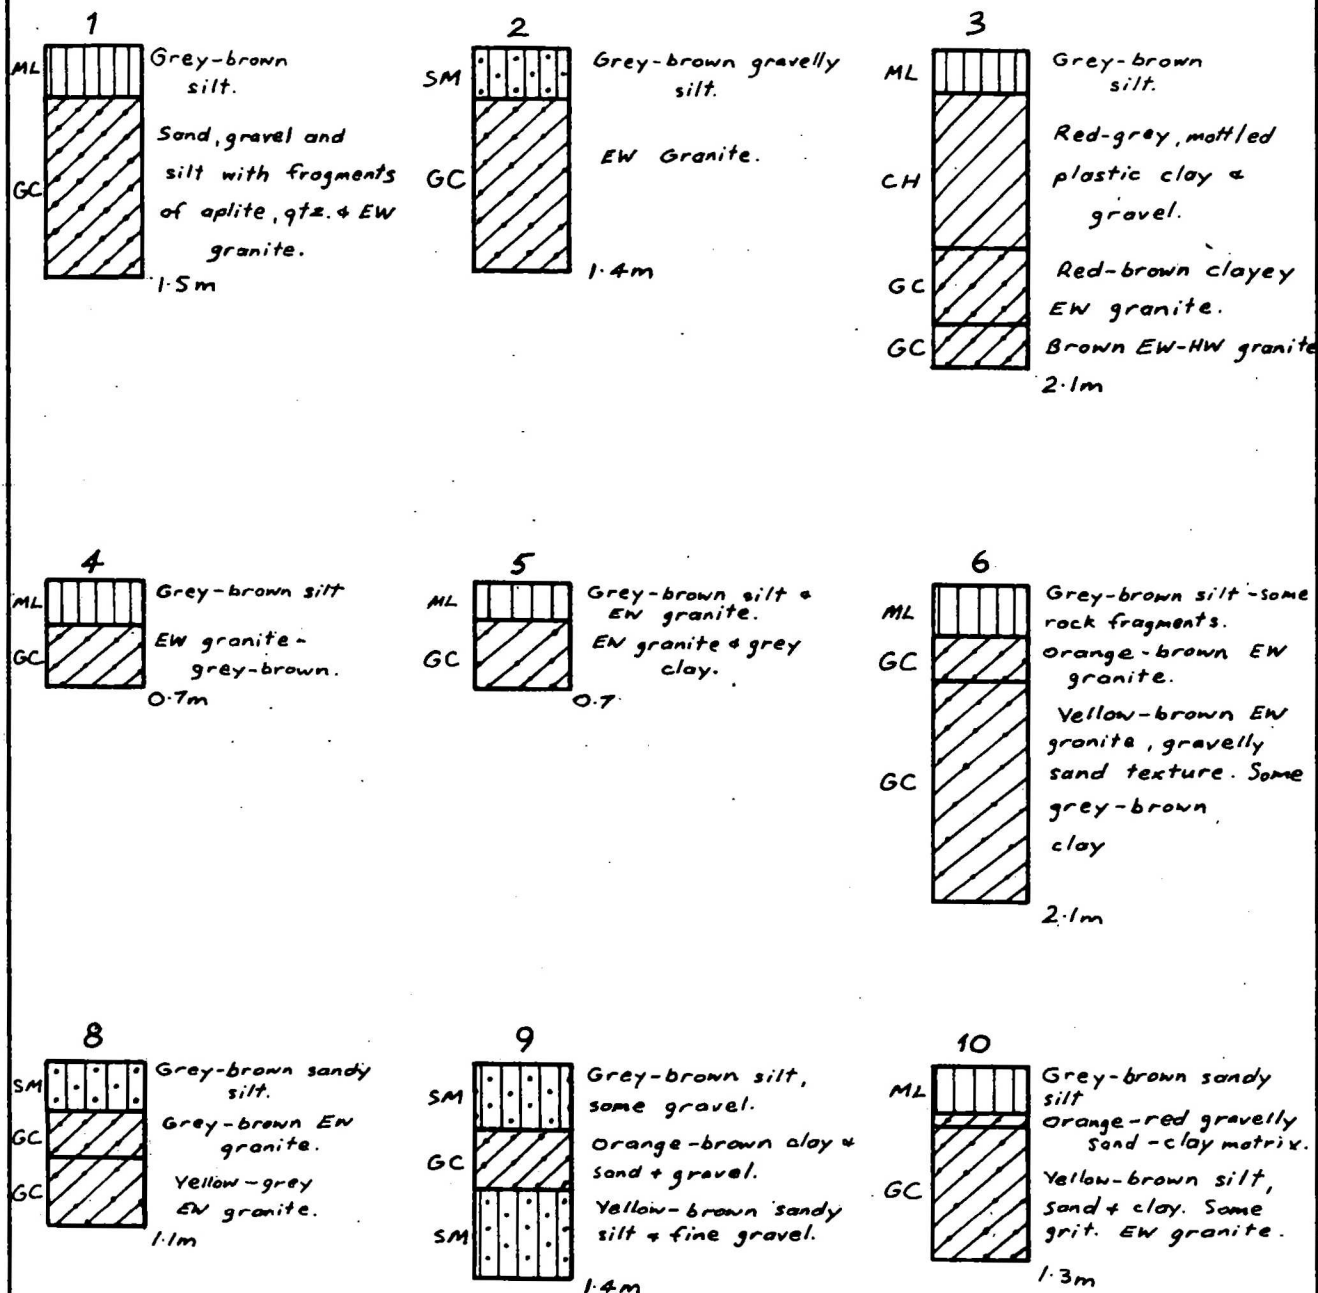
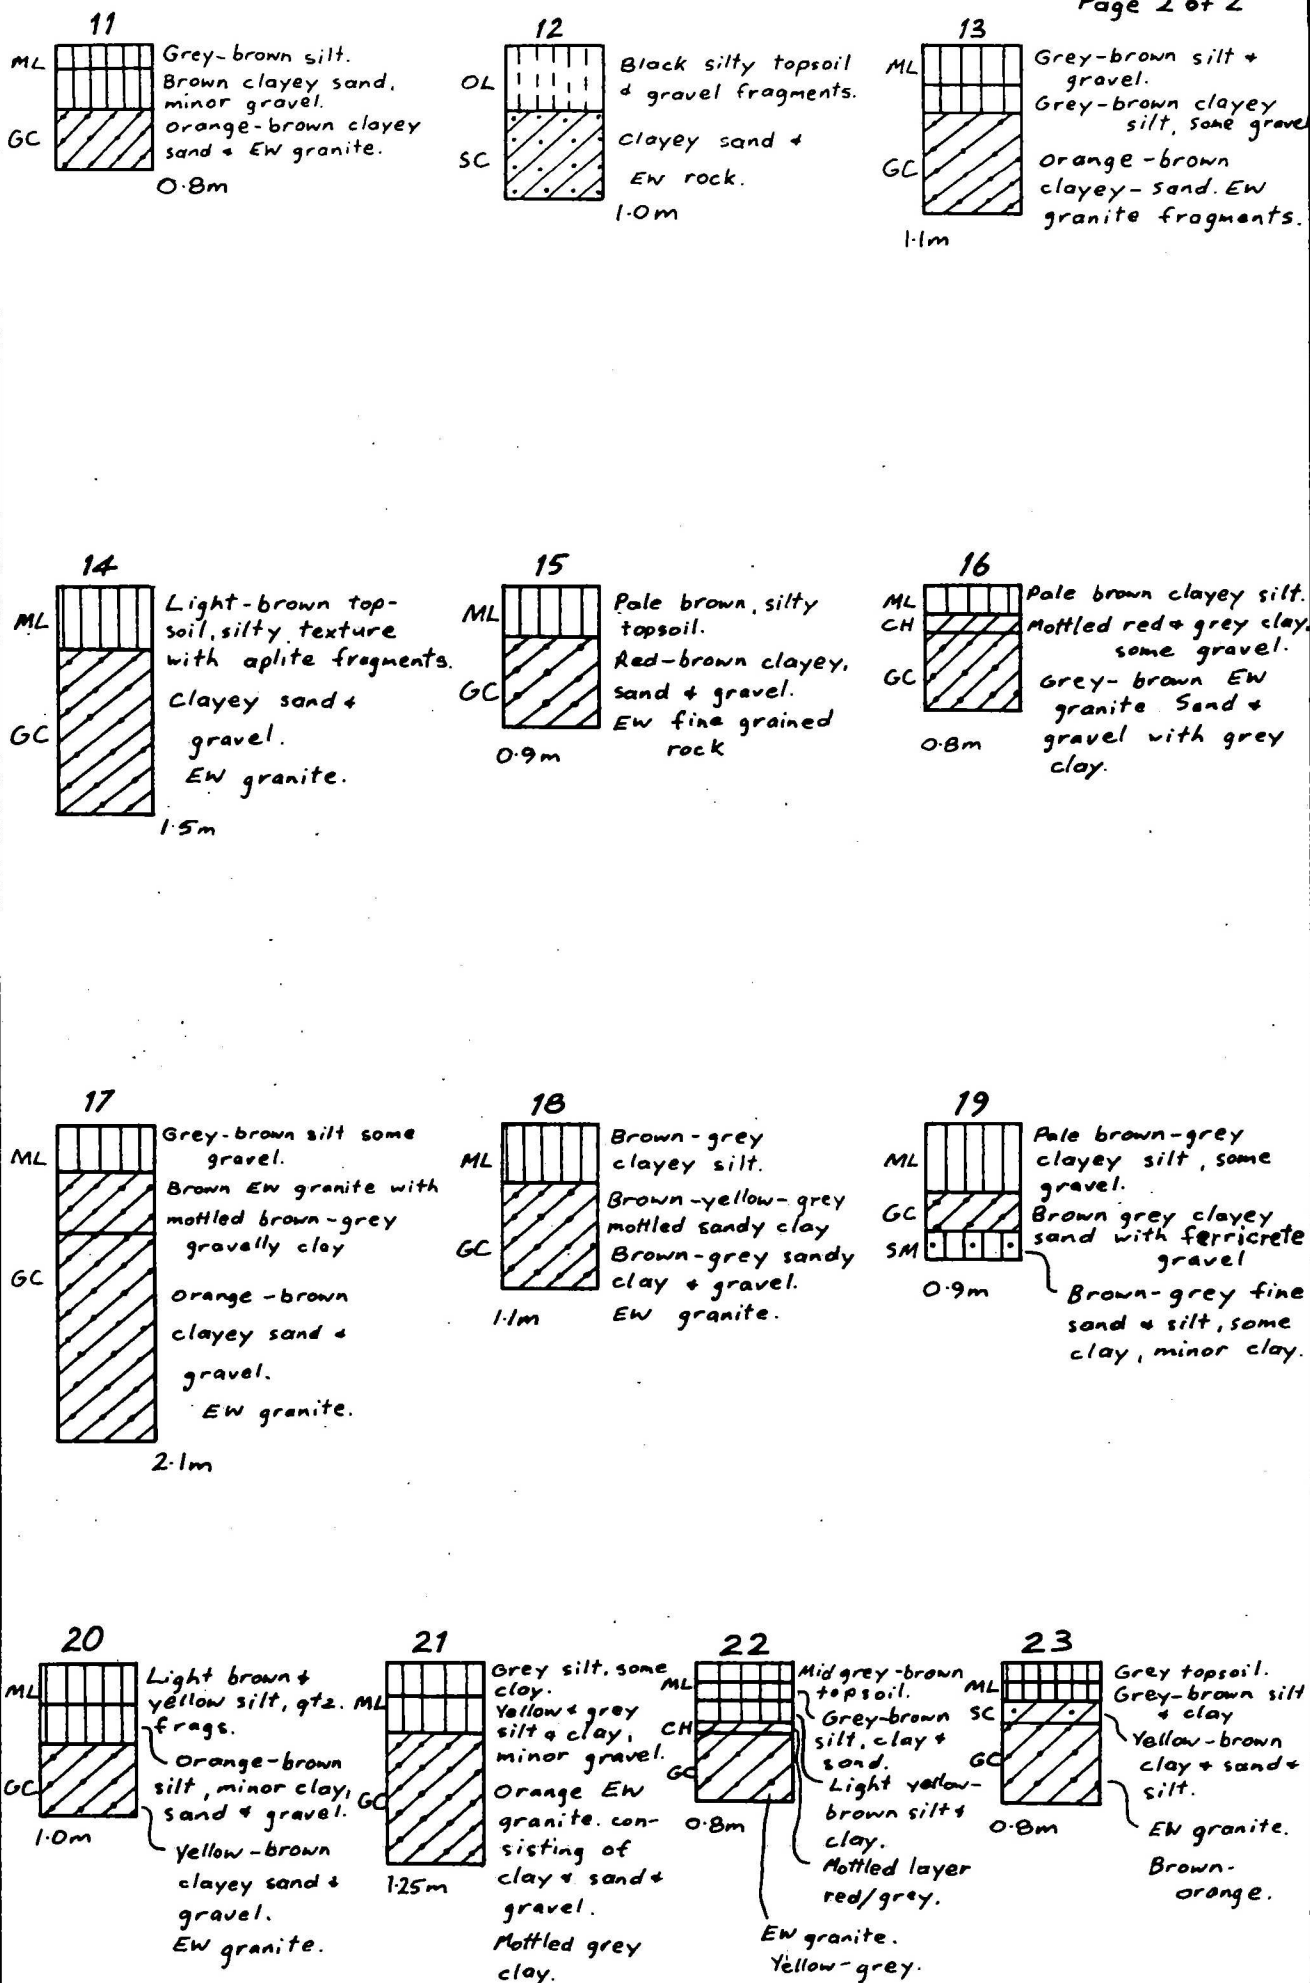
TENNENT DAMSITE WATER TREATMENT PLANT SITE LOGS OF AUGER HOLES

Hand augering in soil-covered areas (for location see Plate 2) indicates that up to 2-3 m of gravelly clay and extremely weathered rock overlie highly to moderately weathered adamellite. Figure 12 shows the logs of the hand auger holes.

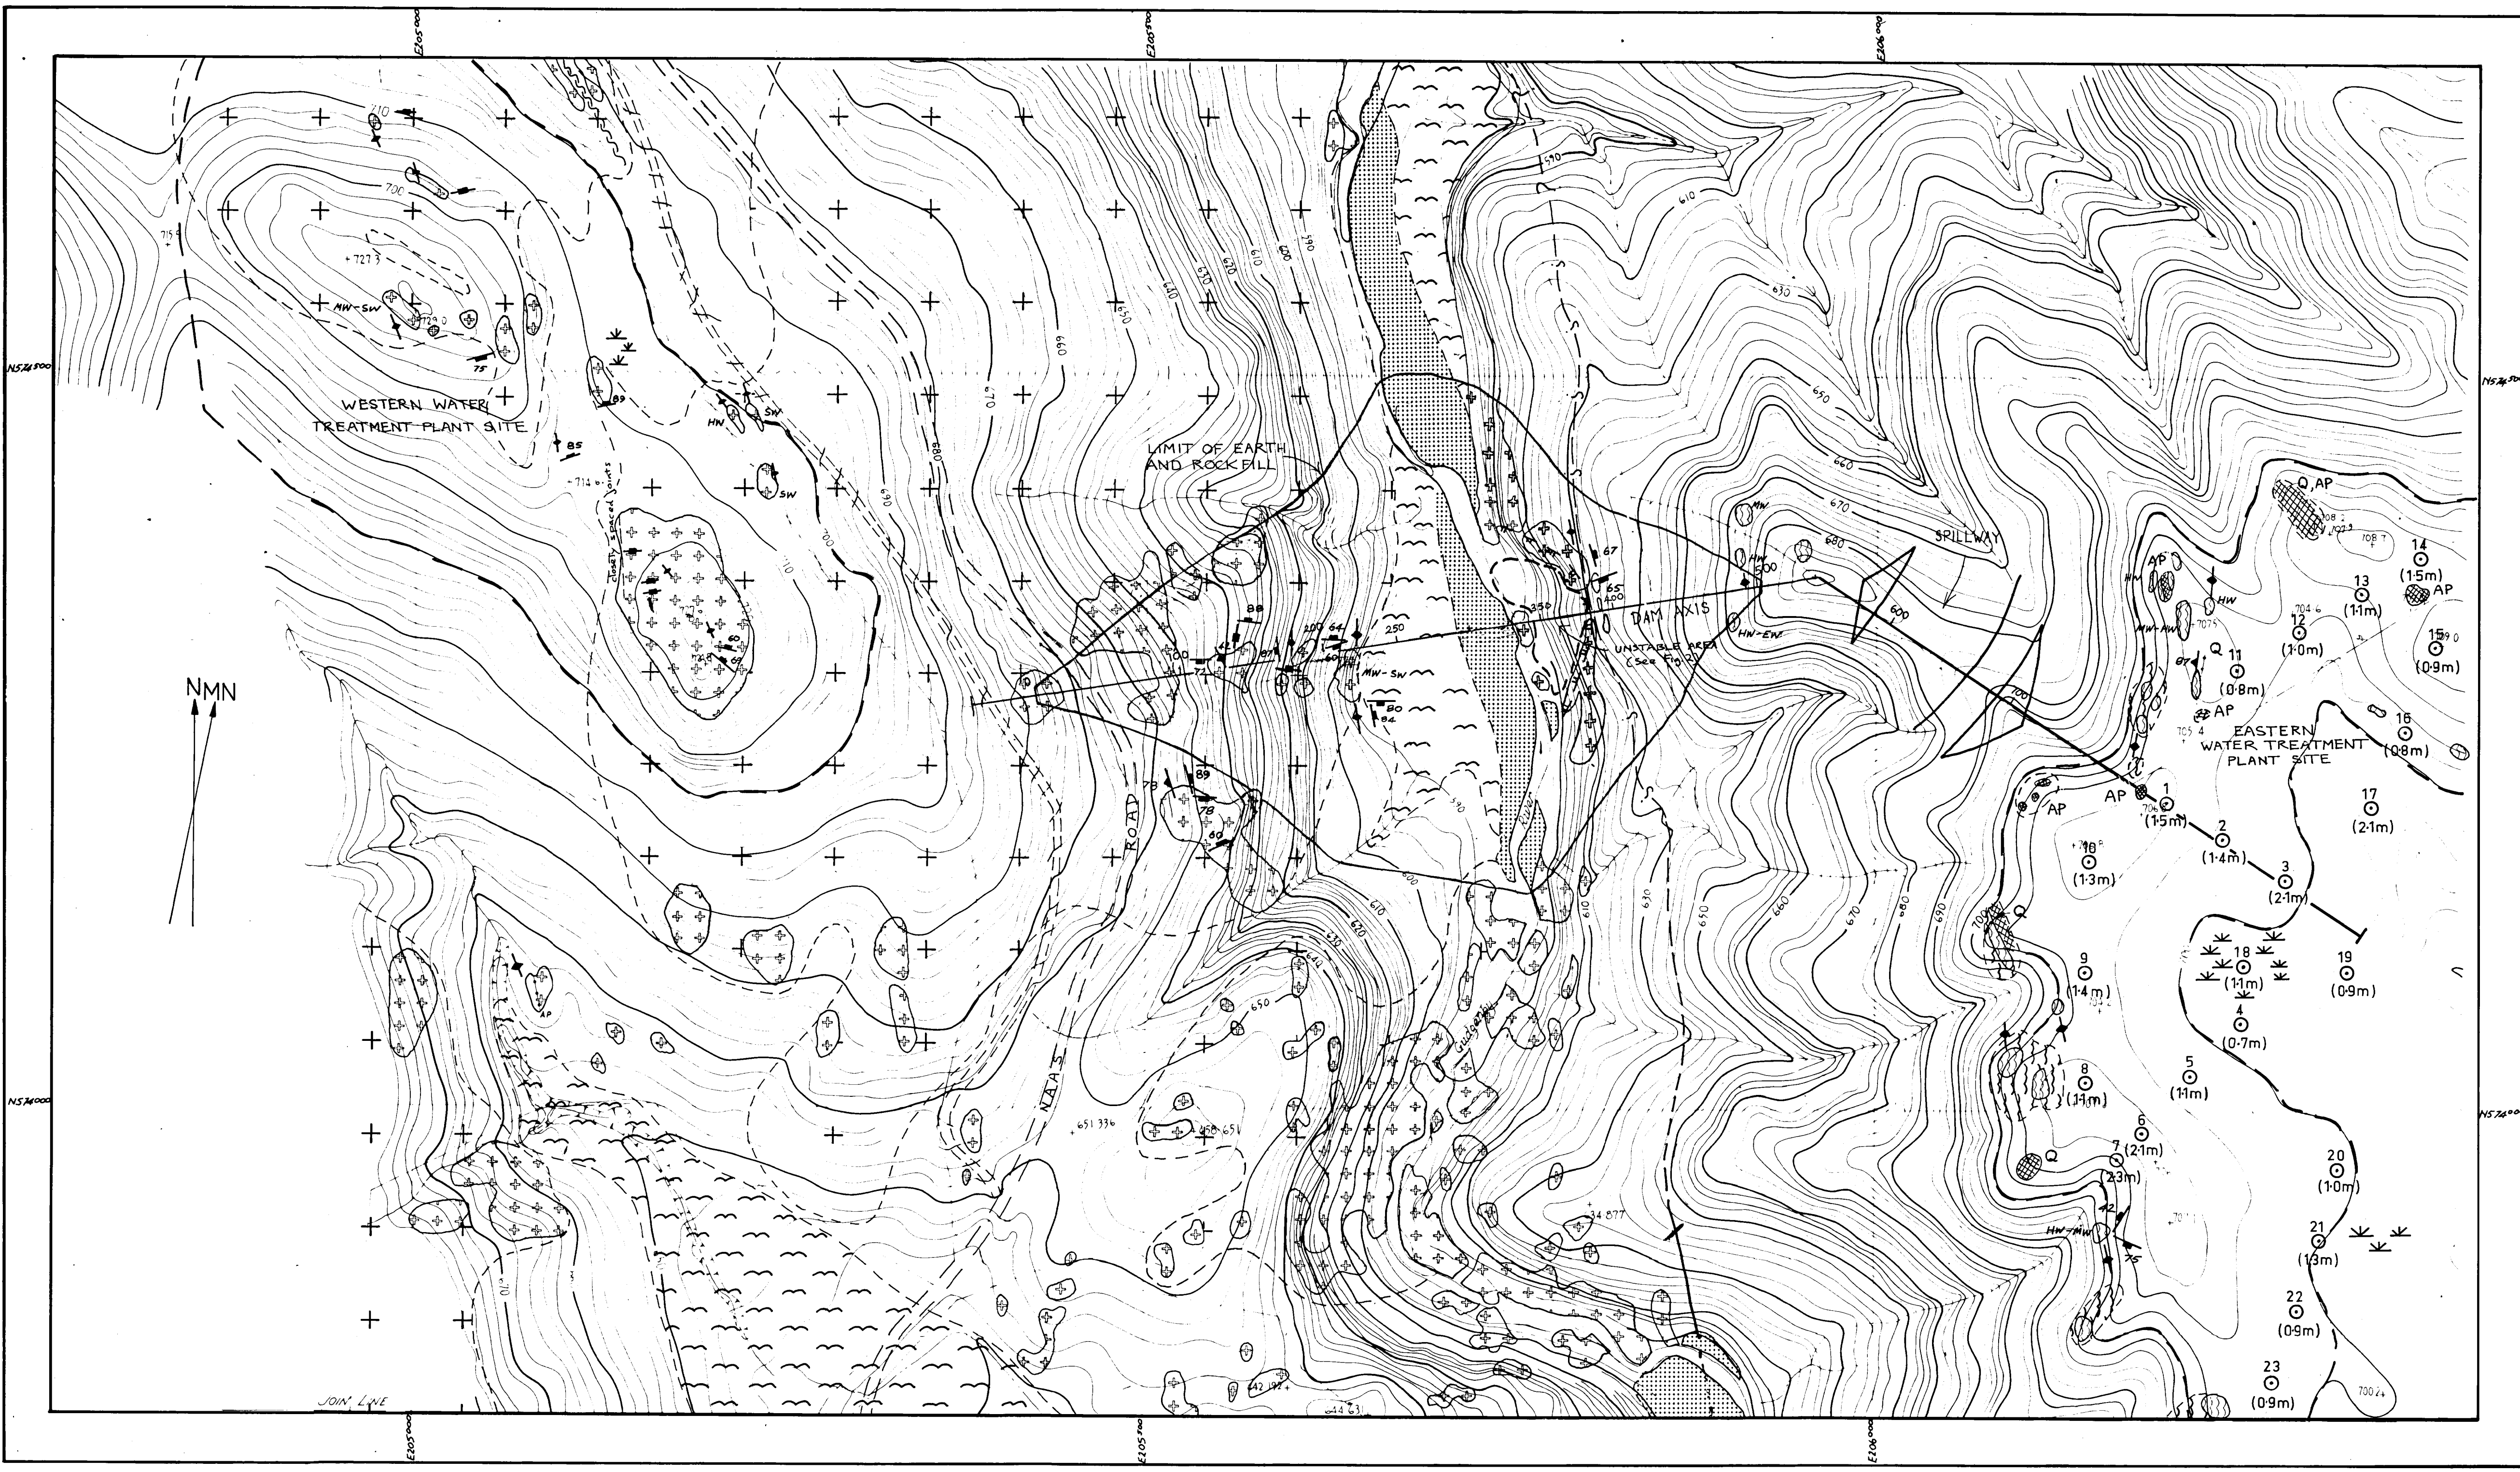
TENNENT DAMSITE 2 GEOLOGICAL MAP OF PROPOSED SITE

The geology of dam site 2 is shown in Plate 2. The site is asymmetric with steep, irregular slopes on the eastern side. Plate 4 shows an interpretative section east-west along the dam centreline. Figure 2 is a general view of the right abutment.

Plate 2 shows the geology of the site. The area is underlain by coarse-grained Tharwa Adamellite, with some minor aplite, quartz, and blastomylonite. The adamellite is foliated parallel to the regional structural trend, and quartz and blastomylonite zones are similarly aligned.

Several small swampy seepage areas were noted in the field (Plate 2). These areas would probably be saturated after periods of heavy rain owing to perched water-tables forming on the clay or hardpan layers in the soil.

The site (shown on the left-hand side of Plate 2) is underlain by foliated, medium to coarse-grained adamellite which has a variable composition and texture. The compositional variation is due to the amount of biotite in the rocks. Textures vary from porphyritic with unoriented plagioclase phenocrysts up to 3 cm in length, to foliated and gneissic. The gneissic varieties are found on the northern hill, while adamellite with poorly defined foliation is found to the south.

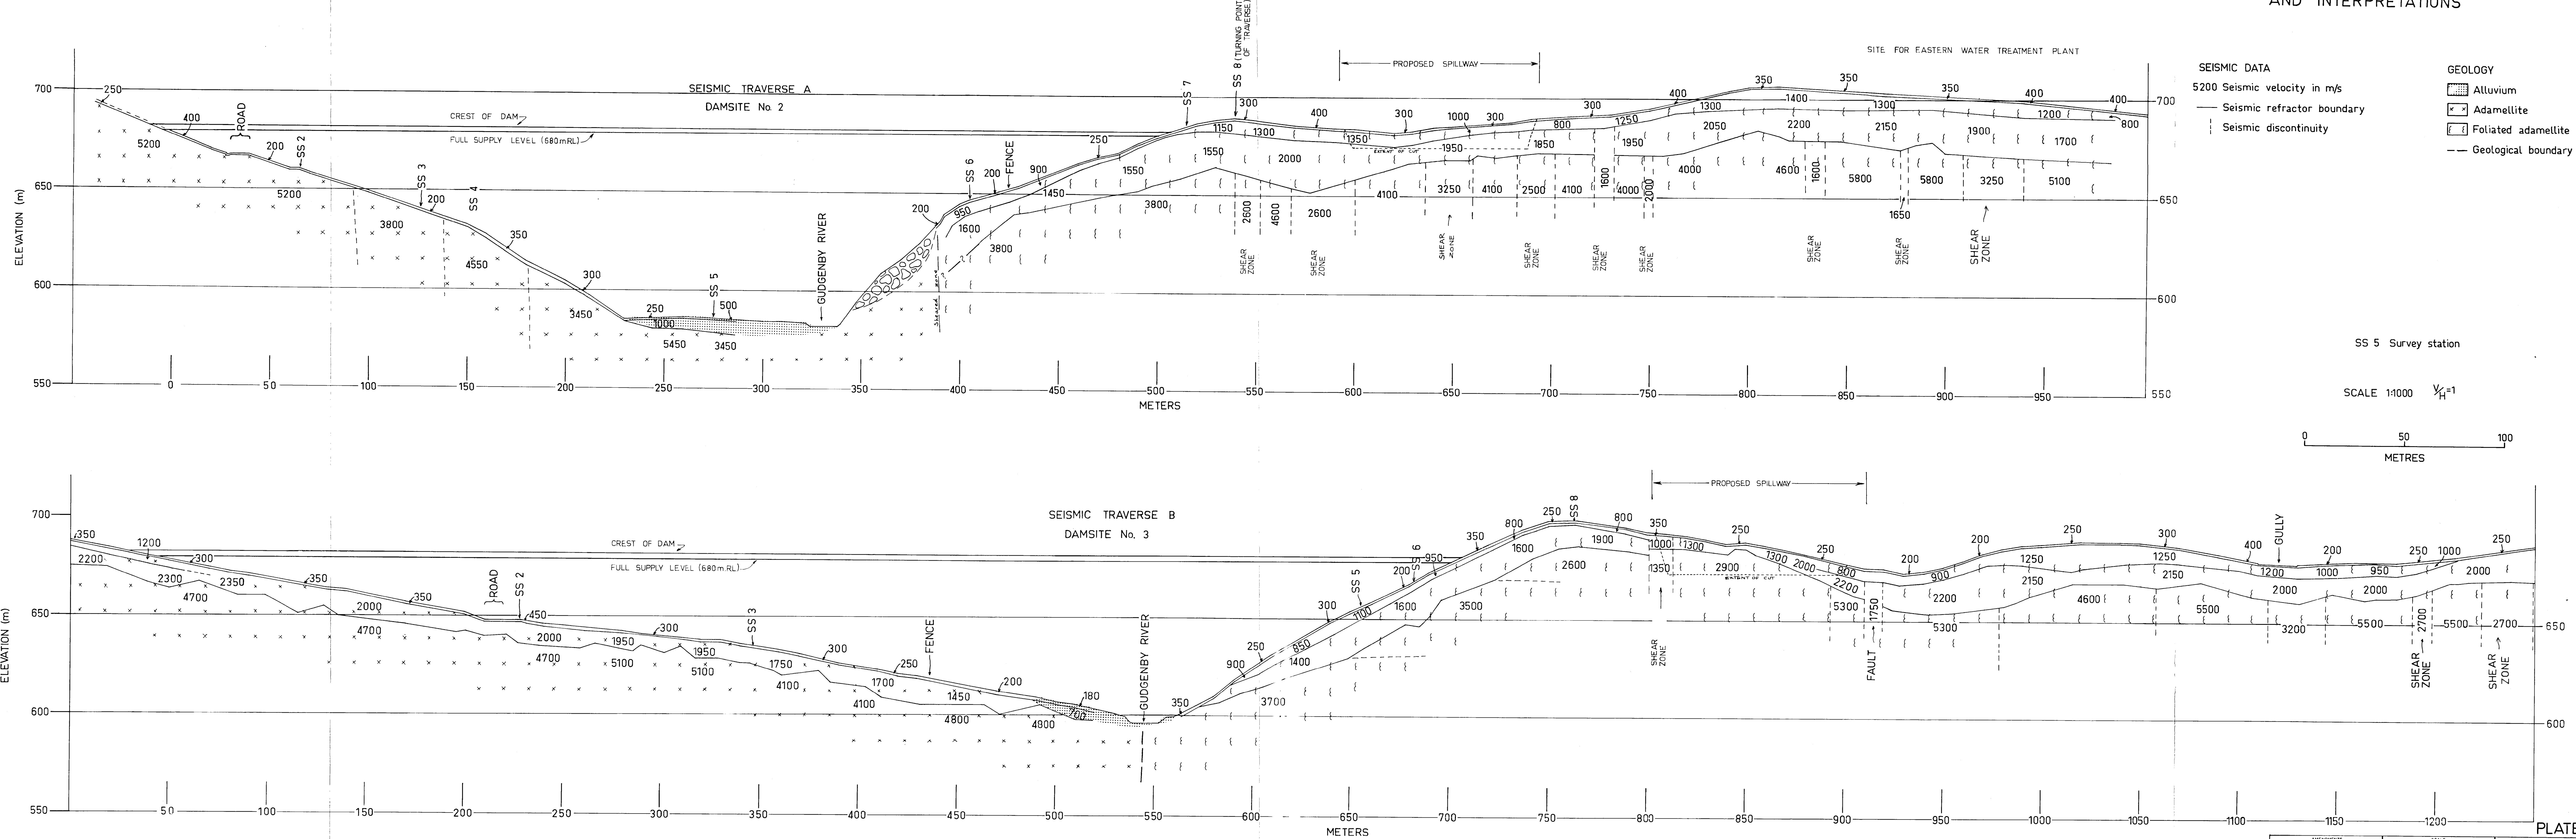
PLATE 4

Right abutment. Foundation conditions are generally poorer on this abutment, which has a deeper and more variable weathering profile than the left abutment. The highest recorded refractor (3800 m/s) is overlain by 15-25 m of highly to moderately weathered rock (1450-1600 m/s; Plate 4). Above RL

The seismic results (Plate 4) show progressively higher basement velocities towards the river in the right abutment. This probably represents a section through the weathering profile. Equivalent lower-velocity material (2600-3500 m/s) has probably been eroded from the left abutment by the easterly migrating river channel.

Left abutment. On the left abutment, fresh rock is 10 m deep, but competent rock should be between 1 and 5 m deep. The intermediate-velocity layer (Plate 4) of 1700-2350 m/s probably represents moderately weathered rock grading into fresh rock (4100-5100 m/s). The irregular margin between moderately weathered and fresh rock may reflect a very irregular profile with large residual boulders of fresh rock within more weathered material.

The valley of the spillway approach follows an airphoto-lineament striking 005° which can be traced for 2.2 km (Plate 1). This lineament probably represents a fault or shear zone. The seismic section (Plate 4) shows a fault at station 920 m (1750 m/s), and diamond drilling is recommended to accurately locate the fault and to determine rock permeability. Considerable treatment of foundations will have to be carried out in these areas.

Seismic results indicate that 10 m of highly weathered rock (seismic velocity 800-1400 m/s) and 15-20 m of moderately weathered rock (2200 m/s) overlie slightly weathered rock at 25-30 m. The seismic section indicates that a series of parallel shear zones intersect the area (Plate 4).
