BUREAU OF MINERAL RESOURCES,  
GEOLOGY AND GEOPHYSICS

Record 1977/31

THE EAST SOLOMON SEA EARTHQUAKE OF 20 JULY 1975; AND NOTES ON  
SEISMIC RISK IN BOUGAINVILLE

I.B. Everingham, B.A. Gaull and V.F. Dent.\*

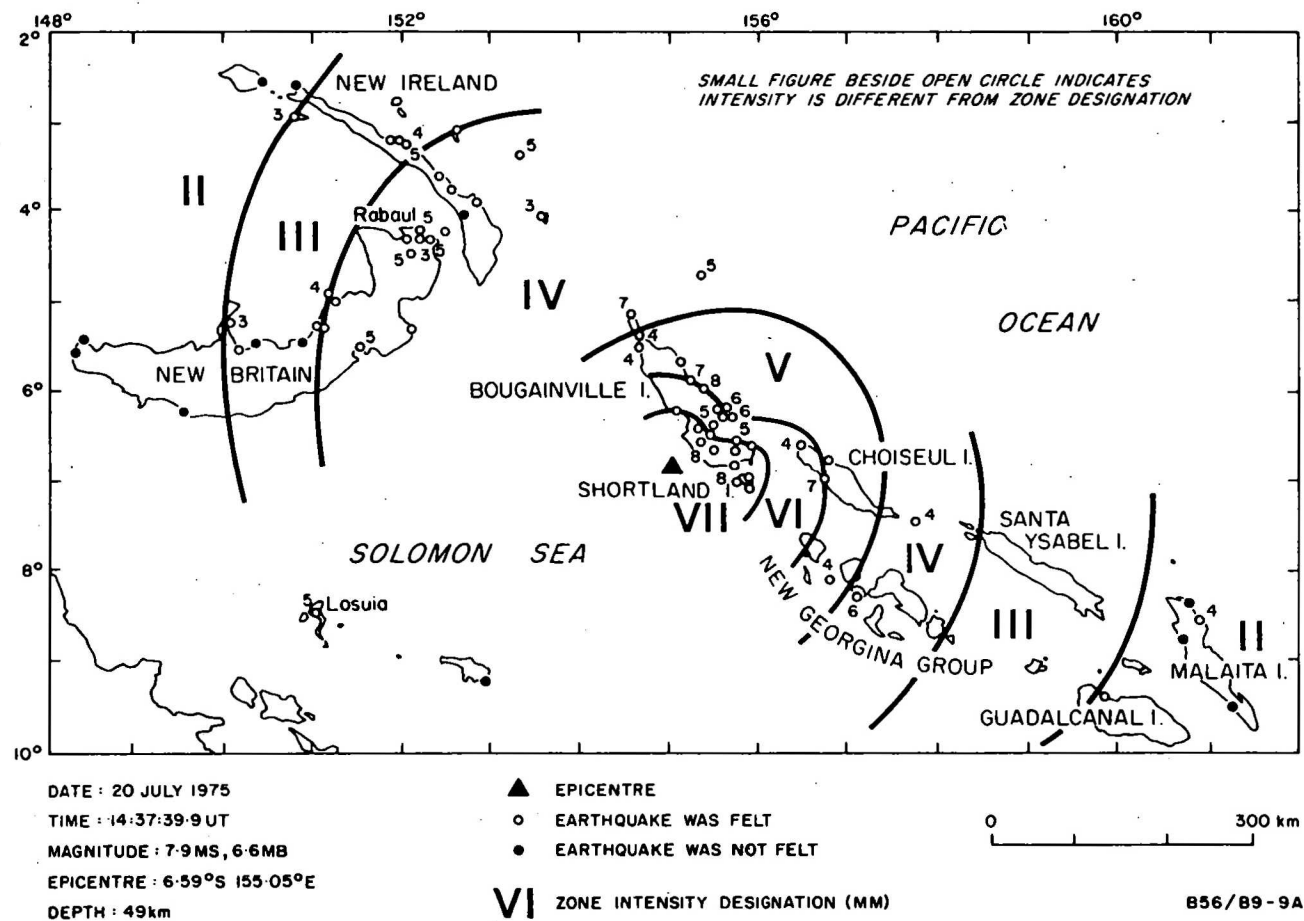
Fig.7 Isoseismal map

Two hundred and ten intensity questionnaires were issued; about one hundred were answered, and these were used to construct a map of intensities (Fig. 7). Observations made during a field inspection of southern Bougainville (discussed later) are not plotted in order to keep the intensity assessments uniform. The chart shown in Appendix 1 was designed to assess uniformly intensity on the Modified Mercalli (MM) scale using the more common evidence available in Papua New Guinea, and a general idea of the effects of the earthquake at different intensity levels may be gathered from this chart.

The earthquake was felt clearly (MM IV or greater) as far away as Rabaul and Losuia, about 500 km from the epicentre. All Bougainville Island was shaken with intensities of MM V or more. However, significant damage was restricted to the southwestern part of the island, where intensities were MM VII or more, and in the Panguna mining area (see Fig. 1), where in places intensities were in the range MM VI and MM VII. High intensities also occurred in the northernmost Solomon Islands (e.g., Shortland Island), which were close to the epicentre.

Generally, in the area with intensities MM VII or more, landslides were common, bridges were damaged, roads cracked, and people had difficulty standing. Unreinforced concrete masonry structures, weaker village homes, and cylindrical corrugated iron water tanks were badly damaged. Structures not fastened securely to their stumps were shaken off them; wharves, and particularly their approaches, were damaged. Some areas along the coastlines subsided.

In the area between the MM VI and MM VII isoseismals, damage was slight and included breakage of articles shaken from shelves, minor subsidences, landslides, and road damage. The MM VI isoseismal averaged at about 150 km from the epicentre. Beyond this distance damage was negligible.
