BMR Record 1979/84

OBSERVATIONS ON GEOLOGY, SOILS, AND GROUNDWATER
RELEVANT TO PAVEMENT FAILURE IN CANBERRA, 1979

E.G. Wilson

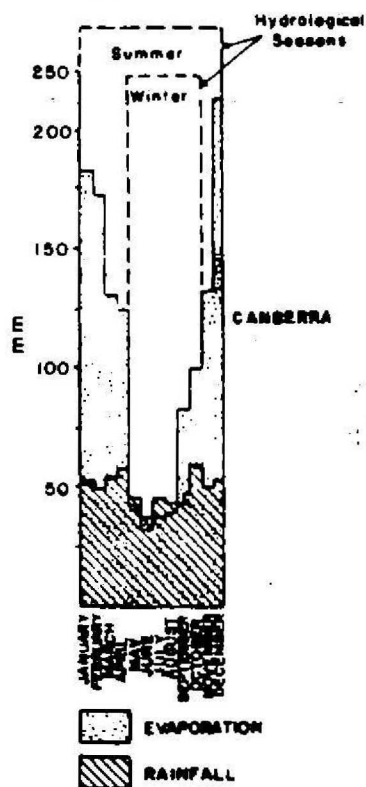
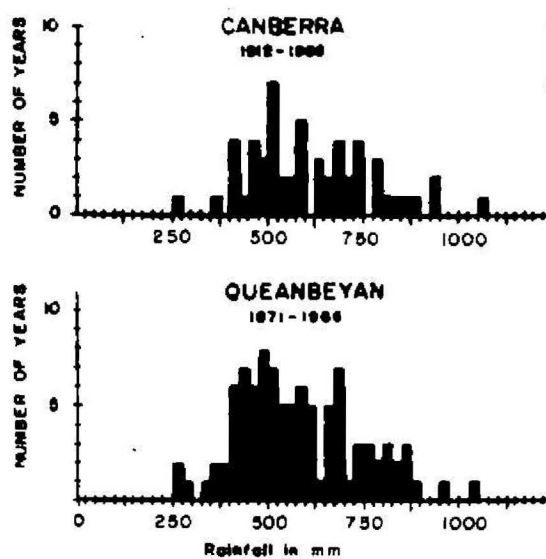
Climatological Data Canberra - Queanbeyan Area

MEAN RAINFALL AND EVAPORATION

ANNUAL RAINFALL HISTOGRAMS

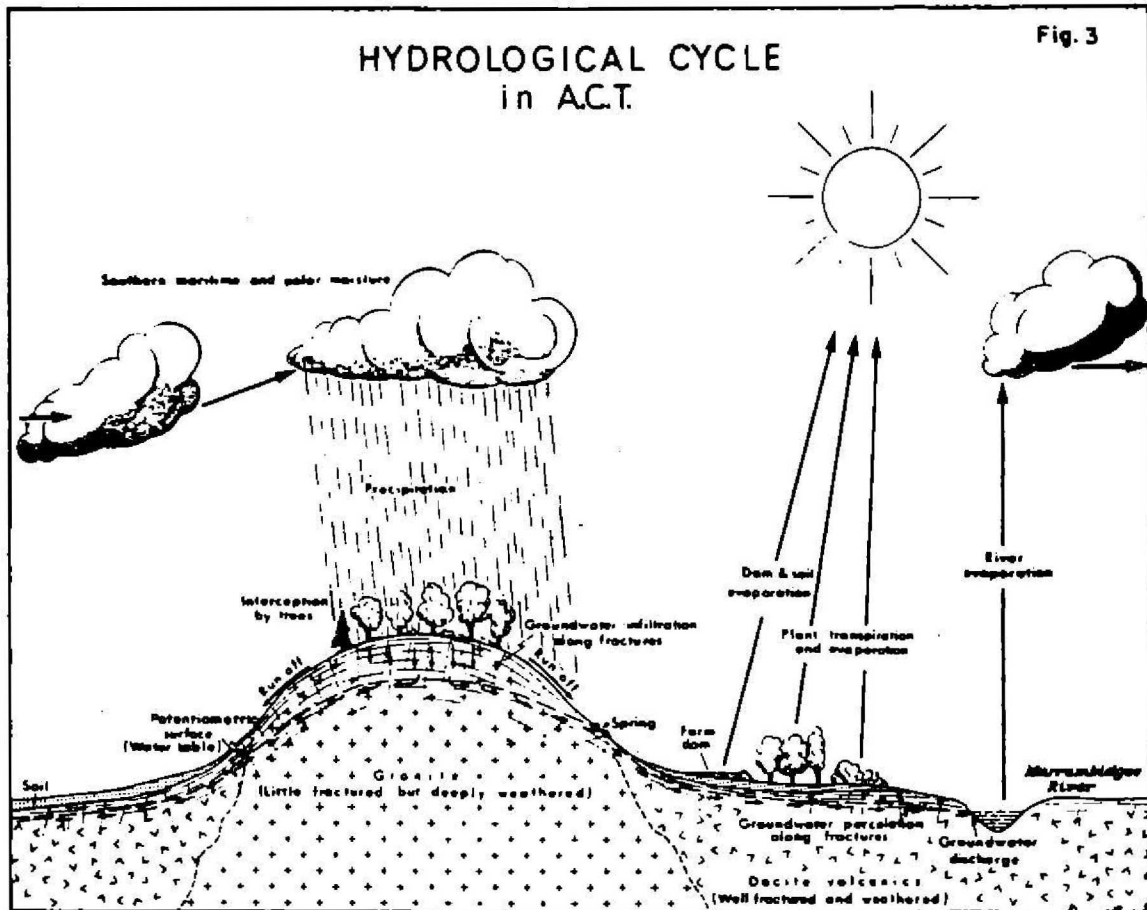
Fig. 3

Infiltration on the hills takes place through open joints in rock, and contributes to groundwater in fractures in the rock underlying the valley (Fig. 3). Infiltration on the lower slopes and valley floor takes place through the thin silty A horizon to voids in the surficial sediments and shrinkage cracks in the clay soils. Infiltration into shrinkage cracks in the soil is high for the first 24 hours of rainfall, but is greatly reduced as expansion of the clays closes the cracks. The widening of shrinkage cracks where they are exposed at the surface by removal of the A horizon seems to have taken place following rainfall; this may be caused by the dispersion of clays such as illite and montmorillonite in water during infiltration, as is recognised as piping in the failure of small earth dams. It follows that soil that attains a high moisture

HYDROLOGICAL CYCLE in A.C.T.
