BMR RECORD 1980/41

GROUNDWATER POLLUTION BY PETROL

AT THE NRMA BUILDING,

BRADDON, ACT

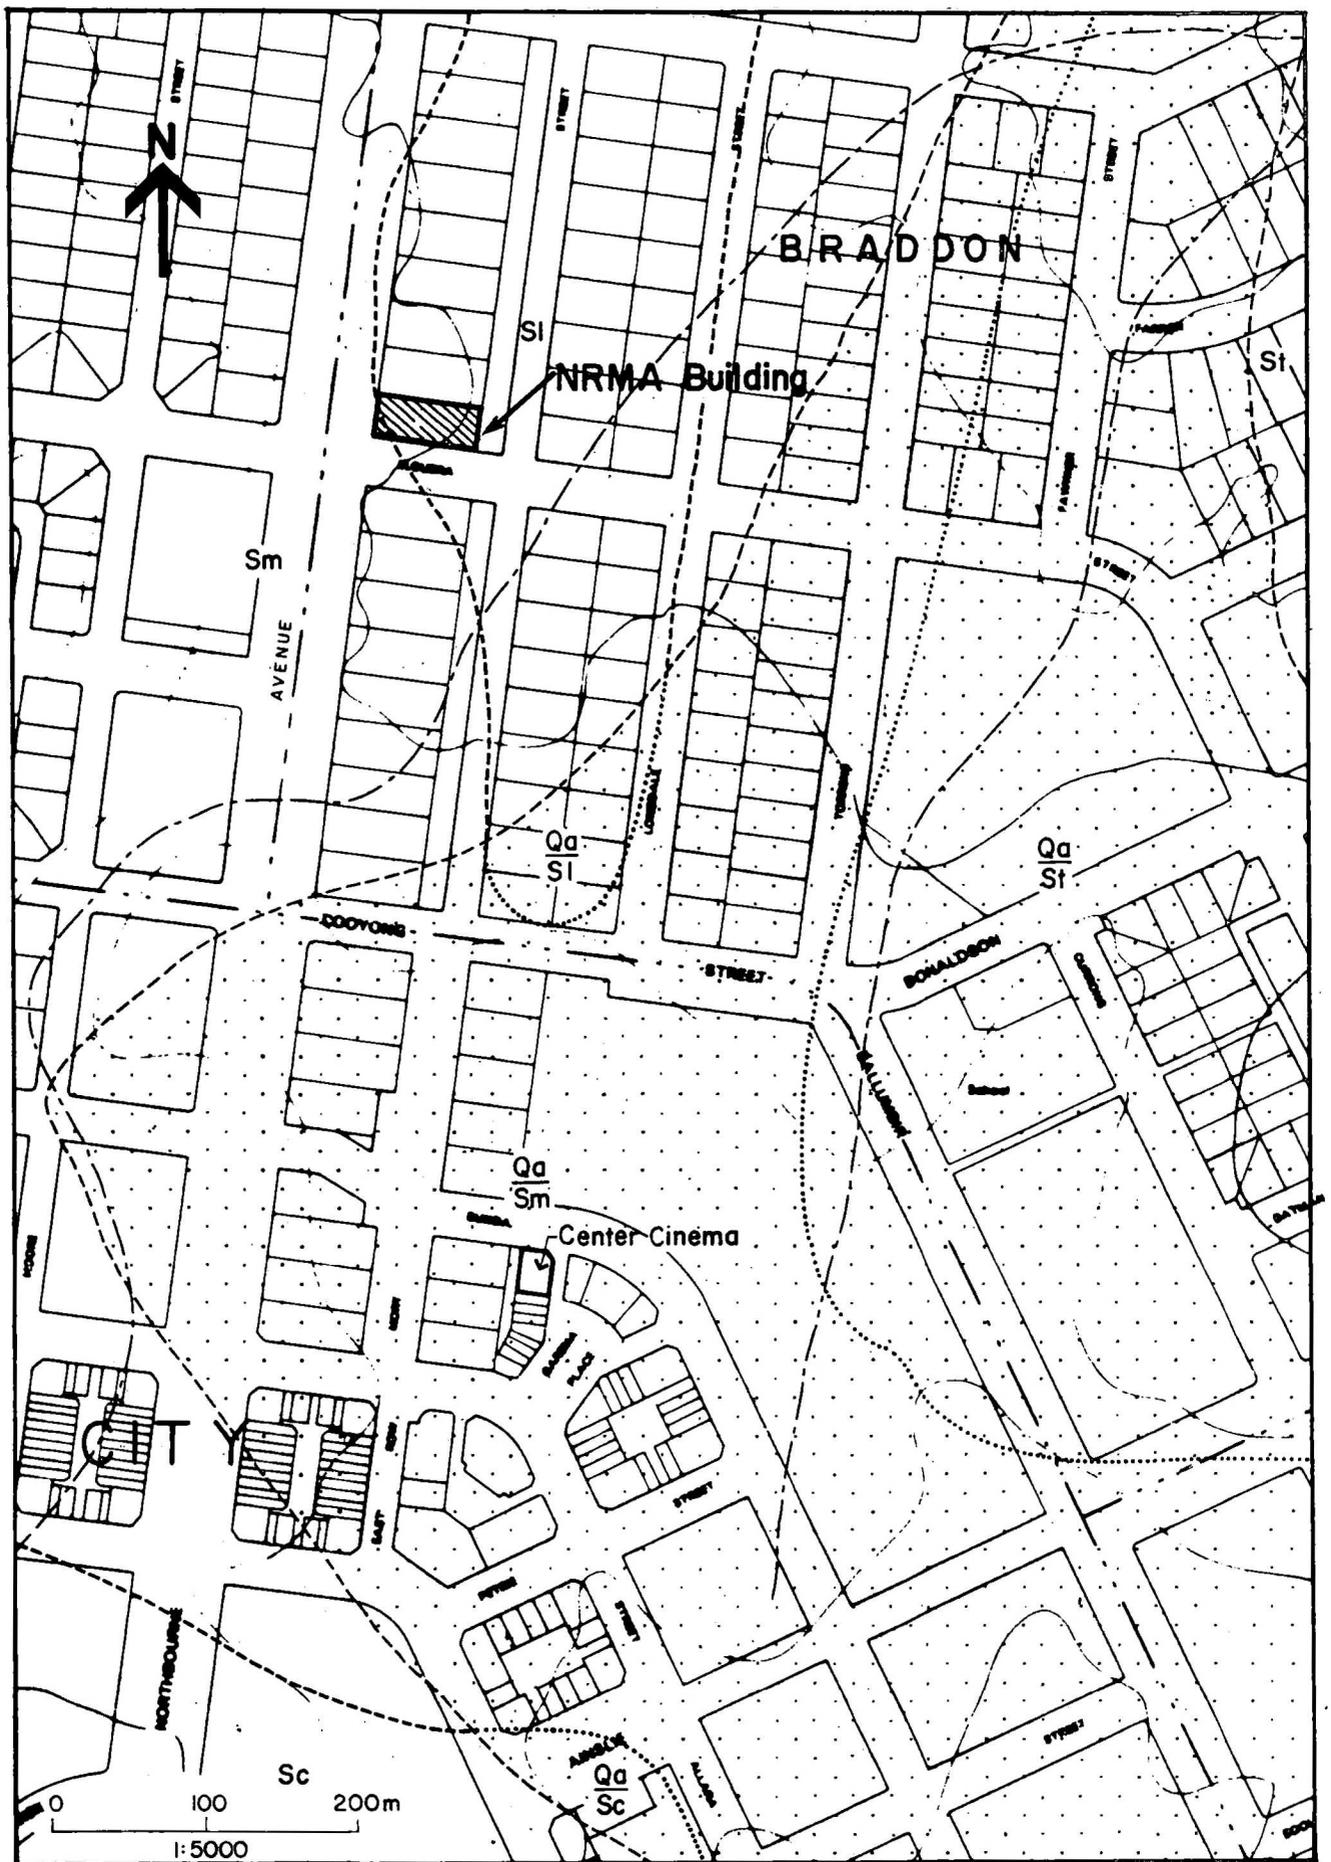
Fig 2 Geology

The geology of the Canberra City-Braddon area is known from records of building excavations and site investigations. Limestone was recorded in the foundation of the NRMA Building, and the geological map of the area (Fig. 2), shows that the building is founded on Silurian limestone, the boundaries of which are known only roughly.

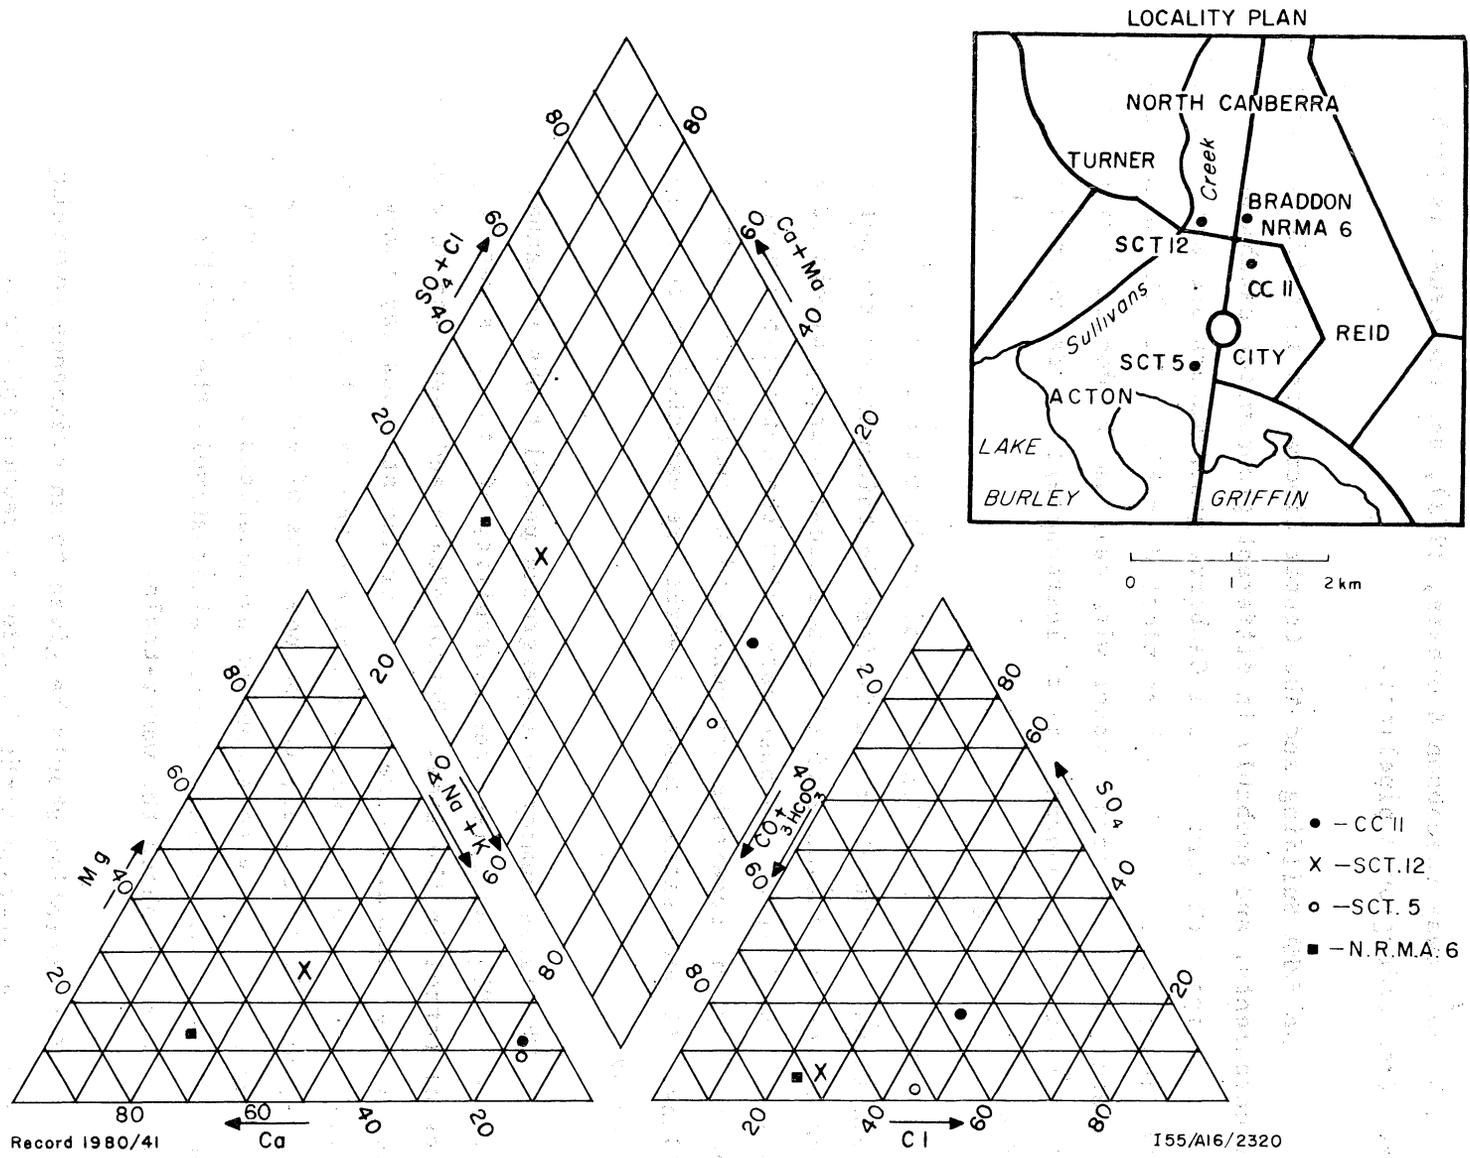
Figure 8 Piper trilinear diagram for Canberra groundwaters. Reacting values for main ionic constituents plotted as percentages.

The NRMA Building and the Center Cinema are in different surface water catchments, and probably in different groundwater catchments. Chemical analyses of some central Canberra groundwaters are shown in Table 1, and the ionic components have been plotted in Figure 8. The NRMA Building groundwater is a bicarbonate water with calcium the dominant cation; whereas the Center Cinema groundwater is a bicarbonate/chloride water with sodium the dominant cation.
