A REGIONAL REVIEW OF COASTAL HAZARDS ALONG THE SOUTH WEST COAST OF WESTERN AUSTRALIA

Minerals and Geohazards Division
Perth Cities Project

**This report was produced as a part
of the graduate traineeship program**

**Geoscience Australia
April – June 2002**

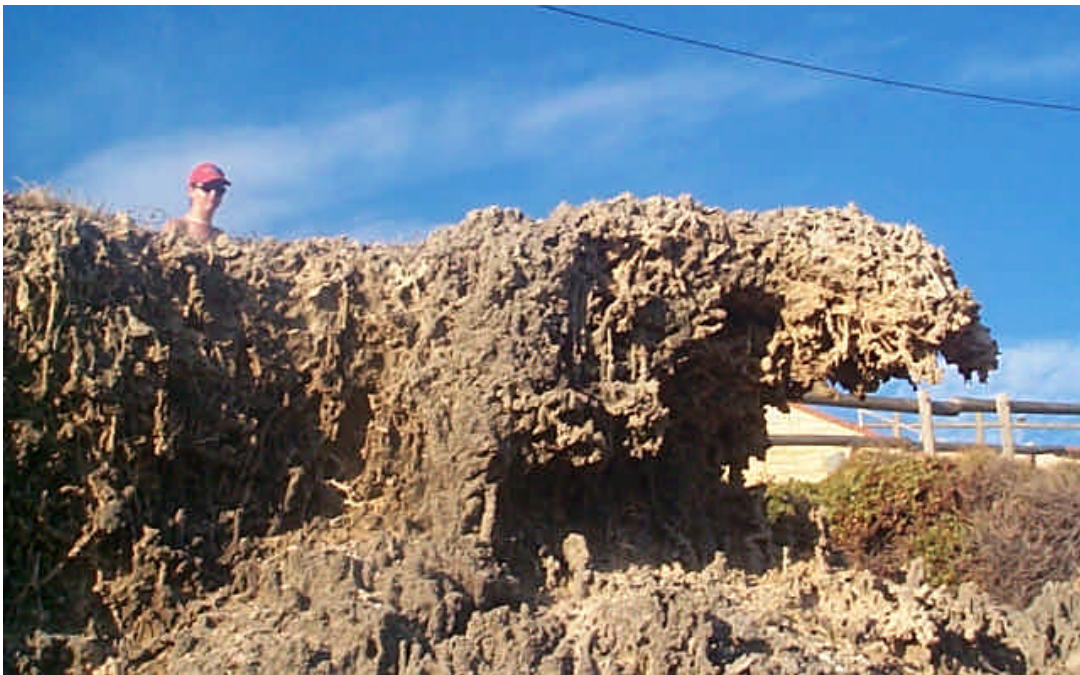
Figure 2.2 Hard calcrete casts and moulds of fossil roots can be seen in this outcrop of Tamala Limestone at site 6 (see Appendix A).

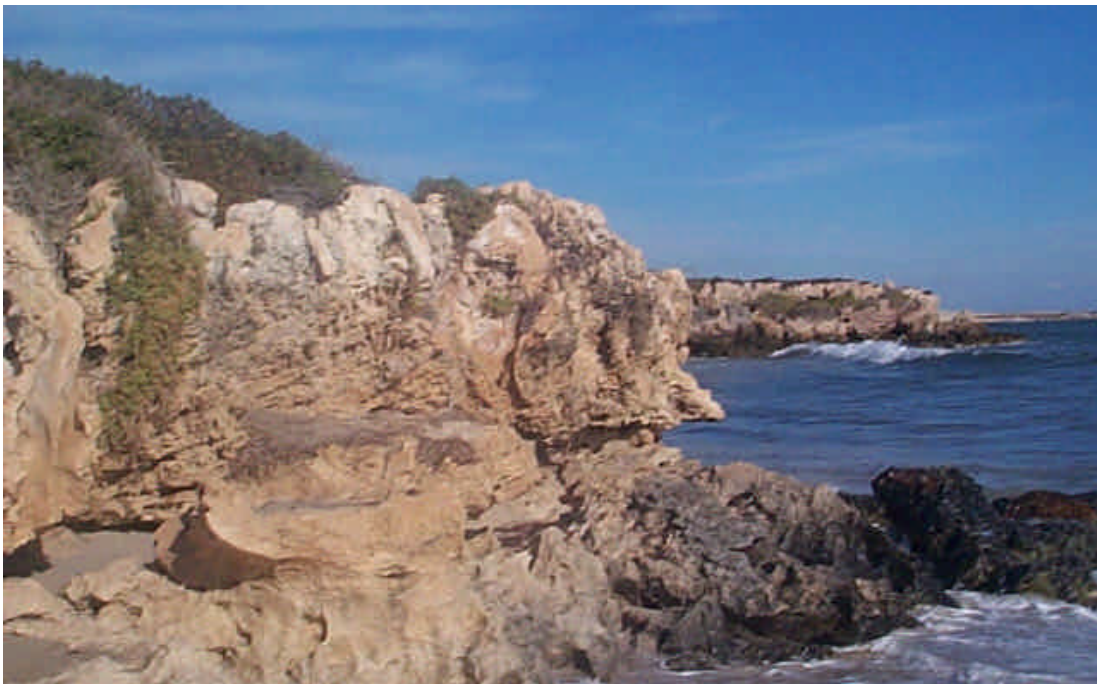
Figure 3.2 Typical exposure of Tamala Limestone within study area no.1. The cliffs in this photo are 3-4 m tall and are located at site 4 (see Appendix A).

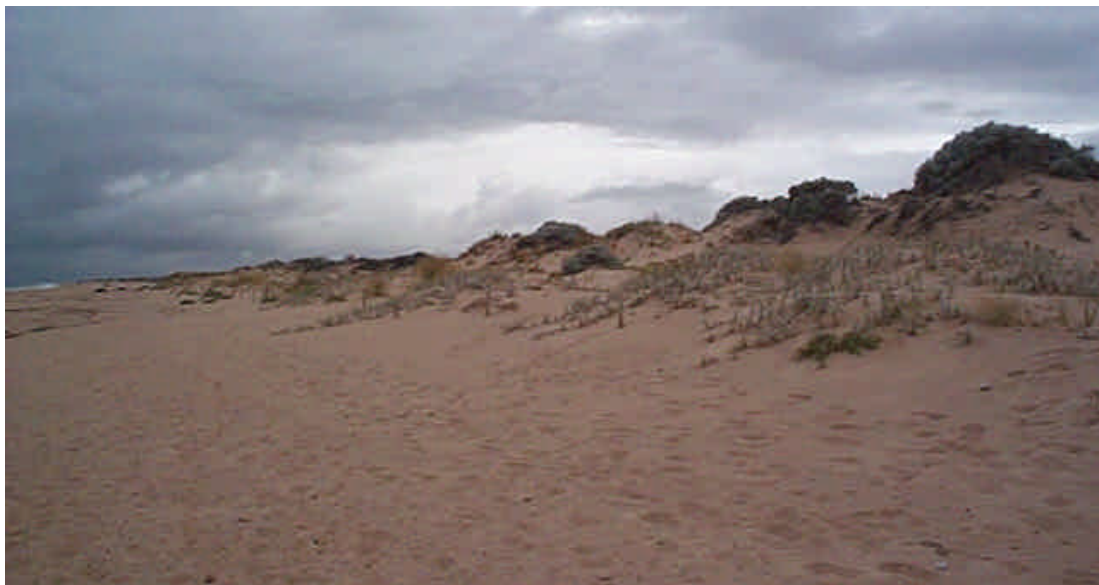
Figure 3.3 Site 13 is a typical example of the sandy beach and low foredunes that characterise area no.3.

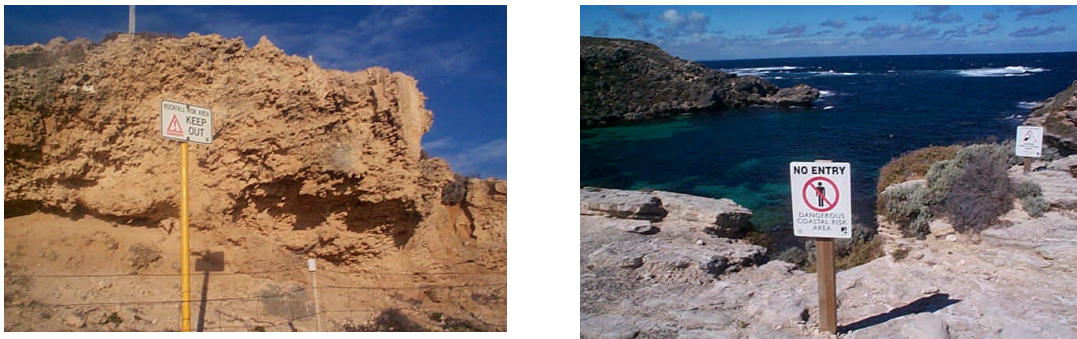
Wire fences have been constructed around some of the more hazardous areas and are often used in conjunction with prohibitive signs such as ‘Keep Out’ (Figure 4.1). Railed walkways can also be an effective way of ensuring that the public walk on designated paths and stay out of hazardous areas.

Figure 4.1 A variety of prohibitive signs in conjunction with wire fences have been constructed to keep people out of hazardous areas.

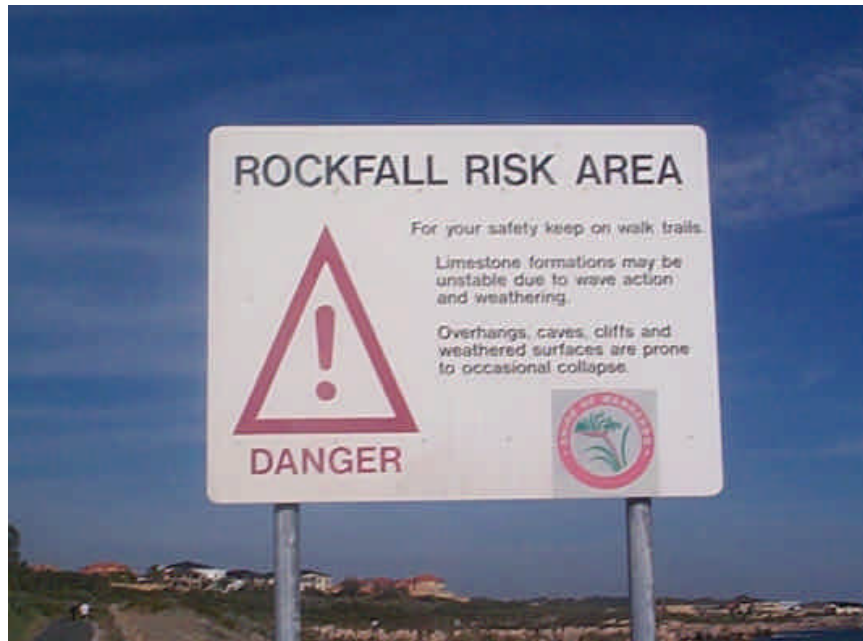
Local Government Authorities have been quite active in erecting a variety of signs warning the public about limestone hazards. These warnings range from prohibitive signs such as ‘Keep Out’ and ‘No Entry’ (Figure 4.1), to more informative signs specifically warning people not to walk over the cliffs and not to shelter under overhangs (Figure 4.2).

Figure 4.2 An example of an informative sign within the City of Wanneroo. This type of sign does not deny public access, but alerts people to the dangers associated with limestone cliffs.

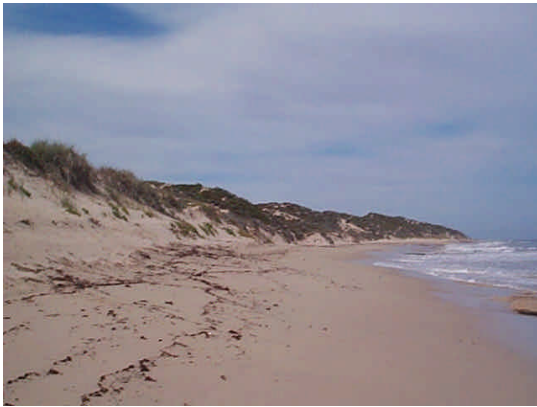
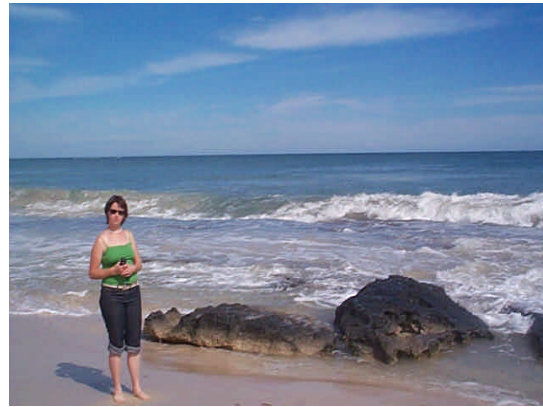
Site number: 1
Location: 1.5 km south of Yanchep Lagoon
GPS: 0370544 / 6506865
Geological unit: Safety Bay Sand, S1 backed by S2

Description: Narrow (<10m) sandy beach backed by large extensive dunes characterises this area. Foredunes are well-vegetated approx 5-8 m tall. Scattered along the waters edge are limestone outcrops ~ 50cm high and of varying diameter.

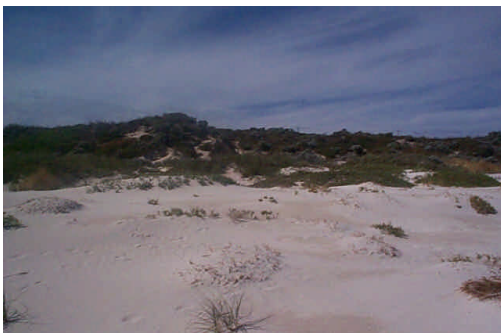
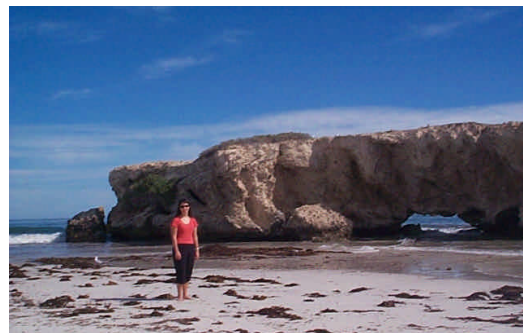
Site number: 2
Location: Two Rocks
GPS: 0365481 / 6514219
Geological unit: Safety Bay Sand (S2), Tamala Limestone (LS1)

Description: Two Rocks beach is a narrow (10-15 m) sandy beach, backed by low (3-5 m) hummocky dunes. A large limestone island sits just off the beach in the water. There are several blocks (1-2 m³) as well as evidence of undercutting, including an archway that has been eroded by wave action.

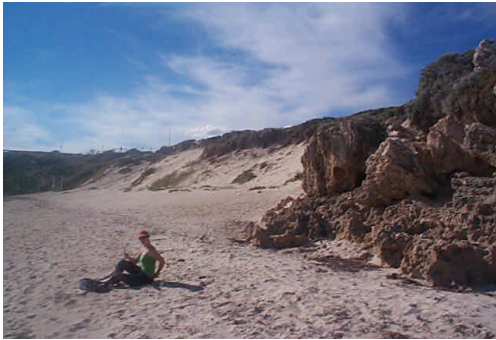
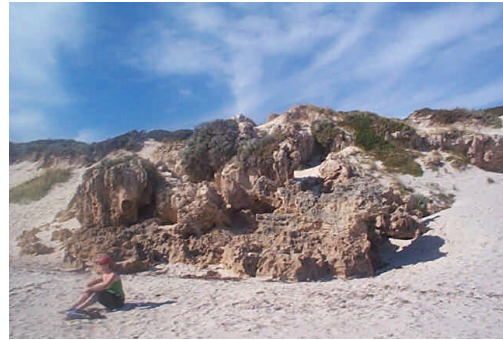
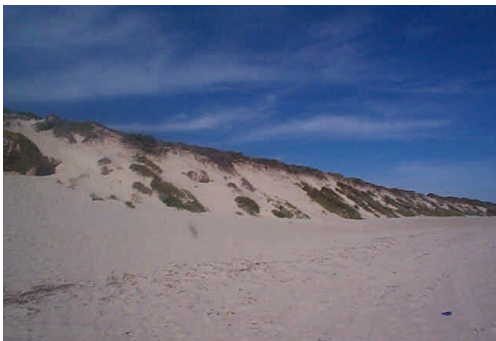
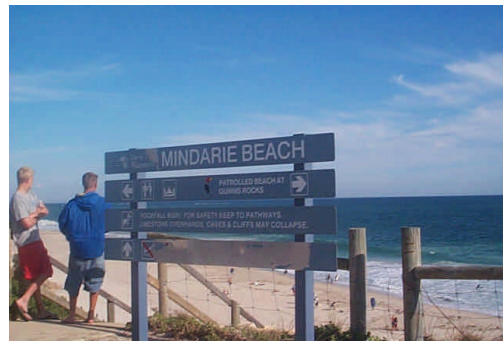
Site number: 3
Location: Mindarie Beach
GPS: 0377069 / 6492532
Geological unit: Safety Bay Sand, S1 backed by S2

Description: Mindarie is a long, wide sweeping beach backed by large (6-10 m) vegetated dunes. There are no limestone cliffs developed on this beach, but there are however, numerous limestone sections protruding from within the sand dunes and some cliffed headlands to the north. One particular outcrop protruding from within the dunes is about 5-6m wide and approx 4m tall. There are some large (1m³) blocks of limestone that have broken off from the main body and toppled to the ground. A sign has been erected at the top of the staircase in the car park, warning people that there is a risk of rockfall and that paths should be used at all times.

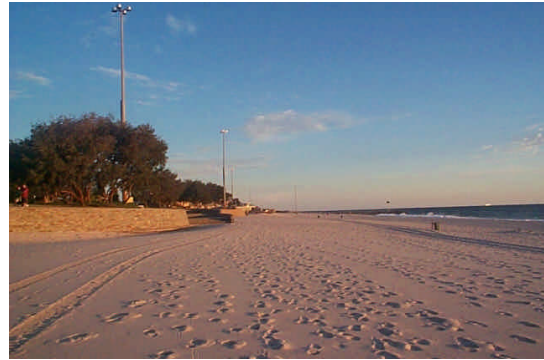
Photo of site 8

Description: This site consists of a wide flat sandy beach. The area has been artificially developed with a stone wall and grassed BBQ/play area backing the beach. There are no natural hazards from limestone cliffs or sand dunes at this site.

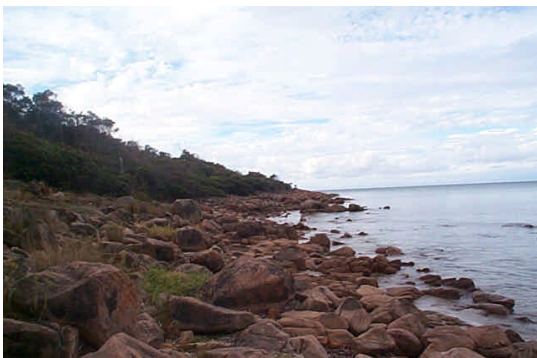
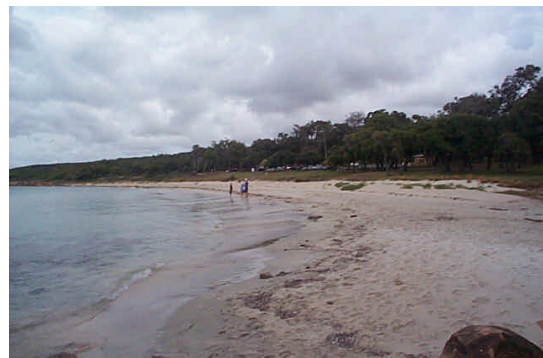
Site number: 9
Location: Meelup Beach
GPS: 0322449 / 6283597
Geological unit: Safety Bay Sand (S1) and Granite Gniess (GN)

Description: Meelup Beach is a small sandy cove in between two rocky headlands. The headlands are composed of large rounded granite gneiss boulders. The narrow beach has a very gentle slope and is backed by a grassed reserve with many trees and a car park. There are no cliff lines or sand dunes at this site.

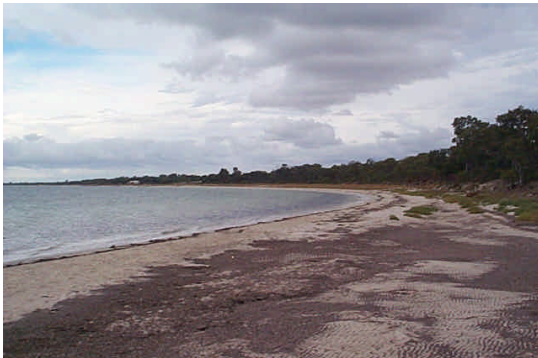
Photo of site 10

Description: The beach at this site is quite narrow (10–15 m) and very flat. Backing the sandy beach are some well vegetated low dunes, no more than 2 m high. The dunes are well stabilised by trees and grasses and do not present a threat to the community.

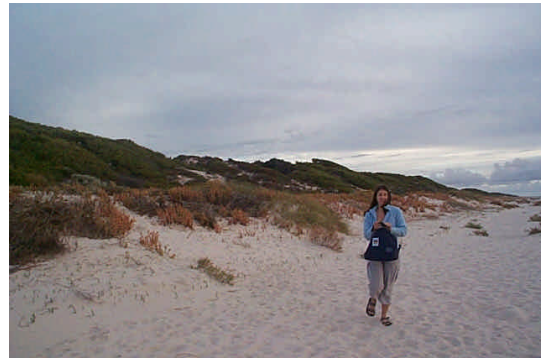
Photo of site 11

Description: Peppermint Grove is a sandy beach, 10-20 m wide backed by small <1m foredunes with moderate vegetation cover. The foredunes grade into larger (>6m) dunes backing the beach that are densely vegetated and appear to be well stabilised.

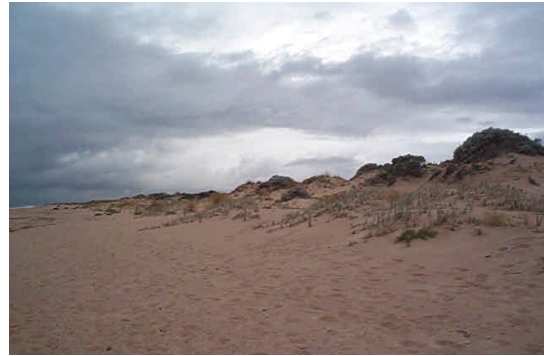
Photo of site 13

Description: Preston is a narrow sandy beach, < 10 m wide backed by small < 4.5m foredunes with moderate vegetation cover. The foredunes have a gentle slope of 10-20° and grade into larger (>10m) dunes backing the beach that are densely vegetated.
