The 30TH September 2009 West Sumatra Earthquake

Padang Region Damage Survey

2010/44

GEOSCIENCE AUSTRALIA
RECORD 2010/44

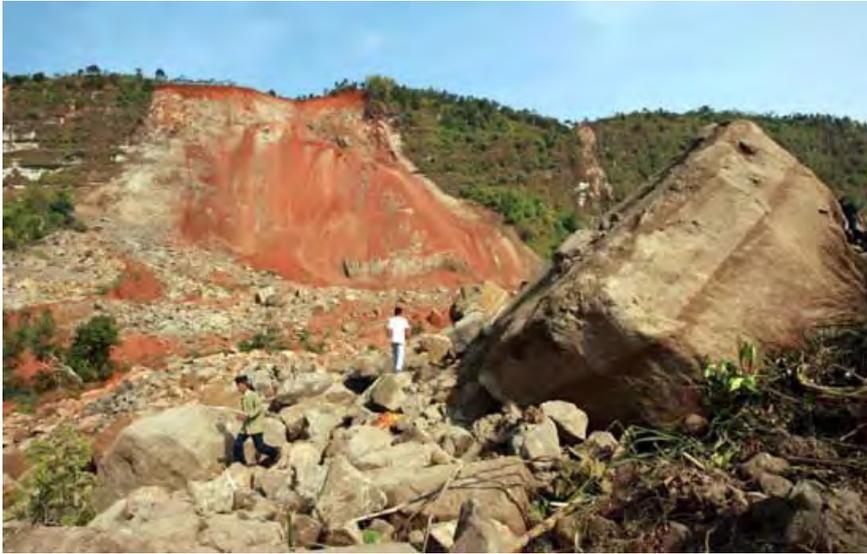
Landslides along the steeper winding roads leading through the hills from the coastal plain to the volcanic plateau were common and moderately damaging. Numerous large rockfalls and flows also occurred from the susceptible caldera escarpment surrounding Lake Maninjau and from the very steep slopes in the gorge between Secincin and Padang Panjang. Figures 3.5 to 3.7 show examples of the slope instability resulting from the event.

Figure 3.5: *Rockfall and flow from the caldera rim which surround Lake Maninjau*

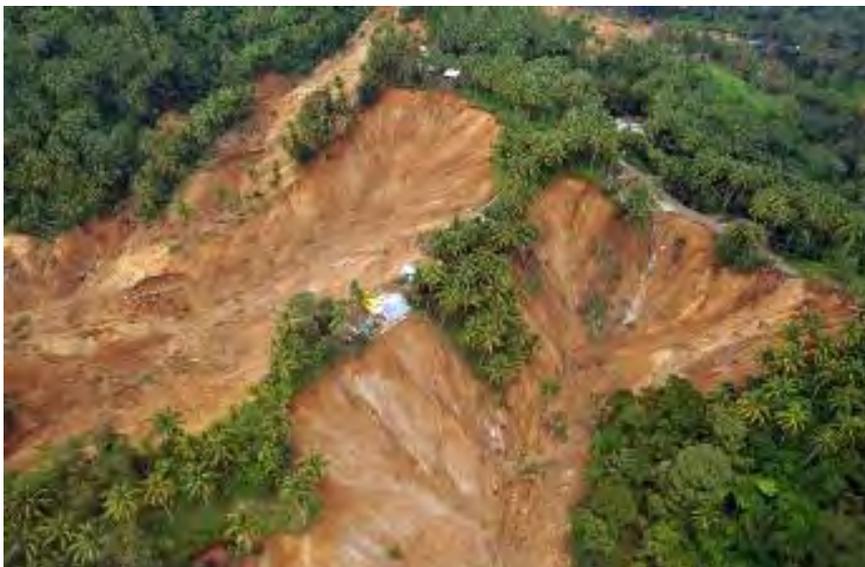
Of greatest consequence were the large devastating earthflows triggered by the earthquake which buried villages and were responsible for over 600 deaths, more than half of the earthquake fatalities. These were triggered within volcanic tuff soil deposits in moderately steep, rounded hills, the instability of which is difficult to predict. It is possible that such landslides in saturated soils may be more readily triggered by the predominance of high frequency ground motions generated by this earthquake. However, with the expected future megathrust earthquakes and perhaps even stronger shaking intensity, it is important for detailed studies to assess the causes of the devastating earthflows and to identify the areas at risk from possible future events.

Figure 3.6: *The source area of large devastating earthflows triggered by the earthquake. These earthflows buried villages and were responsible for over 600 deaths, more than half the reported earthquake fatalities.*

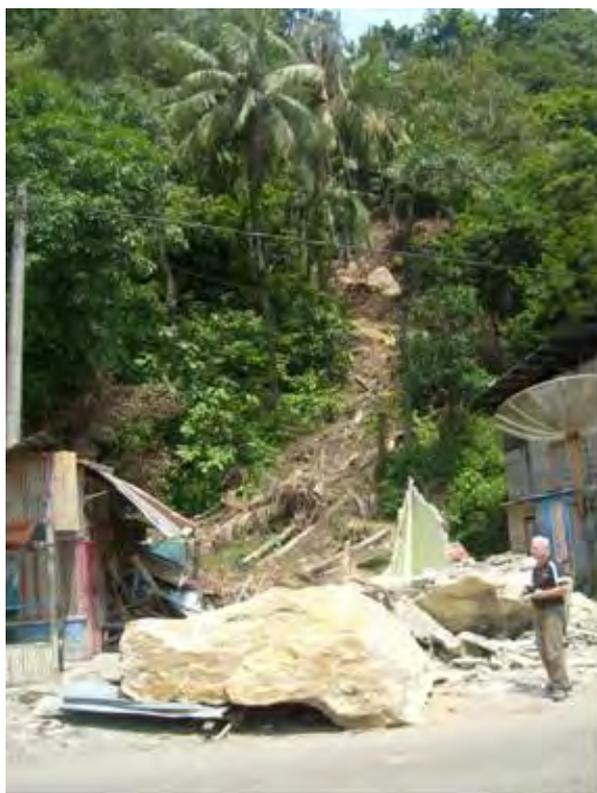
Figure 3.7: *Rock fall from the escarpment behind the port (Teluk Bayur)*

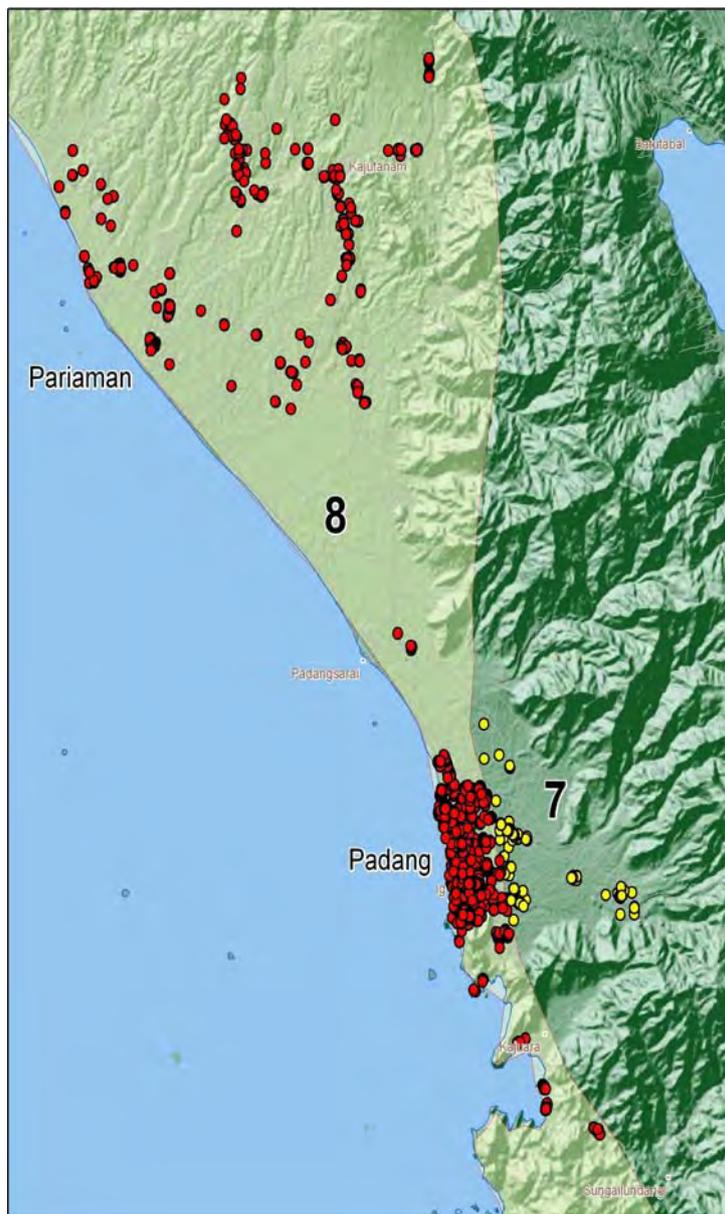
The survey of earthquake damage in the Padang region carried out by the survey team indicated a felt intensity of MMI 7 or 8 in the city with a maximum felt intensity of MMI 9 in Pariaman. An intensity of MMI 6 to 7 is associated with the onset of environmental damage (liquefaction, lateral spreading, landsliding) and damage to non-earthquake resistant structures, with these indicators all becoming increasingly severe with further increases in intensity. Using these indications along with occupant interview observations the intensity map shown in [Figure 6.1](#) was developed. It indicates an MMI of 8 across most of Padang and Pariaman dropping off to MMI 7 with distance inland.

Figure 6.1: *MMI attribution based on observed liquefaction, lateral spreading, landsliding and building damage along with resident interviews conducted by the survey team. Red dots show locations where an MMI of 8 was recorded. Yellow dots show locations where an MMI of 7 was recorded.*

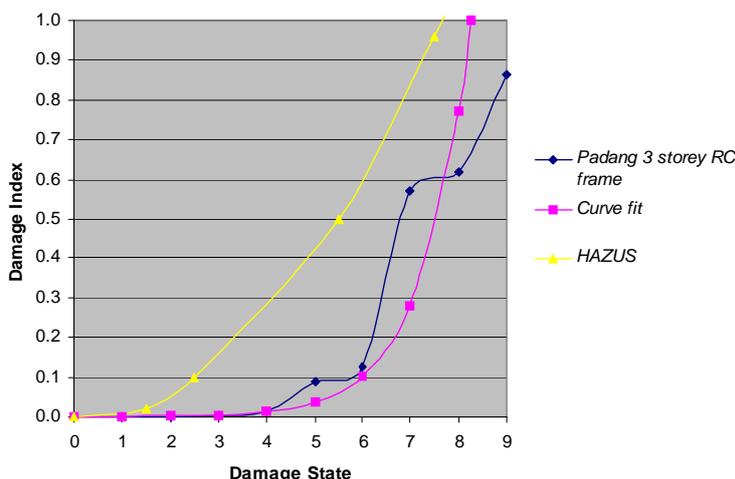
Quantity surveyor style costing of repairs to damaged buildings was undertaken for two types of buildings: a 3 storey reinforced concrete frame office building and a generic single storey confined masonry building. Detailed measurements were taken in the field of a representative 3-storey office building and representative dimensions were assigned for a single storey confined masonry building. Detailed descriptions of physical damage to each building were assigned to each element of the building fabric for each damage state together with the required work to effect repairs to a reinstatement standard similar to that observed in Padang. The repairs for each damage state were costed using Padang repair rates supplied by ITB reflecting neutral demand surge conditions. The damage index versus damage state results are presented in [Figures 6.2](#) and [6.3](#).

Note that for the concrete framed building some expensive elements (e.g. deep foundations) were not costed to be replaced and hence the calculated damage index (DI) failed to reach unity. For the residential building the DI was able to exceed 1.0 because the demolition costs made up a significant component of full repair. Smooth curves were fitted to the plotted values of damage index versus the damage state number in [Figures 6.2](#) and [6.3](#). Also presented on the figures are the equivalent DI

Figure 6.2: *Damage index versus damage state number for the 3 storey office building.*
 $DI=0.000229*2.76^{(Damage\ State\ Number)}$

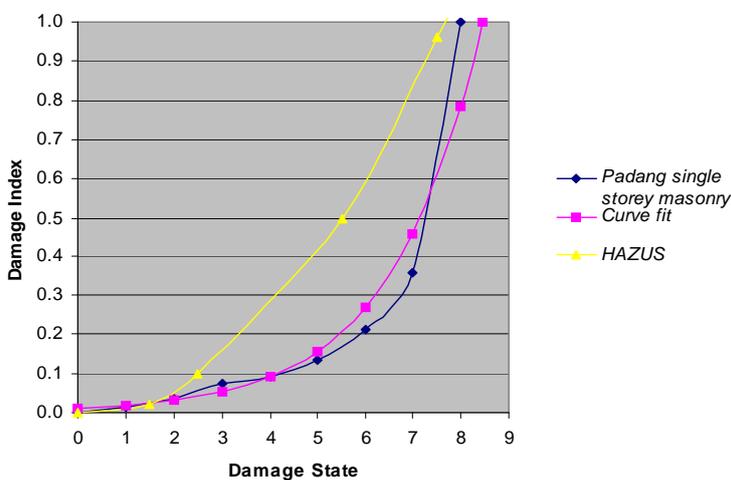
Figure 6.3: *Damage index versus damage state number for the generic residential building.*
 $DI=0.0106*1.72^{(Damage\ State\ Number)}$

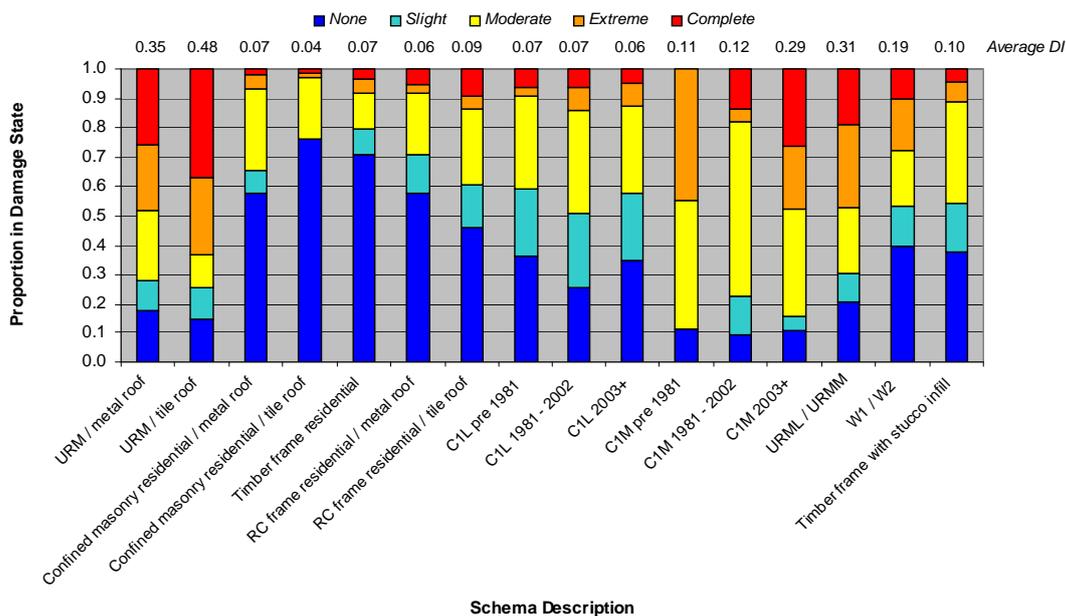
Fragility represents the probability of a given building sustaining a predetermined level of damage for a given hazard magnitude. Fragilities were calculated for well represented building categories in the building schema using the damage state loss ranges summarised in [Table 6.3](#). These were building type specific and were derived from the fitted curves shown in [Figure 6.2](#) and [6.3](#). Also presented in [Table 6.3](#) are the HAZUS damage index ranges for comparison purposes only. The fragility results are shown graphically in [Figure 6.4](#) and presented in [Table 6.4](#). It can be noted in [Table 6.4](#) that the DI range for complete damage was less than 1.0. While this suggests that buildings that were completely damaged in a physical sense were repairable, in practice these were demolished in Padang rather than repaired. For this reason, the fragility categorisation herein presented does reflect the observed outcomes for damaged structures.

Figure 6.4: Fragilities for well represented building types in Padang subjected to MMI 8 shaking.

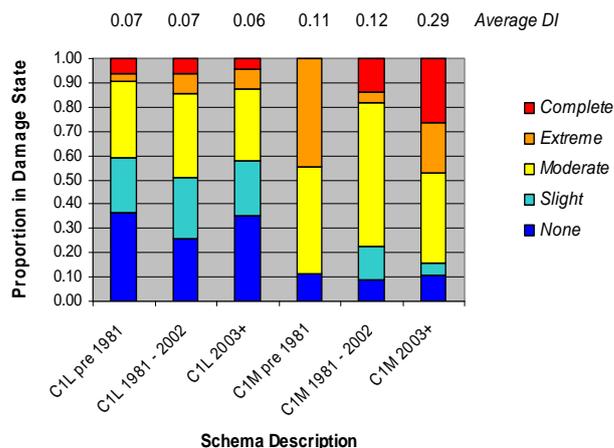
The data indicate that there has been no significant improvement in reinforced concrete frame building performance with construction date. More recently constructed buildings performed no better than older buildings of the same type. This can be observed in the data in Figure 6.5 which presents fragilities for 1 to 3 storeys (C1L) and 4 to 7 storeys (C1M) reinforced concrete frame buildings in three age brackets (pre 1981, 1981 to 2002 and later than 2003). The age brackets chosen relate to the introduction of improved building design standards in Indonesia. It would be expected that the more modern buildings would perform better if they had been designed and built in accordance with the more rigorous, modern standards. It is of interest that the 4 to 7 storey buildings displayed an increase in vulnerability with age and were shown to be more vulnerable as a class than the 1 to 3 storey equivalent buildings. It was noted, however, that a significantly smaller number of buildings in the taller height category were surveyed that may have introduced sample size issues.

Figure 6.5: Variation in fragilities of reinforced concrete framed buildings with age

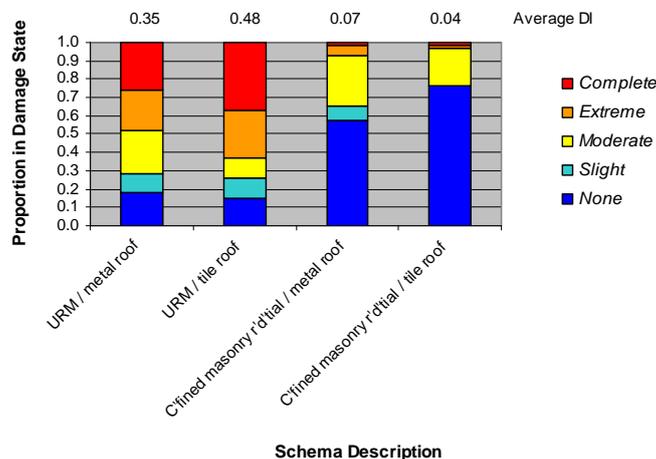
The data indicate that confined masonry buildings perform distinctly better than unreinforced masonry (URM) buildings. The data in Figure 6.6 present overall damage indices for residential buildings having both heavy tile and light metal roofs along with two different structural systems: URM and confined masonry. There is a clear superiority of performance that was demonstrated by the confined masonry buildings. Overall, there was an observed 10 fold increase in damage (DI) at MMI 8 in moving from confined masonry to unreinforced masonry for heavy tiled roof building types. The difference was also significant but smaller for the equivalent structures with lighter metal roofs.

Figure 6.6: Variation of fragility of residential buildings with structure type

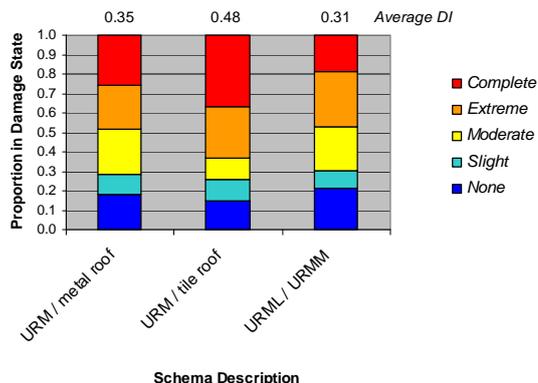
Unreinforced masonry buildings of any type perform poorly when subjected to earthquake actions. The data in Figure 6.7 show fragilities for three types of URM buildings: residential with metal roof, residential with tile roof and non-residential URM. All three categories show poor performance with significant proportions of the population falling into the extreme and complete damage states.

Figure 6.7: Consistency of fragility across different types of unreinforced masonry (URM) buildings

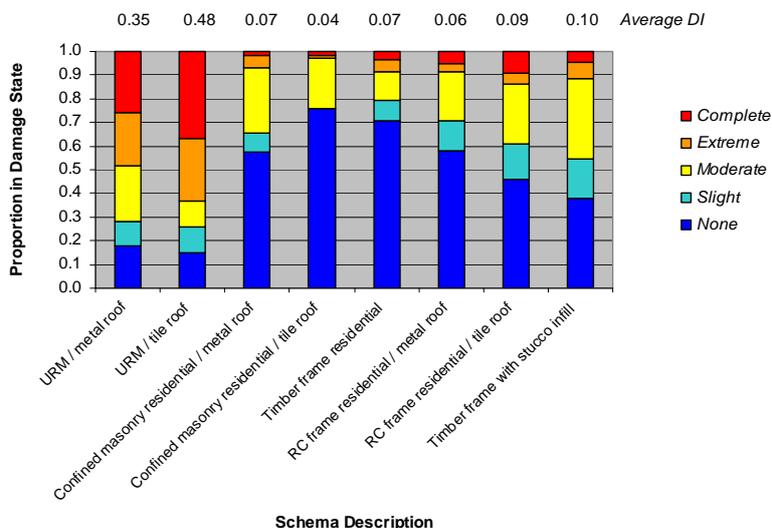
The data indicate that a structural system with framing of any type will perform significantly better than load bearing unreinforced masonry wall buildings. This is an important result when considering reconstruction activities in Padang; new residential buildings should have a structural frame and URM type buildings should be avoided. Consider the data in Figure 6.8 showing fragilities for residential buildings of all types. Clearly buildings with a structural frame, irrespective of the type (reinforced concrete, timber, confined masonry), perform better than URM buildings.

Figure 6.8: Variation in fragilities across different types of residential buildings.

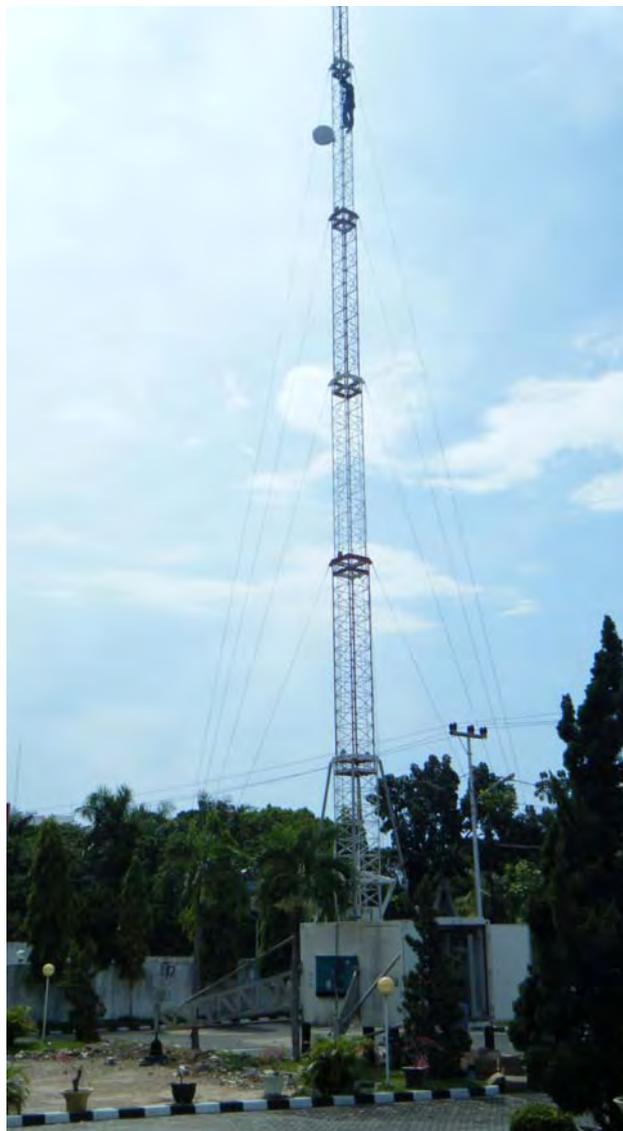
where the survey party was accommodated. [Figure 6.9](#) shows a picture of a substantial temporary transmitter tower erected there to bolster local communications.

Figure 6.9: *Temporary communications tower erected in the hotel carpark*

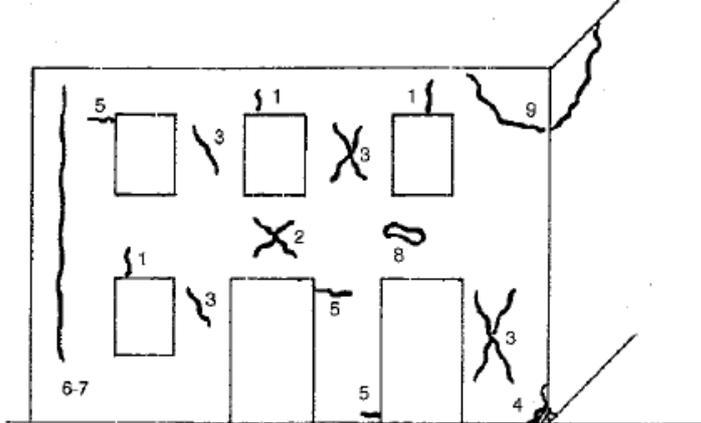
Figure 7: types of cracks in masonry bearing walls:

1) vertical cracks on openings; 2) diagonal cracks on parapets and on doors and windows lintels; 3) diagonal cracks on vertical walls between openings; 4) local masonry crushing with or without spalling; 5) horizontal flexural cracks on top or bottom of vertical walls between openings; 6) vertical cracks at wall intersections; 7) passing through vertical cracks at wall intersections; 8) spalling of material due to beam or floor pounding; 9) separation and expulsion of two corner walls.

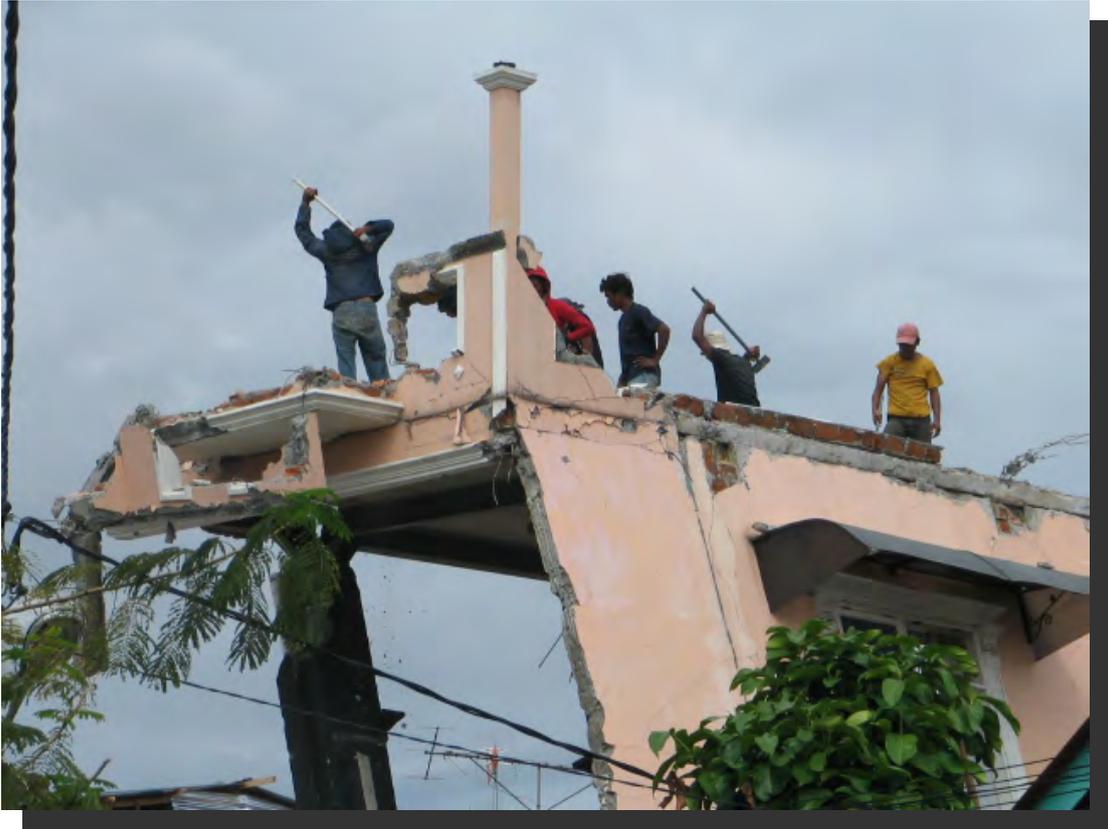
Figure 8 Demolition methods—recycling steel bars

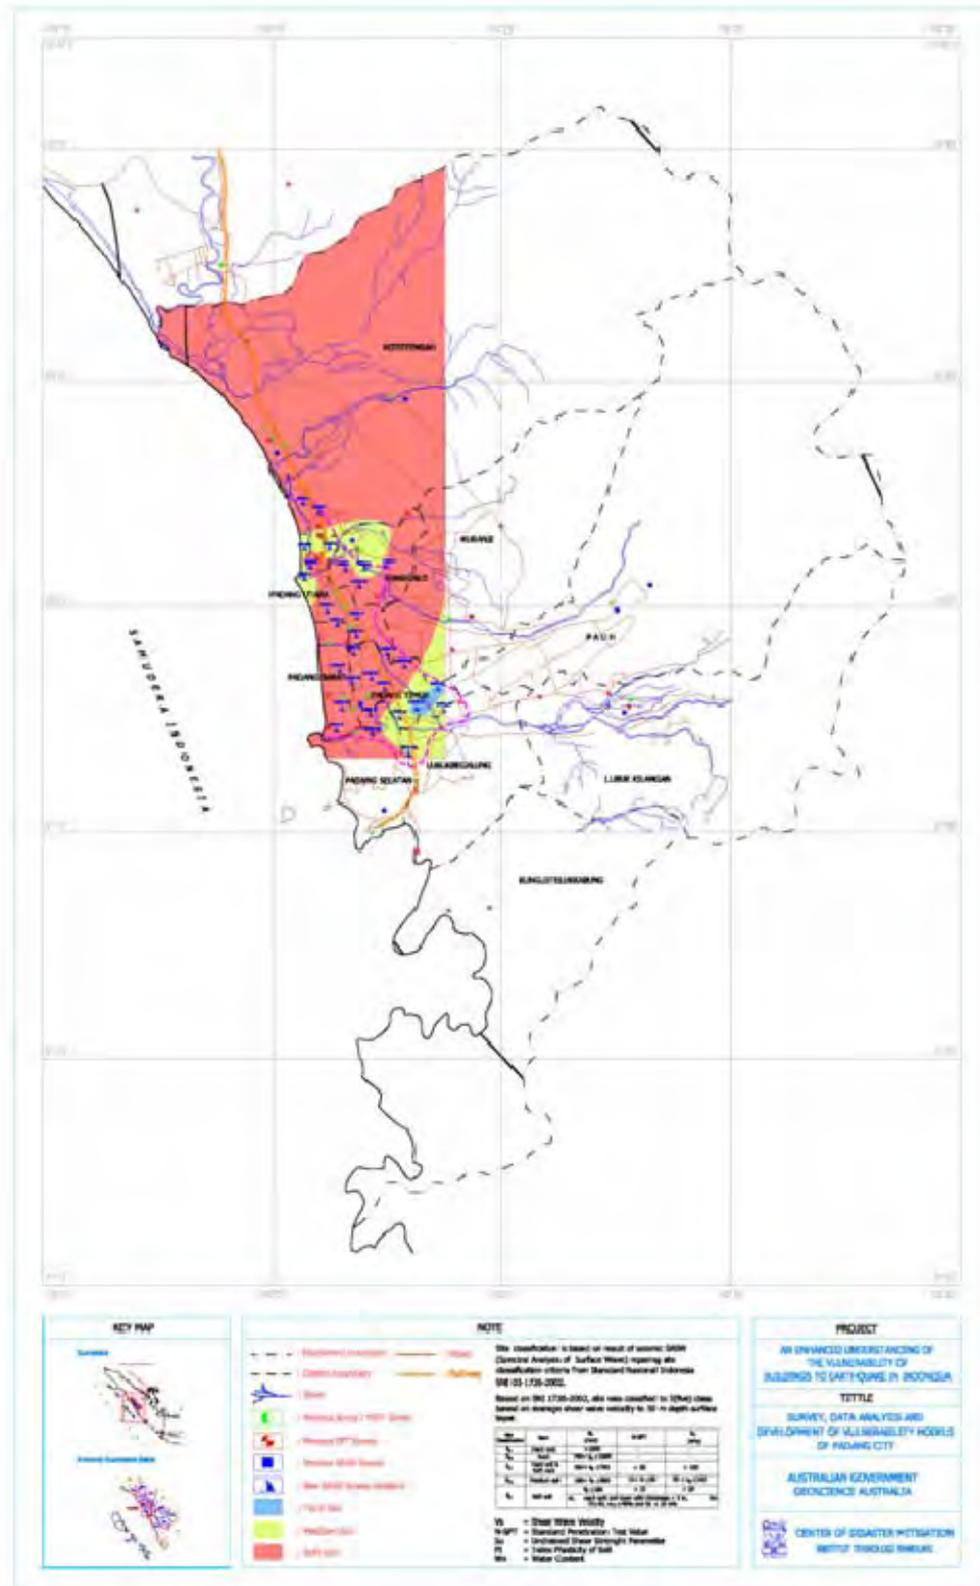
Figure 2.15. Site classification map for city of Padang based on the recent MASW's average shear wave velocity

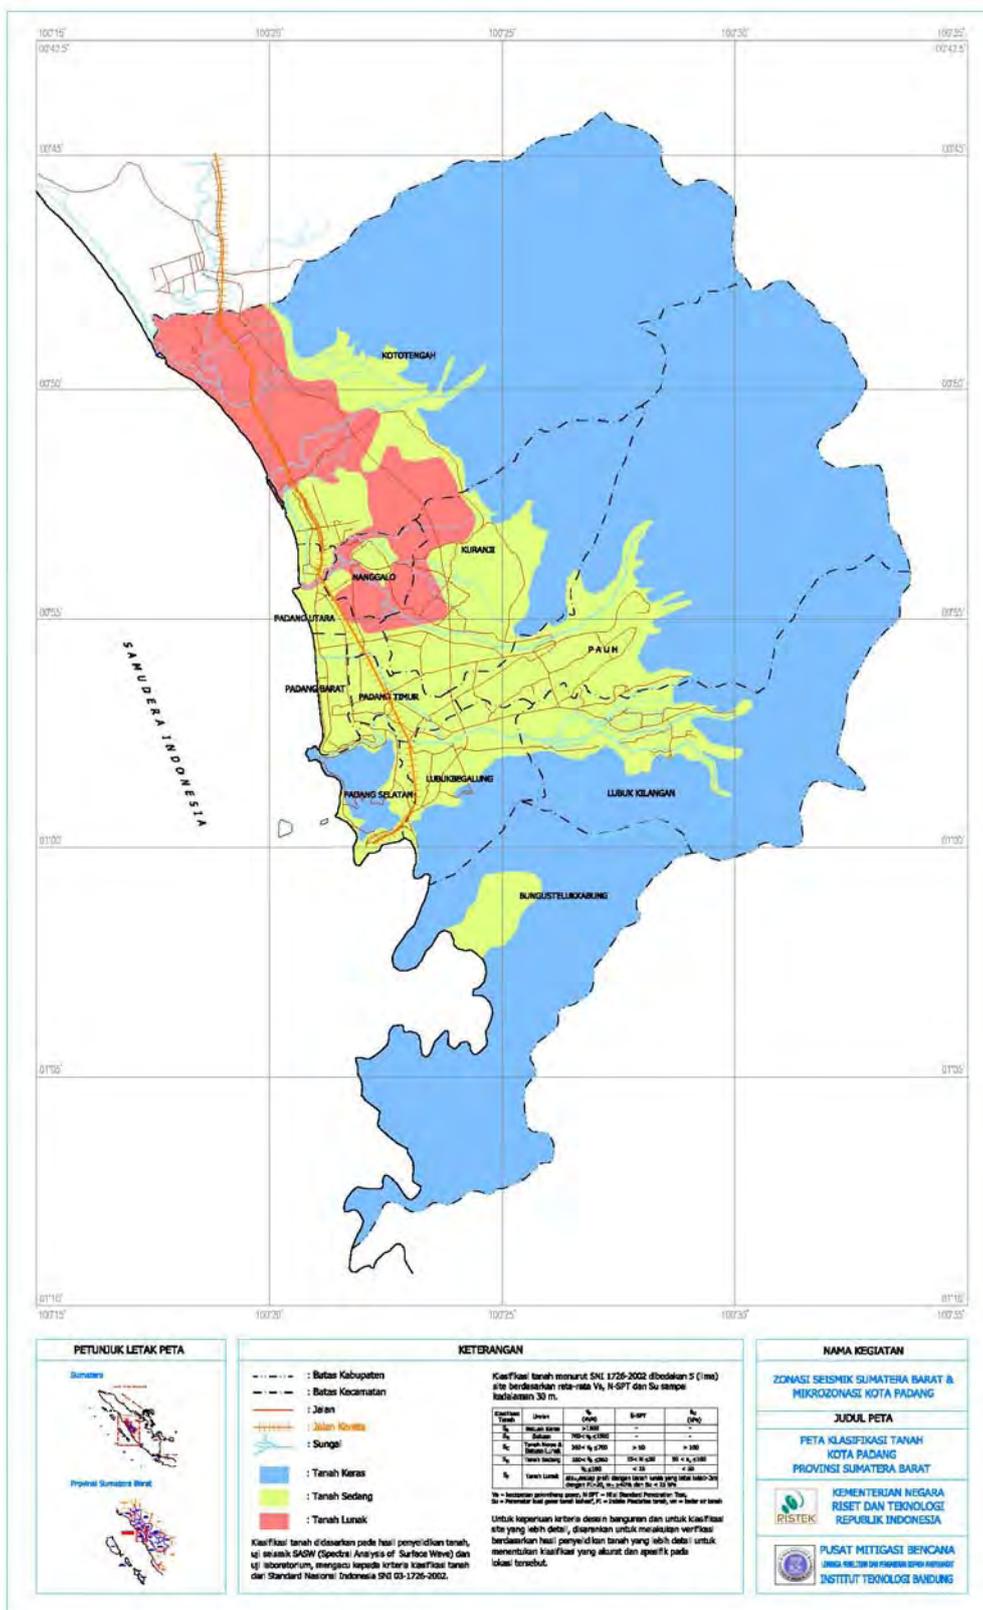
Figure 2.16. Site classification map for city of Padang based on the previous geotechnical investigation

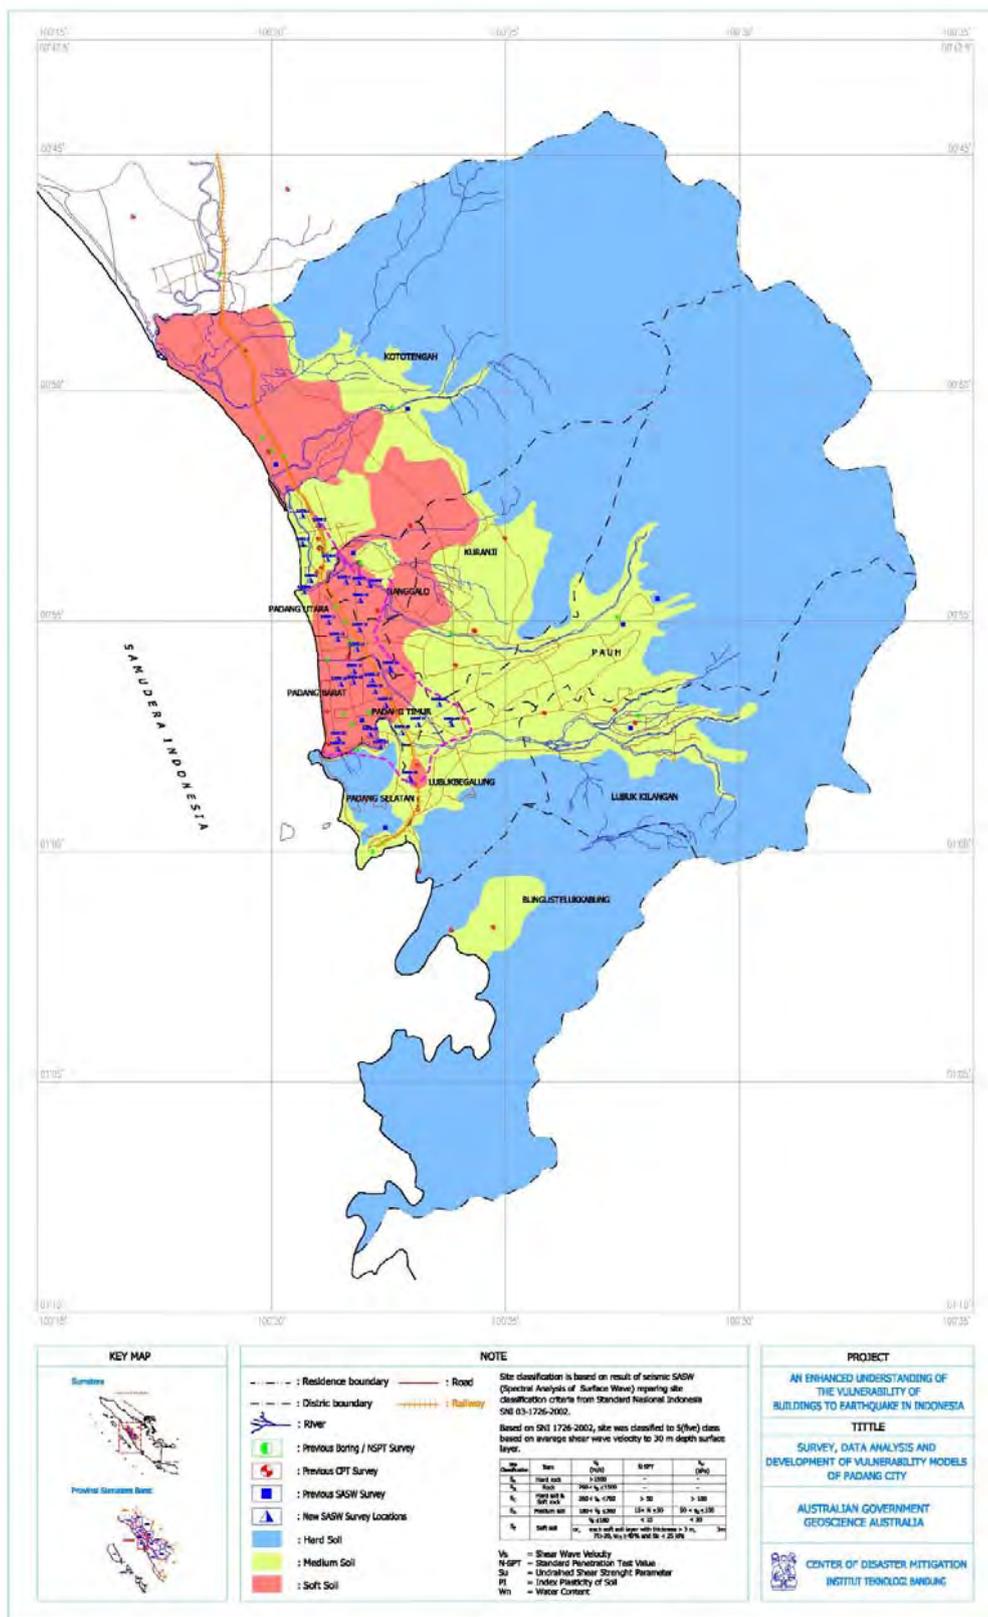
Figure 2.17. Combined Site classification map for city of Padang based on the recent MASW survey and previous geotechnical investigation

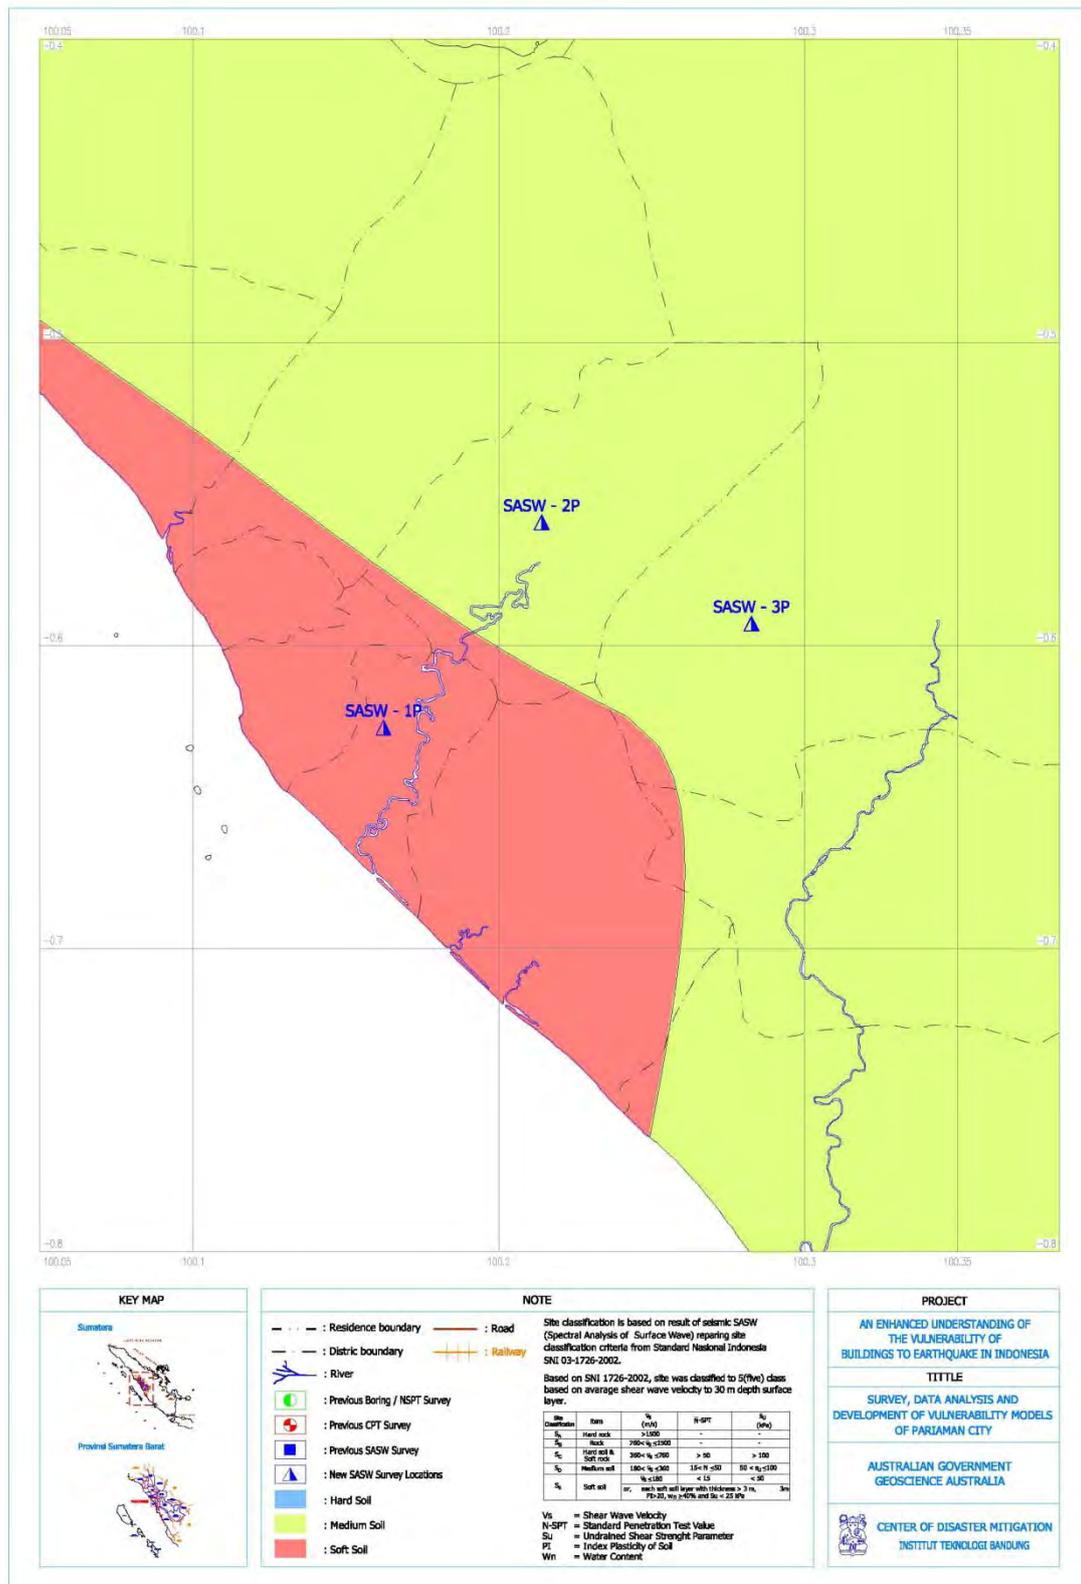
Figure 2.18. Combined Site classification map for city of Pariaman based on the recent MASW survey and previous geotechnical investigation

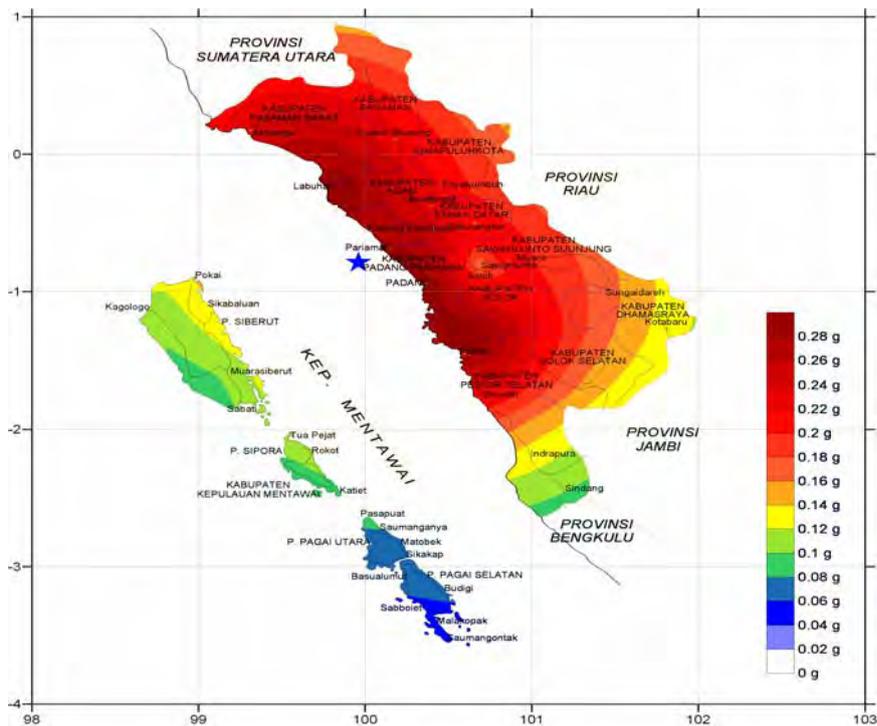
Figure 3.4 shows spatial distribution of the estimated PBA. It is indicated that PBA at city of Padang is about 0.28g.

Figure 3.4 Estimated PGA (reference base-rock) spatial distribution using Young's Intraslab attenuation due to 30 September 2009 West Sumatra Earthquake

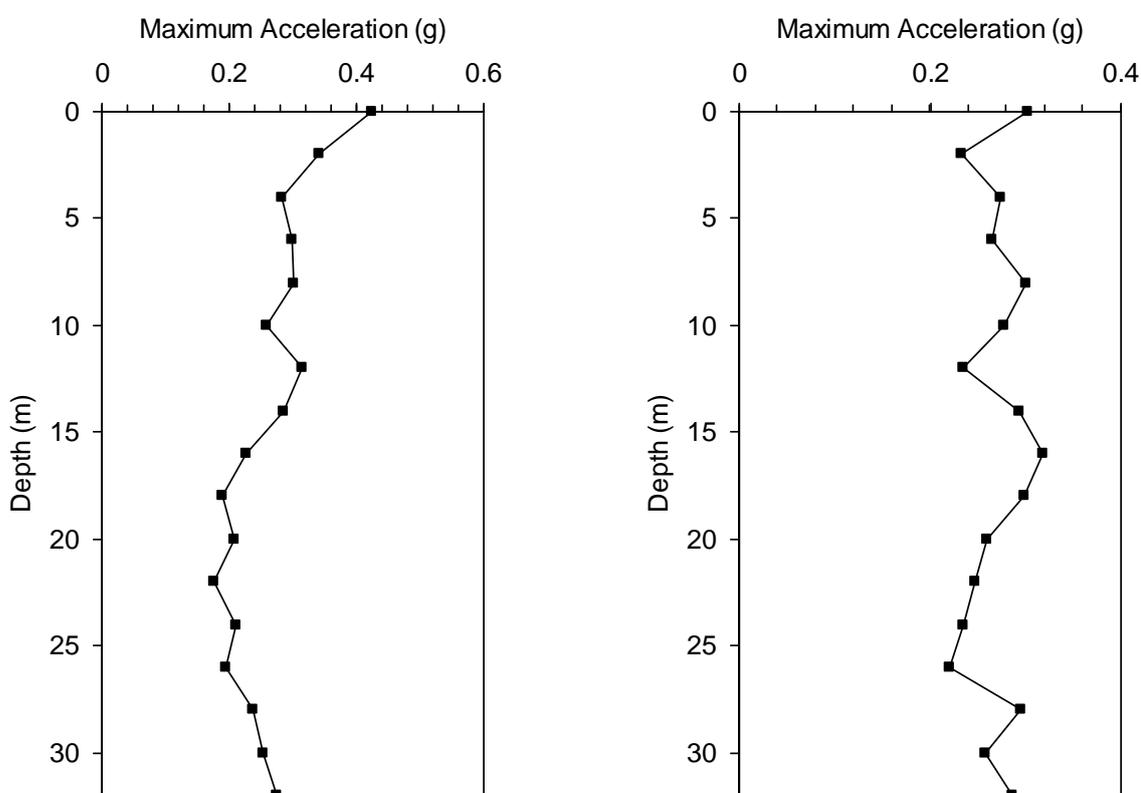
The value of maximum acceleration on the ground surface (Peak Ground Acceleration/PGA) is very affected by the value of earthquake acceleration in the baserock, the dynamic nature of ground (in these case Vs) and input motion which represents the duration and frequency contents. The variation of earthquake acceleration value on that ground layer during propagation from base rock to the ground surface is shown in [Figure 4.7](#).

Figure 4.7. Variation of ground acceleration from base rock to the ground surface for soft and hard soil classification

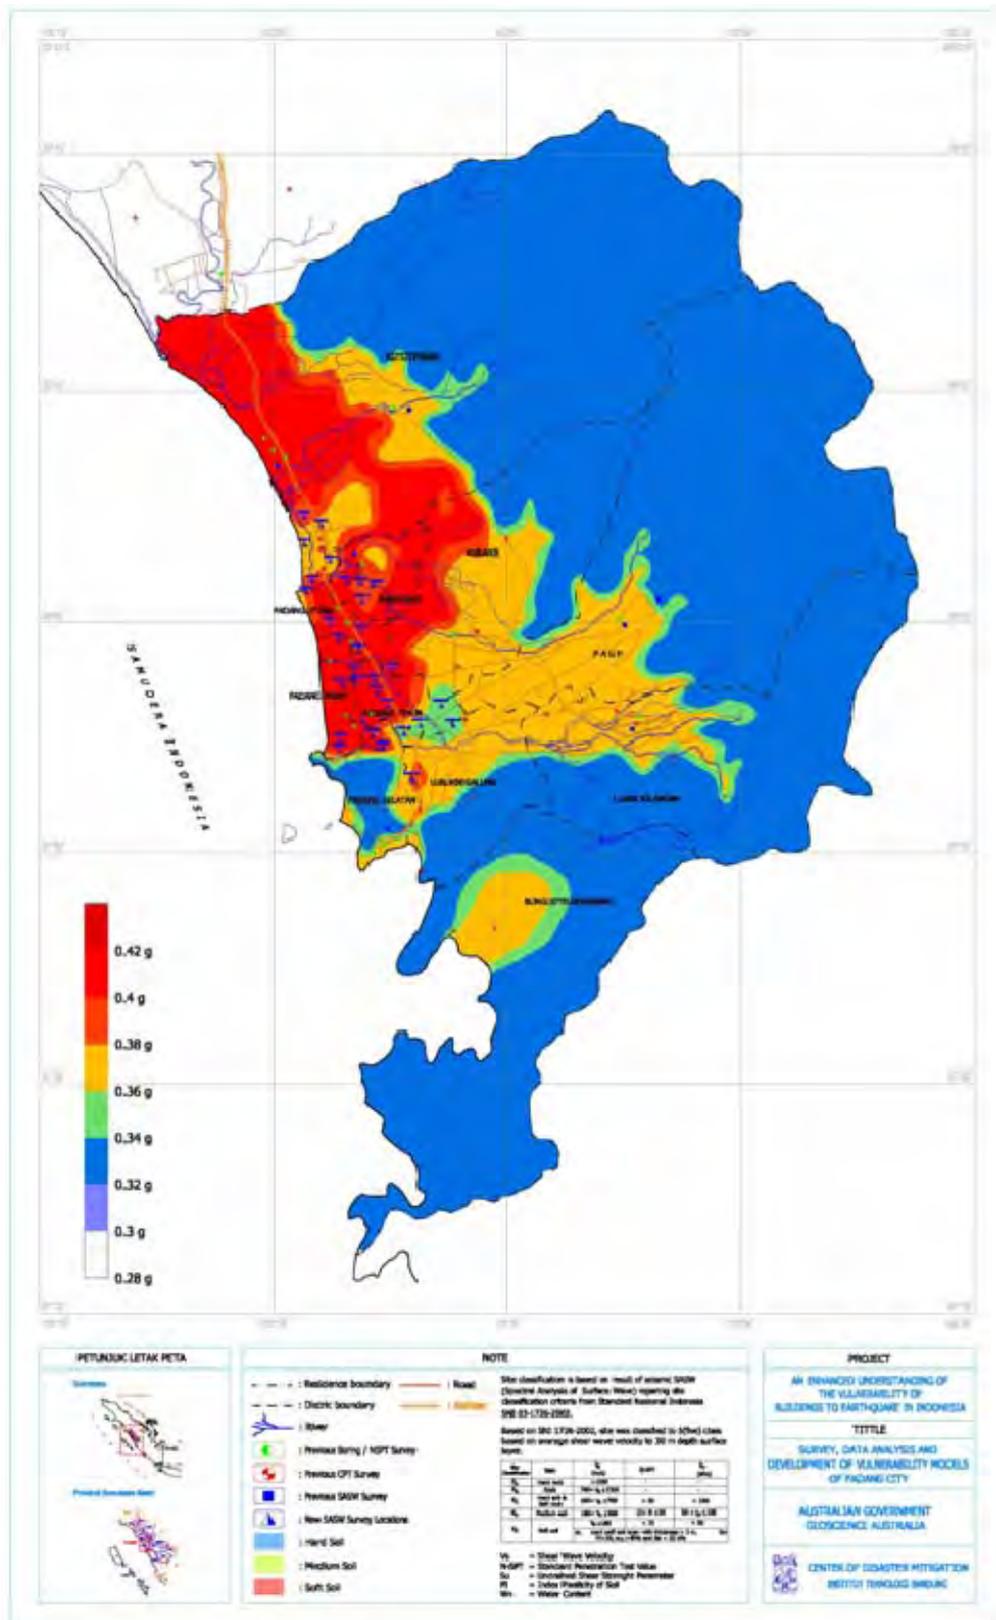
Based on the result of seismic wave propagation analysis, which was carried out by considering the field condition on each locations in the sub district and the earthquake acceleration on the base rock, a microzonation map city of Padang and Pariaman are then developed which shows that the maximum value of seismic acceleration on the ground surface or Peak Ground Acceleration (PGA) as shown on [Figure 4.8](#) and [Figure 4.9](#).

Figure 4.8. Peak Ground Acceleration (PGA) map for the city of Padang

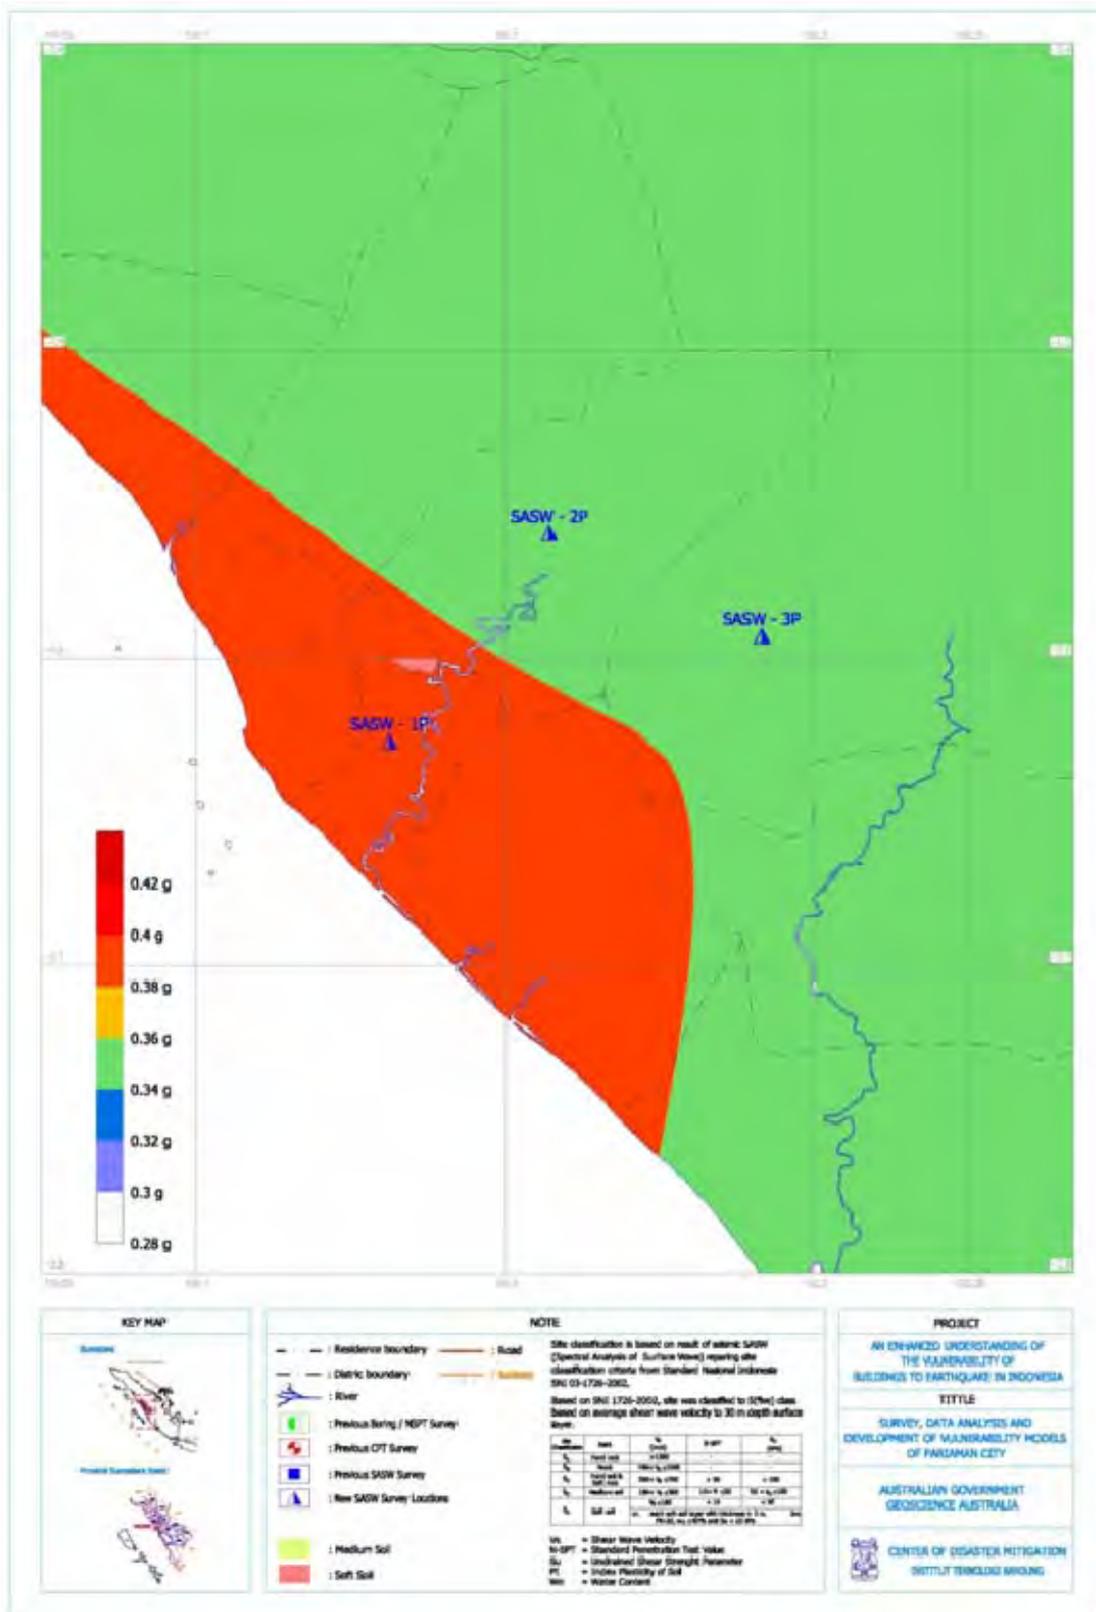
Figure 4.9. Peak Ground Acceleration (PGA) map for the city of Pariaman

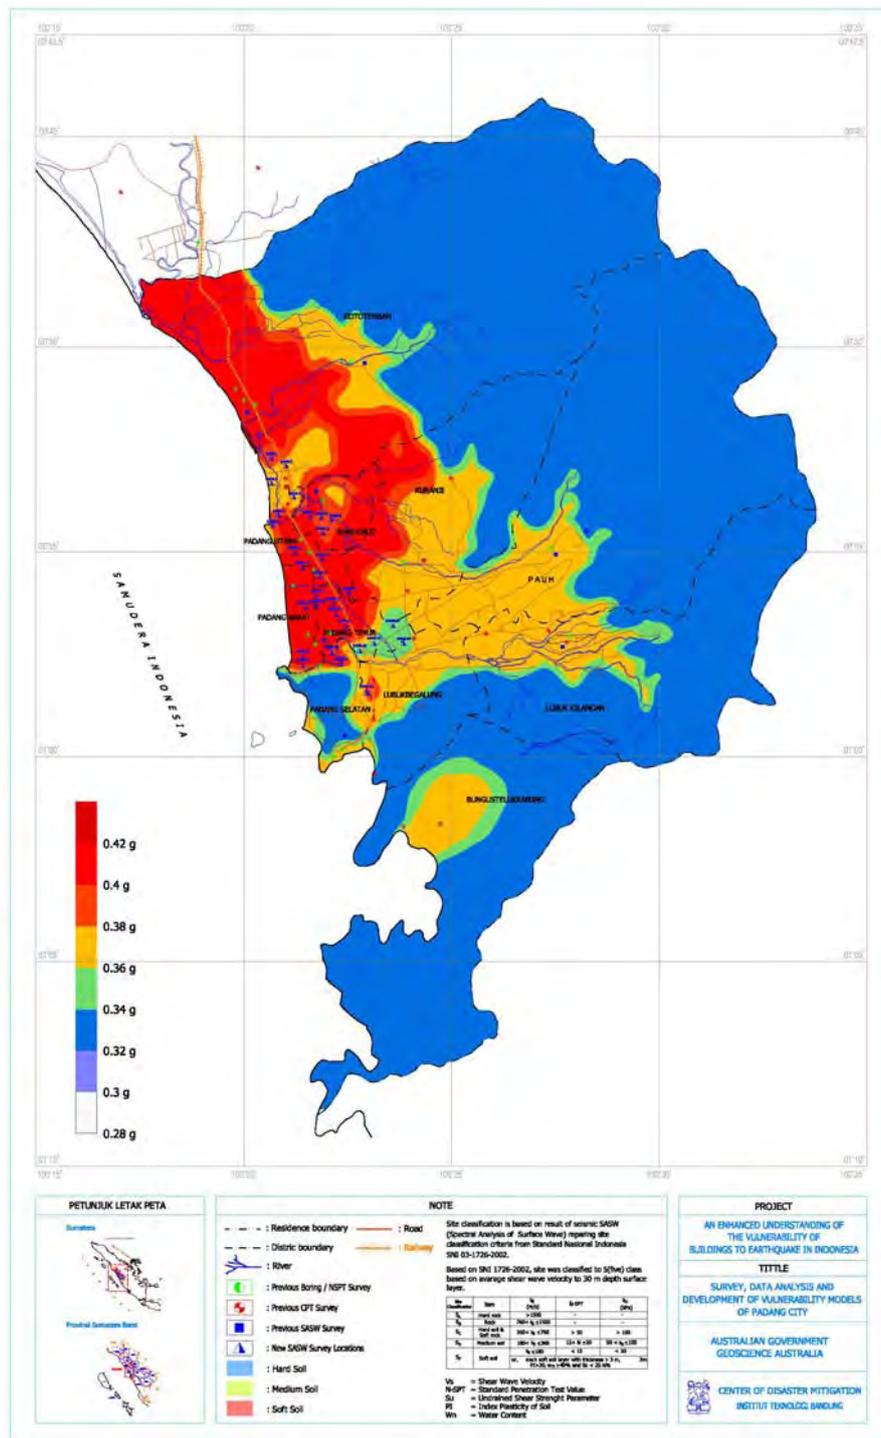
Based on result of seismic wave propagation analysis, which was carried out by considering the Vs30 data for each location in the sub district and the estimated earthquake PGA at the base rock, a spatial PGA distribution map at the ground surface of city of Padang and Pariaman have been developed. The map for Padang is presented in [Figure 1](#).

Figure 1. Spatial distribution of ground surface PGA for city of Padang
