**GEOLOGICAL SURVEY OF UPPER COTTER DAM**

**SITES A AND B1, A.C.T.**

**W. J. PERRY**

Records No. 1953/108.

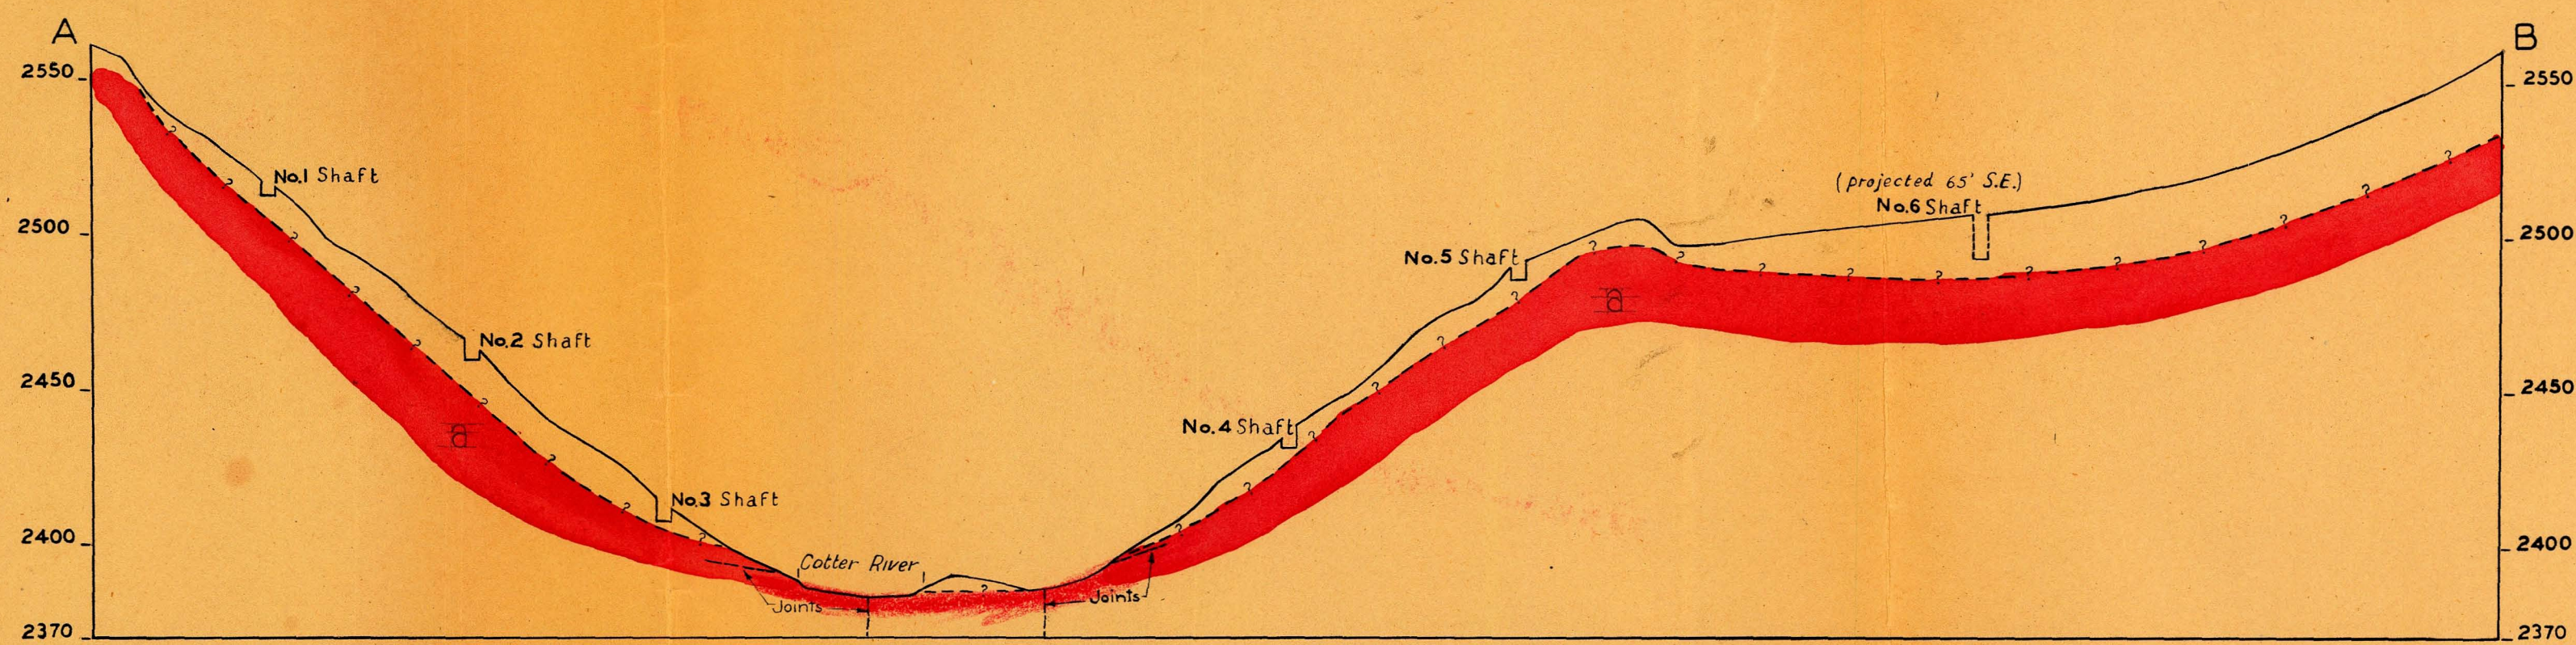
SECTION C-D

In this area the quartzite is traversed by numerous open joints, and some removal of loose rock and probably grouting may be necessary. Should it be necessary to build a wall along the saddle on the south bank (Section CD), much excavation will be necessary before solid rock is reached. Test shafts No's. 1, 2, and 3 were sunk to depths of  $7\frac{1}{2}$ , 12, and 4 feet respectively, and each hole showed only very weathered
