Direction Island Unidentified (Cocos Keeling Islands) Inspection Report

Technical Data

Site Name: *Direction Island unidentified.*

Date of Inspection: 2/11/2004

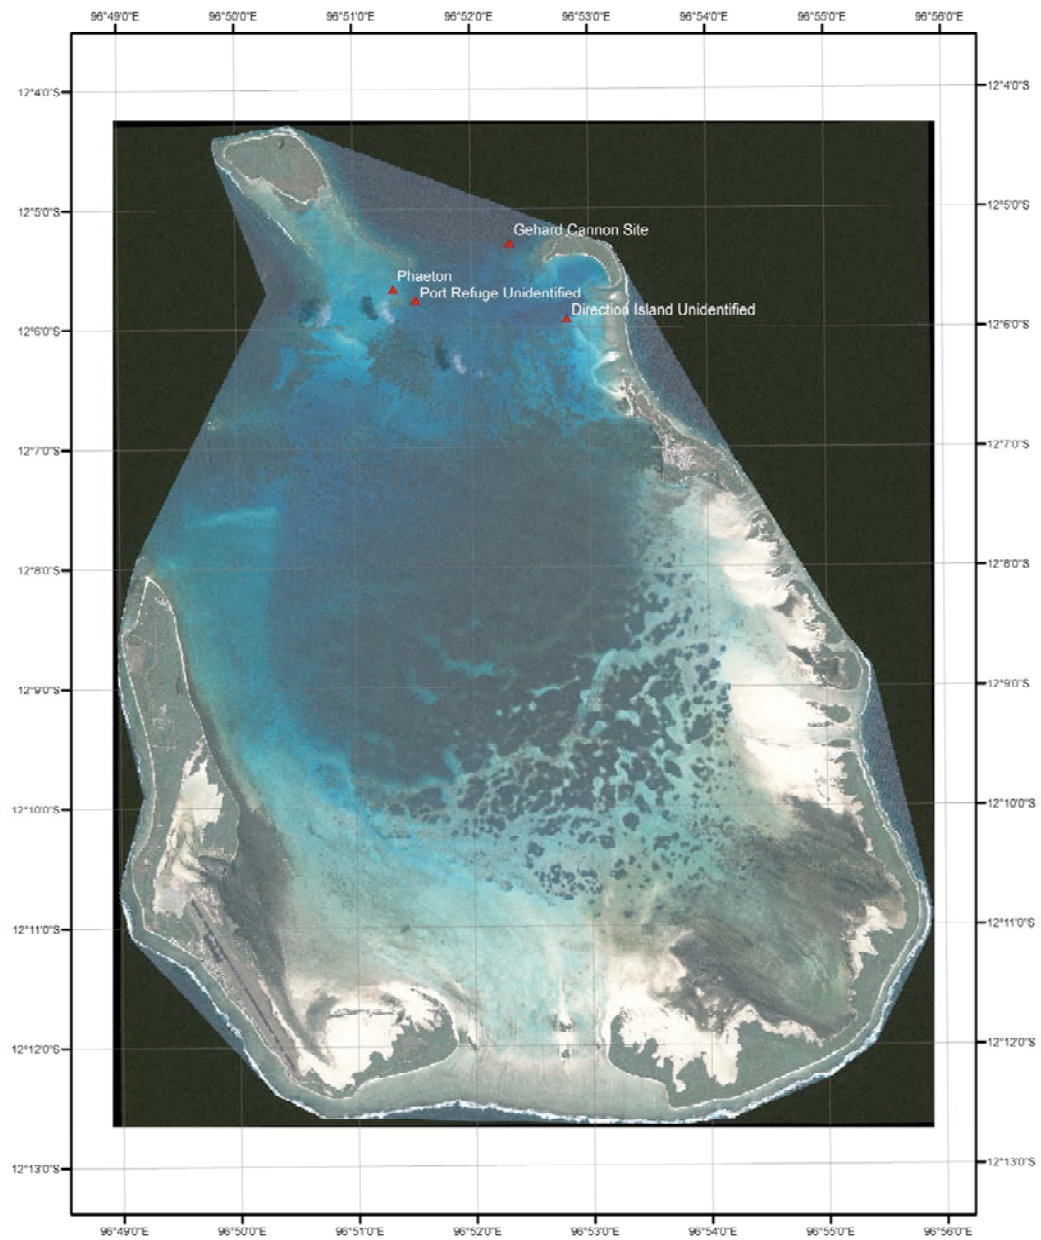
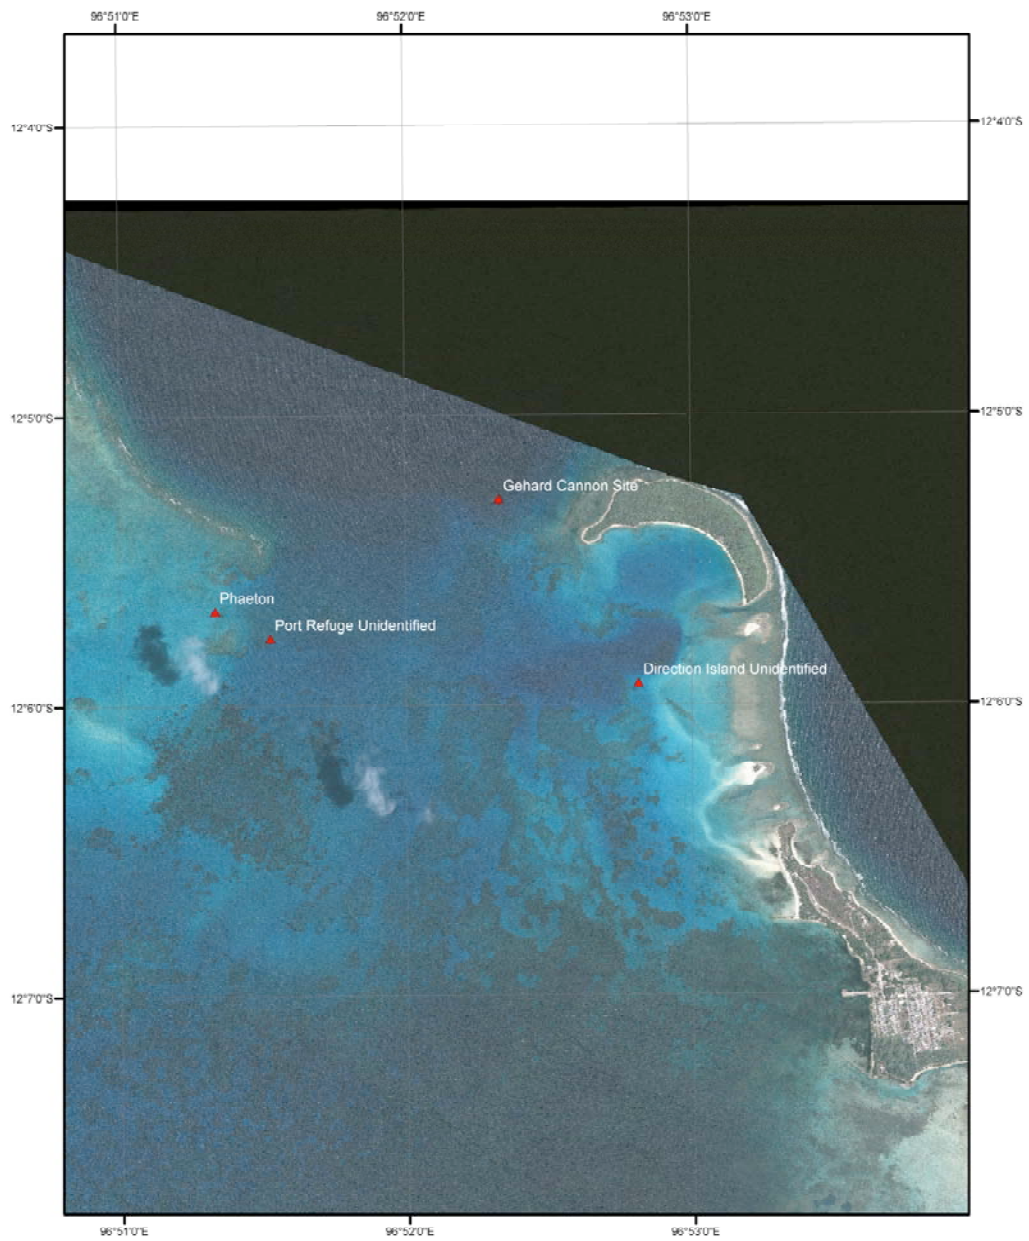
Satellite image showing access to site:

Note: The line of the keelson is clearly visible as a distinct dark line on the seabed. The cause of the inverted 'V' shape at the top of the line is unknown at present. (See recommendations)
