### Department of Transport & Regional Services

### **Cocos (Keeling) Islands**

### Report On Seawall Upgrade Design Concept

January 2000

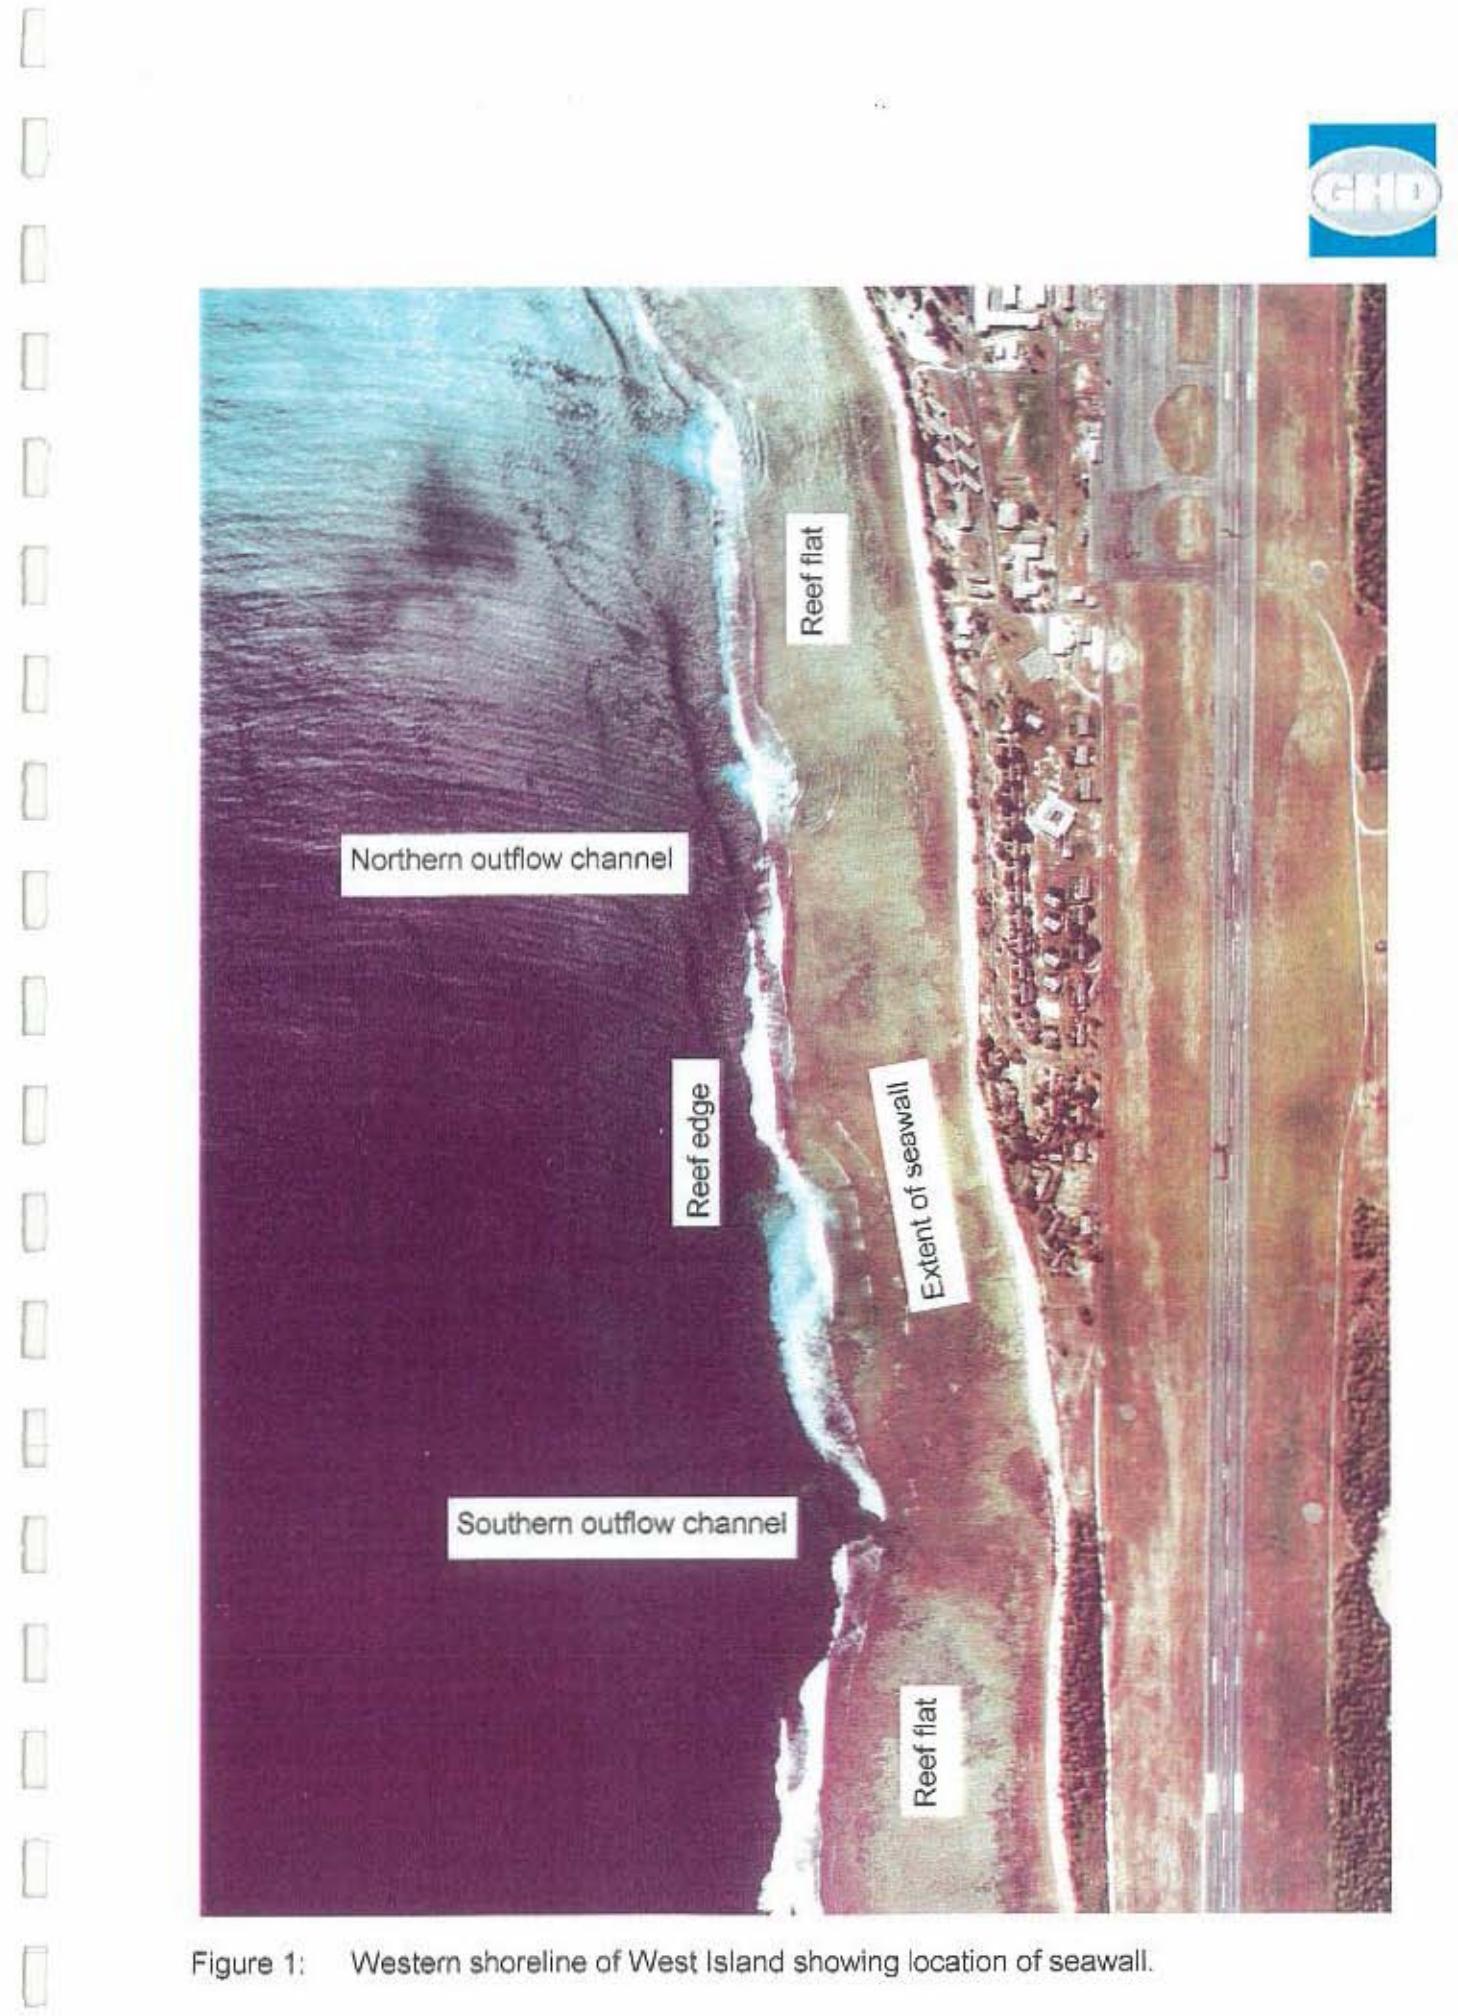
It is known that the wall has been overtopped at least 3 times in the past 20 years and on one occasion the extent of overtopping was sufficient to cause collapse of sections of the wall. In recent events wave overtopping has occurred at water levels lower than high tide. In the event that large wave conditions occur coincidently with high tide the volume of water overtopping the seawall will be greater and adjacent houses may be damaged. It is possible that future overtopping could occur more frequently and that a major storm event, say with a 1 in 20 year or 1 in 50 year return period, could cause a substantial breach and threaten the safety of the houses.

Figure 2. Damage to northern end of seawall, 1980
