RECORDS 1956, No. 137

SEISMIC REFRACTION SURVEY OF No. 2 DAM SITE AREA, KIEWA, VICTORIA

by
W. A. WIEBENGA, D. F. DYSON and M. J. O'CONNOR

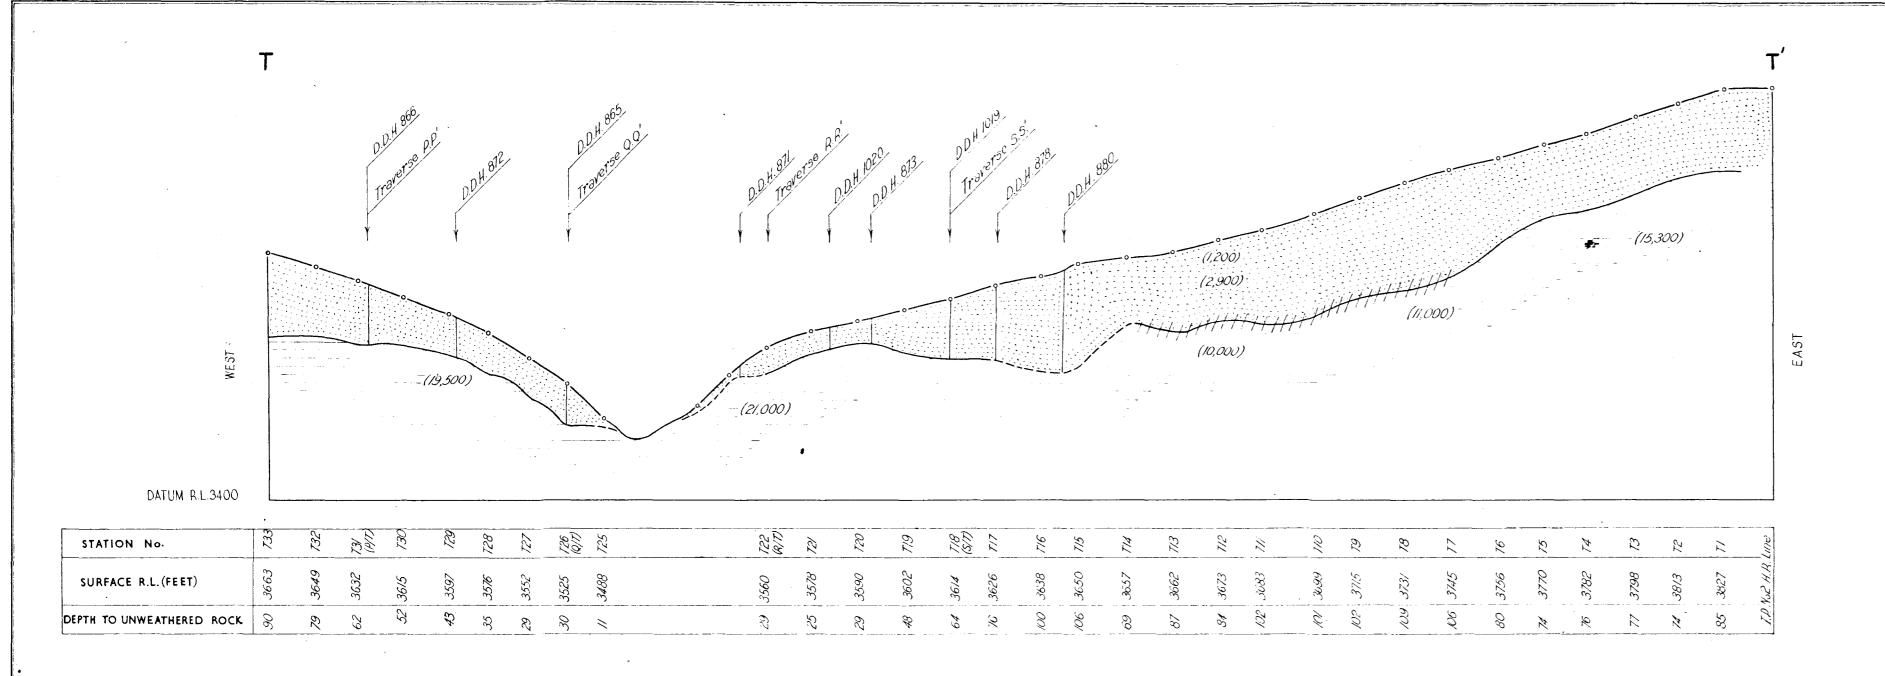
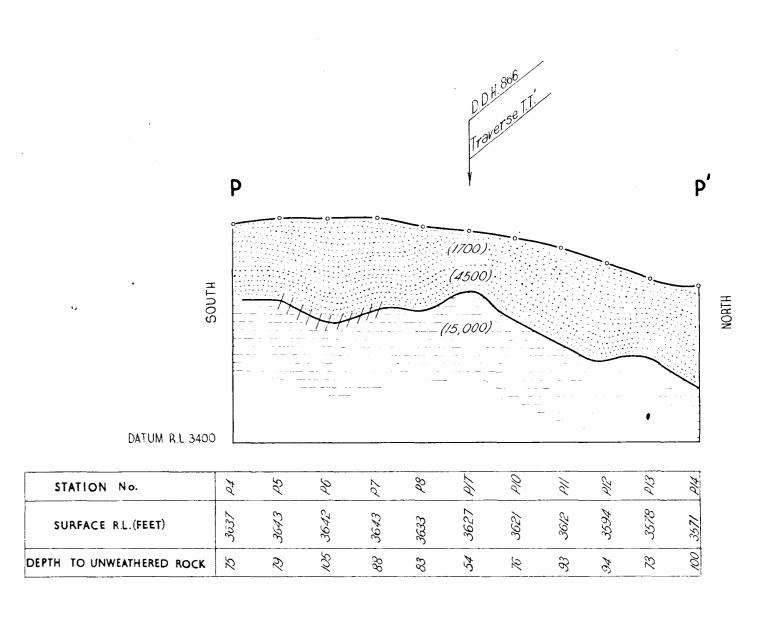
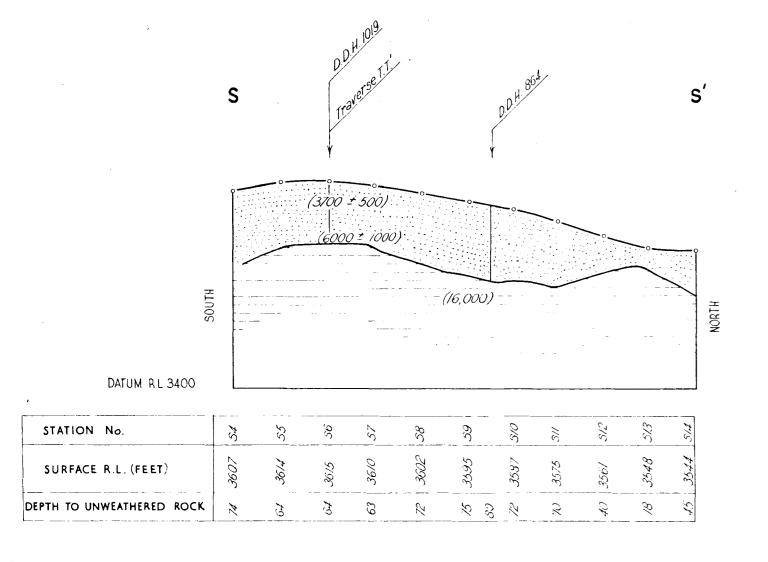
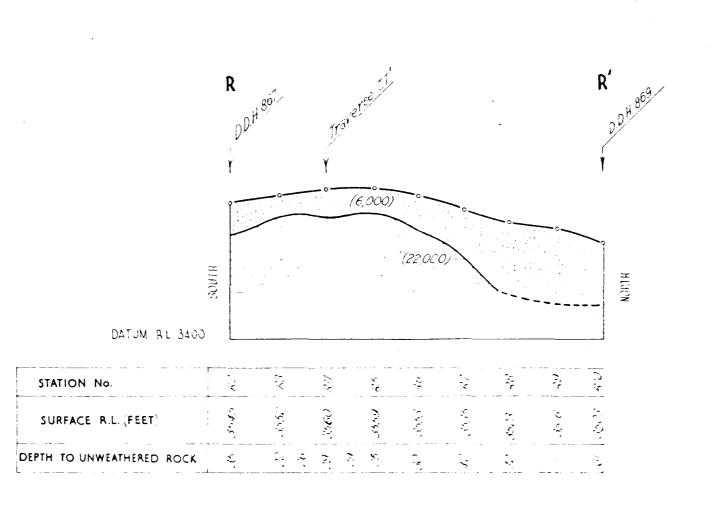
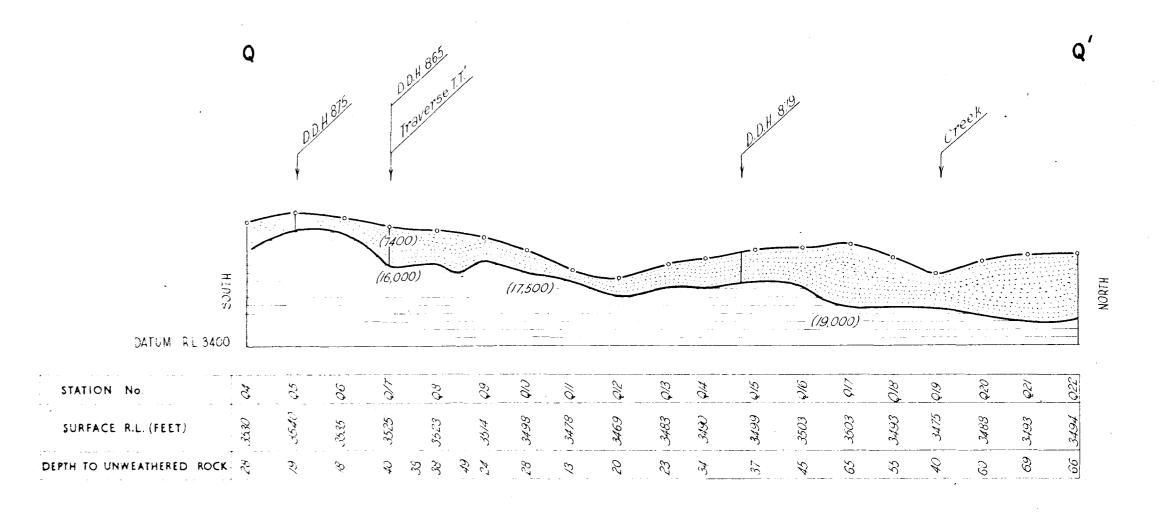
PROFILES SHOWING DEPTHS TO UNWEATHERED ROCK (DEPTHS ARE MEASURED PERPENDICULAR TO SURFACE) GEOPHYSICIST

- Plate 1. Traverse plan and topography (Inset-locality map).
 - 2. Profiles showing depths to unweathered rock.
 - 3. Contour map of unweathered rock.
 - 4. Isopach map showing thickness of overburden.
