GROUNDWATER INVESTIGATION ON MIRIVASE ISLAND GULF DISTRICT,  
PAPUA.

G. Brouxhon

Records 1965/147

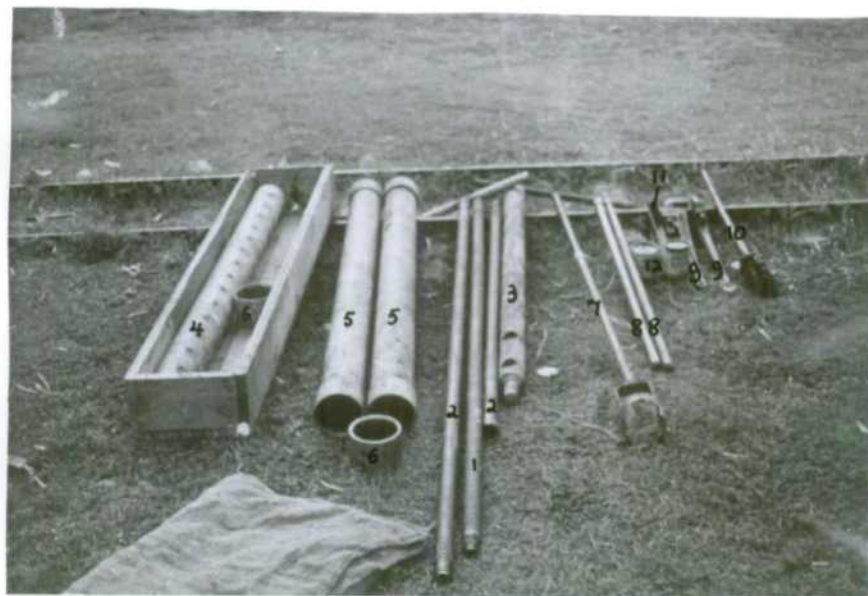
A

1. Drilling rod handle
2. Drilling rod extension
3. Sand-pump
4. Perforated casing (screen)
5. Casing pipes
6. Casing couplings
7. Hand auger
8. Hand auger rod extension
9. Adjustable spanners
10. Chain tongue
11. Scrubbing brush
12. Grease pot.

The three main component parts of the Banka drill are:-

1. The drilling tools
2. The casing
3. The platform

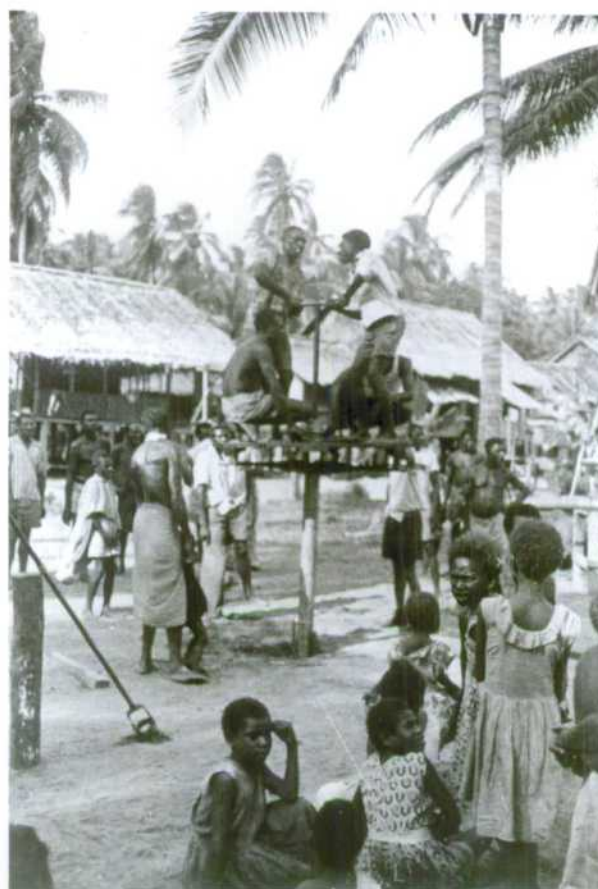
B

### B. The drill in operation.
