SITE INVESTIGATION TECHNIQUES AT CORIN DAMSITE,
COTTER RIVER. A.C.T.

SITE INVESTIGATION TECHNIQUES USED AT CORIN DAMSITE
COTTER RIVER, A.C.T.

RECORD 1967/113

- * This paper was presented, by the senior author, to the Fifth Australia - New Zealand Conference on Soil Mechanics and Foundation Engineering, which was held in Auckland, New Zealand on 13th to 17th February, 1967.

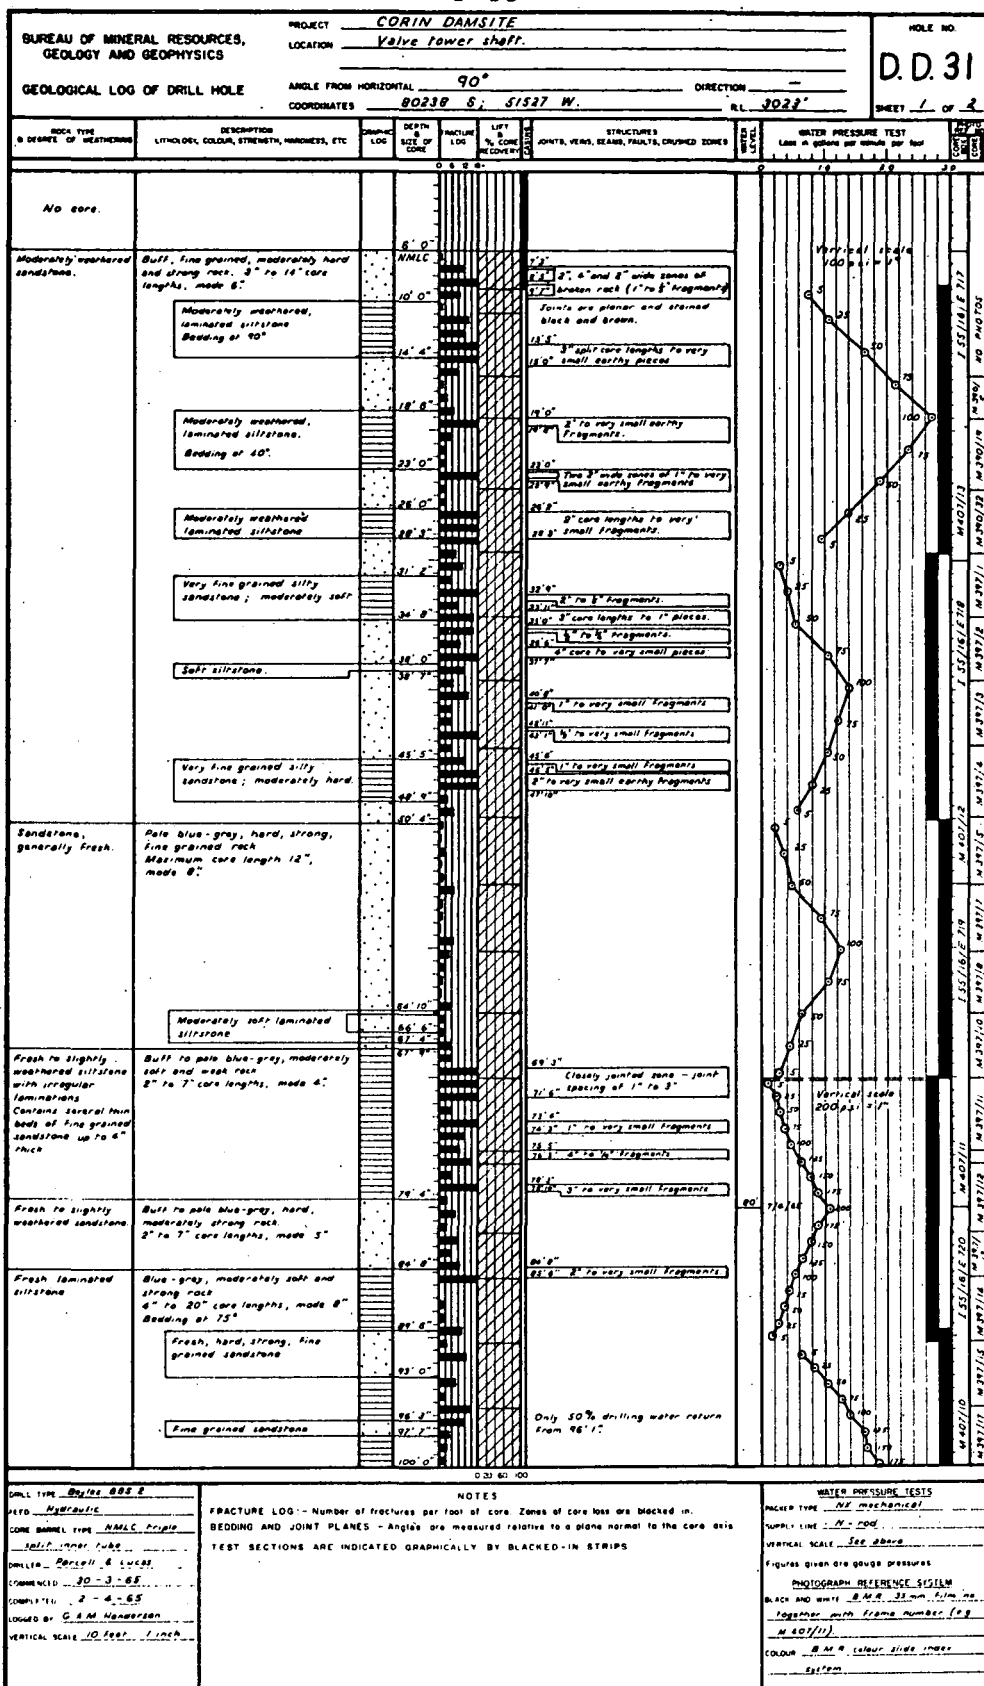
Note: The scales noted on the log are incorrect as this figure has been reduced from foolscap size.

Figure 1: Typical geological log of diamond drill hole from Corin Damsite.

in a convenient manner. An attempt was made during the Corin Damsite investigation to improve on earlier drill logs and Fig. 1 is a typical example of one of the later geological log sheets. New features are the fracture log and the method of presentation of water pressure test results. The fracture log, which is a graphic representation of the number of fractures per foot of core, is sometimes only semi-quantitative in nature but nonetheless it serves to emphasise visually zones of broken and sound rock and variations in joint spacing. The graphical method of showing water losses has the advantage of showing the actual uncorrected readings for each test section. The more usual presentation of histograms for a pre-determined range of gauge pressures necessitates interpolation of field data; this is undesirable because the reliability of the measured data cannot be gauged from the log sheet. It should also be noted that all information necessary for the correction of field readings is included on the drill log sheet.
