RECORD 1968/110

PRELIMINARY GEOLOGICAL REPORT ON  
PROPOSED NORTH MOLONGLO OUTFALL SEWER, A.C.T., 1967

G.A.M. Henderson

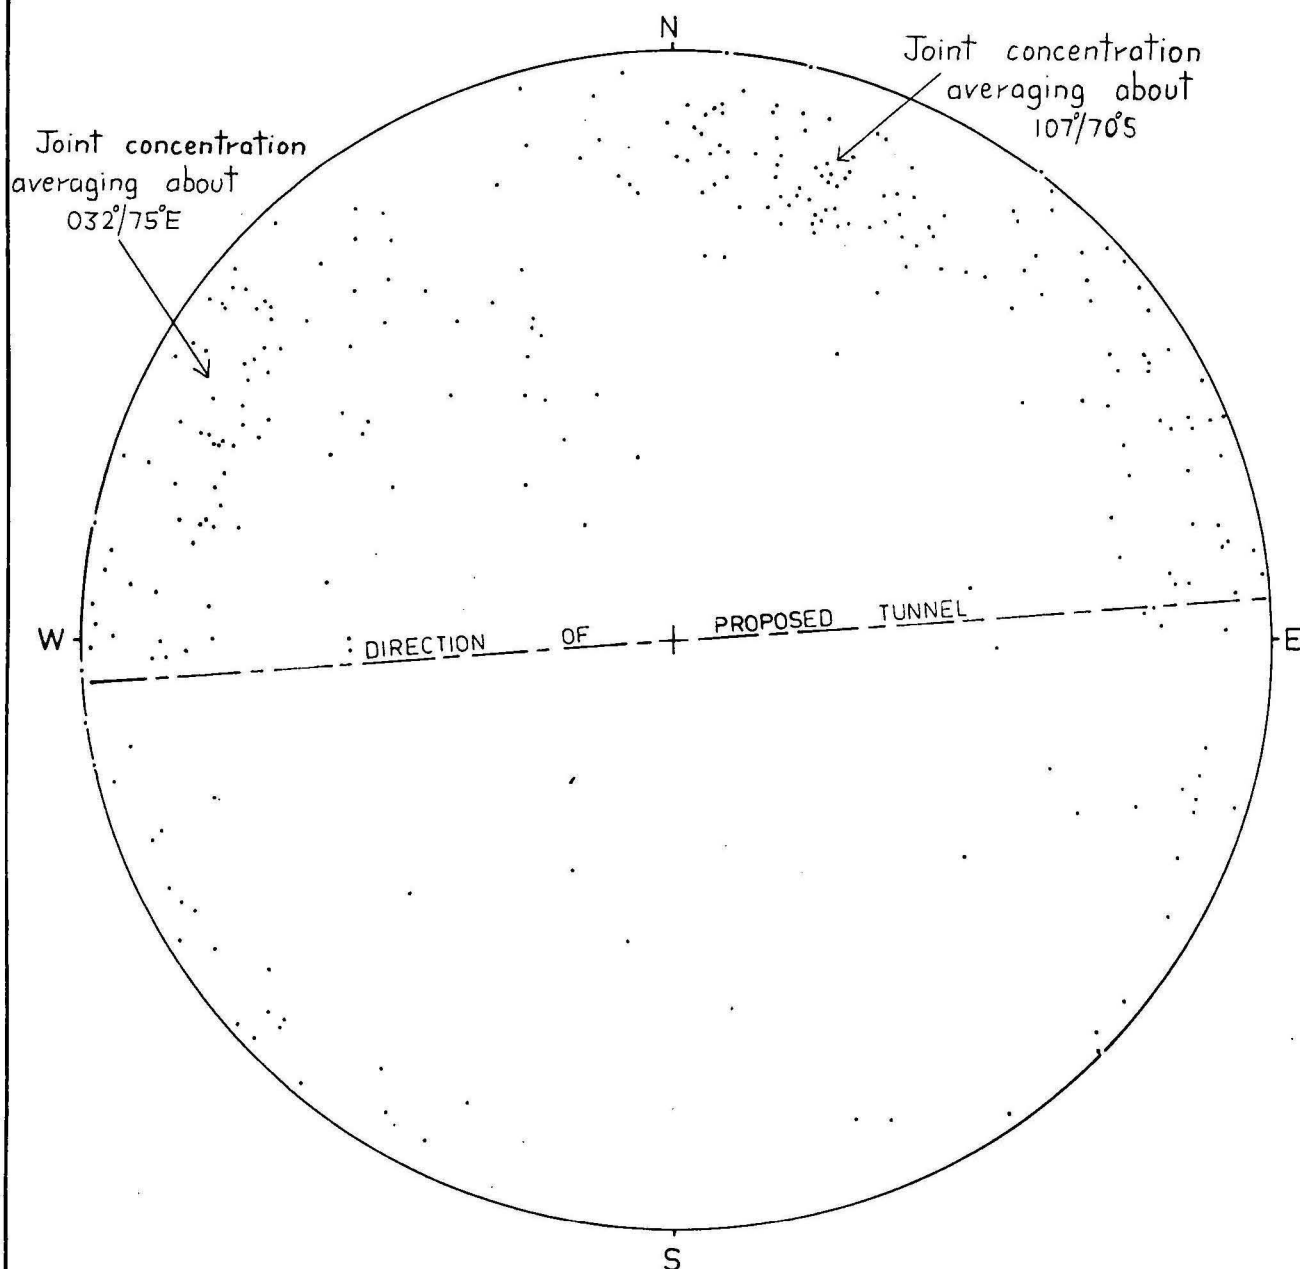
Fig. 1

# POLES TO JOINTS IN BLACK MOUNTAIN SANDSTONE

True bearings

Plot of poles to 282 joints, lower hemisphere equal area stereographic projection.

Joints in the sandstone are well exposed in cuttings along the Black Mountain Road and, apart from bedding plane joints, mostly dip at angles greater than 60 degrees (see joint stereograms - Figure 1). The most common directions average about  $107^{\circ}/70S$  and  $032^{\circ}/75^{\circ}E$ . Because of the large number of joints measured it was impossible to plot them individually on the plans; instead the dips and strikes of several adjoining, similarly oriented, joints were averaged and plotted as one joint. (It should be noted that the strike directions of the preferred joint orientations correspond with two of those at Scrivener Damsite. This could be indicative of a general regional joint pattern.)

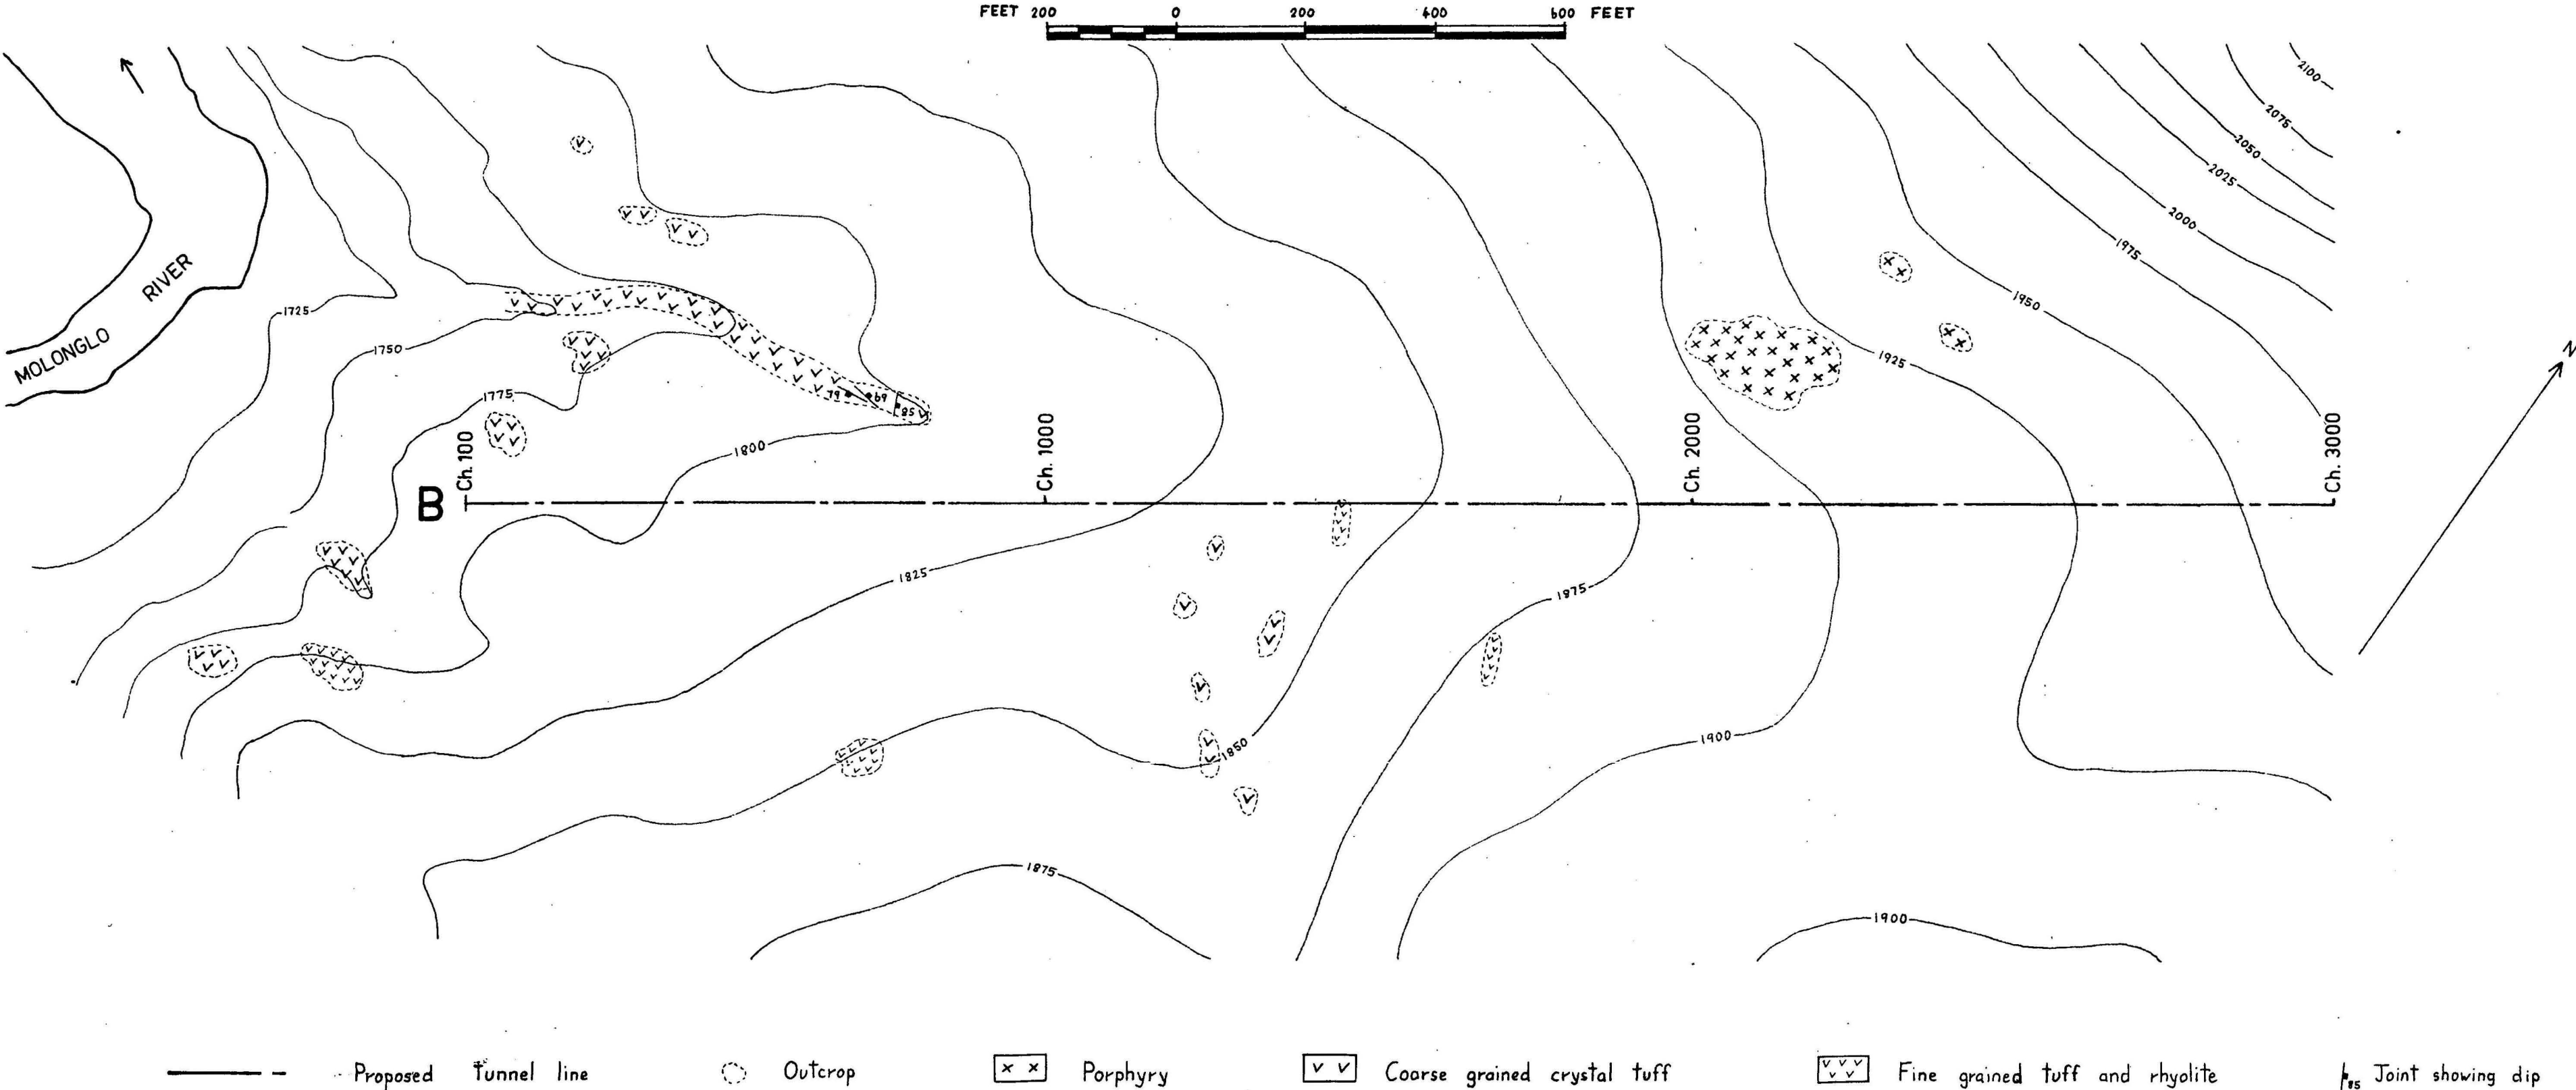
NORTH MOLONGLO OUTFALL SEWER  
ROUTE BCD - OUTLET TO CHAINAGE 3000 FEET  
SHOWING SURFACE GEOLOGY
