DEPARTMENT OF NATIONAL DEVELOPMENT

Record No. 1969 / 11

Geology of the Central Area
of Canberra, A.C.T.

With Section on Groundwater by G.M. Burton

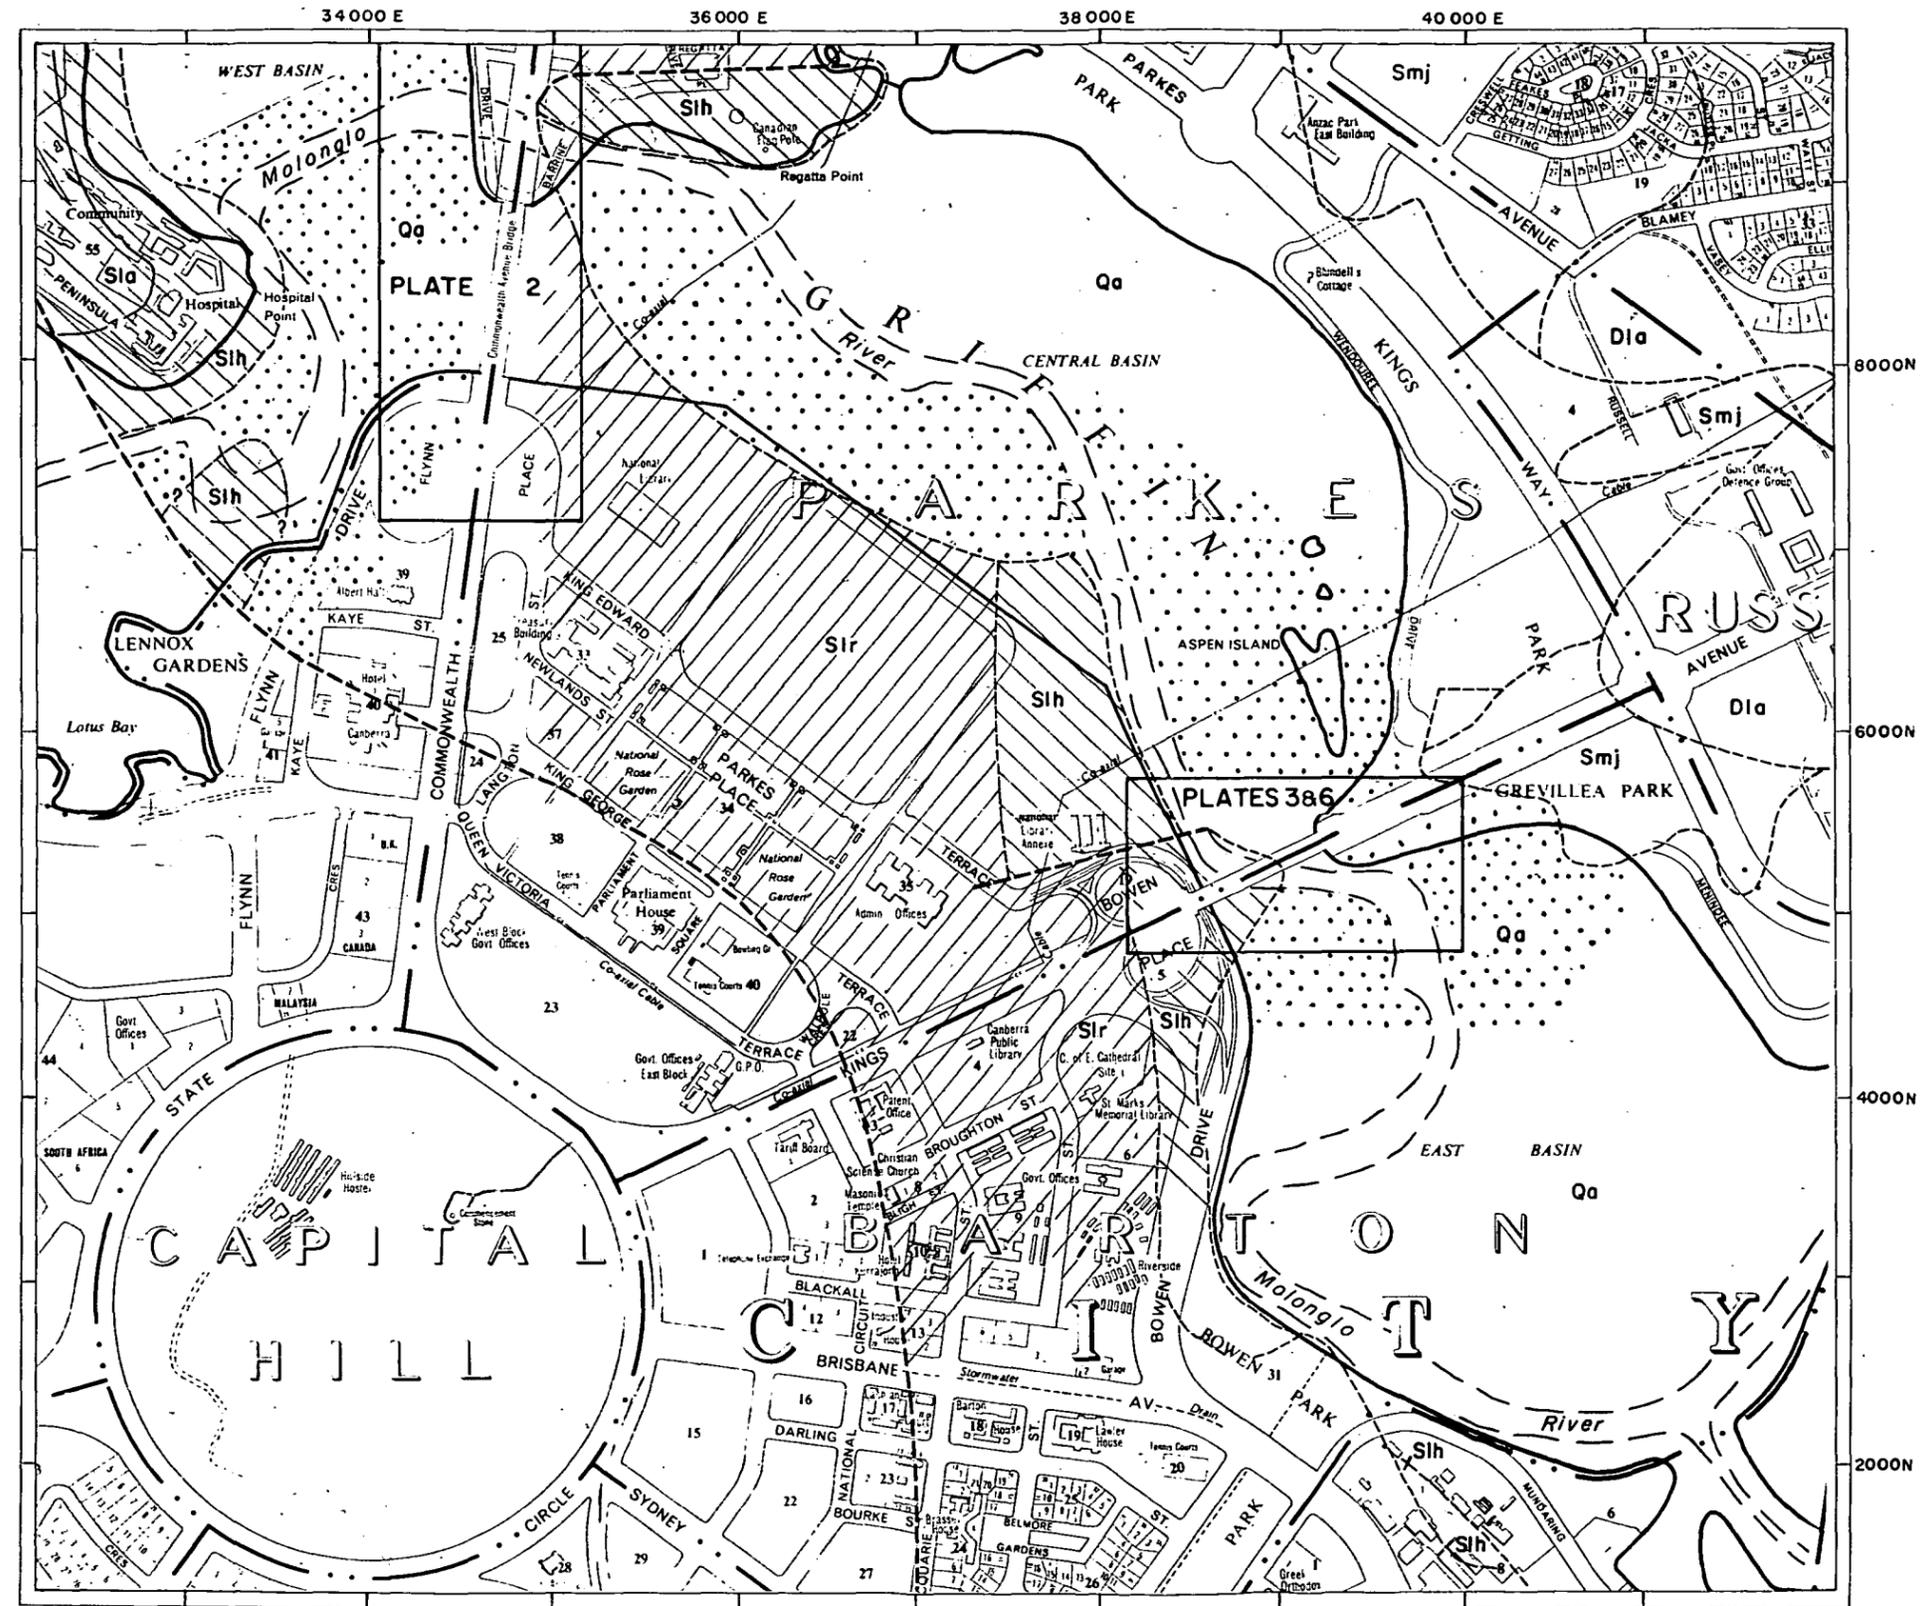
— PLAN SHOWING DRILL HOLES AND SEISMIC TRAVERSES —

COMMONWEALTH AVENUE BRIDGE SITE
EXPLORATORY DRILLING BASED
ON SEISMIC REFRACTION SURVEY

- Seismic stations
- Areas of low seismic velocity indicating possible fault zones or shear zones.
- Low velocity area extending beyond limit of seismic survey.
- 6400 f.p.s. Seismic velocity in feet per second
- Drilling site
- Bored cylinder foundation at pier site

Based on Gardner, 1958, Drawing No. A.C.T. 28-3 and Hawkins and Stocklin Record 1957/34
Drawing No. C263-5, C263-4

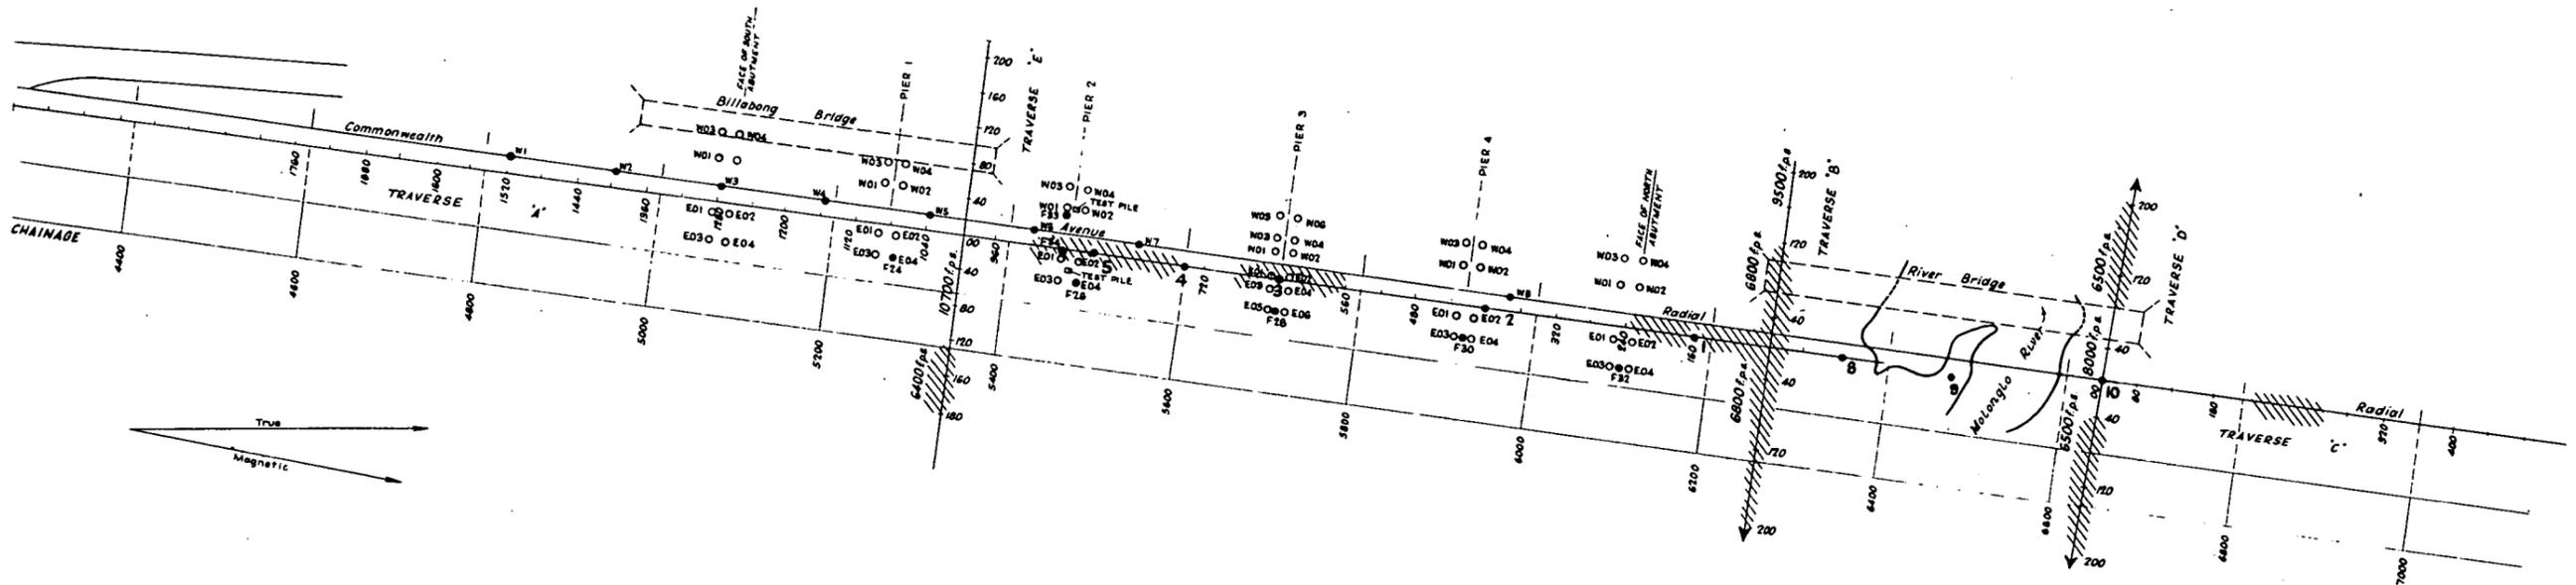
— VERTICAL SECTION —

- Boundary between overburden and bedrock
- 10000 f.p.s. Recorded seismic velocity in feet per second
- 1900 f.p.s. Average seismic velocity in overburden
- Approximate width of possible fault zone or shear zone indicated by seismic survey
- Alluvium
- D.B. - Decomposed bedrock
- V - Very weathered bedrock
- M - Moderately weathered bedrock
- S - Slightly weathered bedrock
- Bored cylinder foundation
- Reference as for diamond drill hole

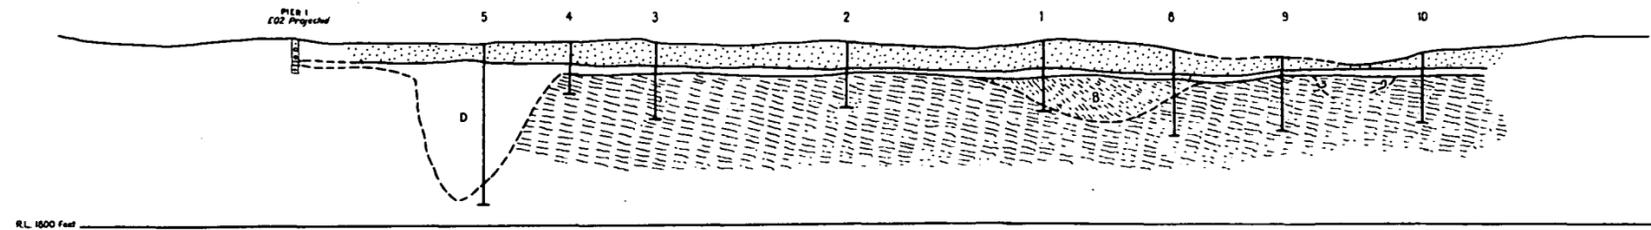
SECTION (natural scale) 0 100 200 Feet

COMMONWEALTH AVENUE
BRIDGE SITE

(From Gardner 1958, Drawing No. ACT 28-2, 28-3)

- Alluvium (organic silt, sand, gravel)
- Plastic clay resulting from weathering and decomposition of the bedrock in situ
- Weathered but firm claystone, silty claystone and siltstone.
- Firm weathered siltstone etc (B class), containing bands and pockets of plastic clay.
- Calcareous mudstone or claystone.

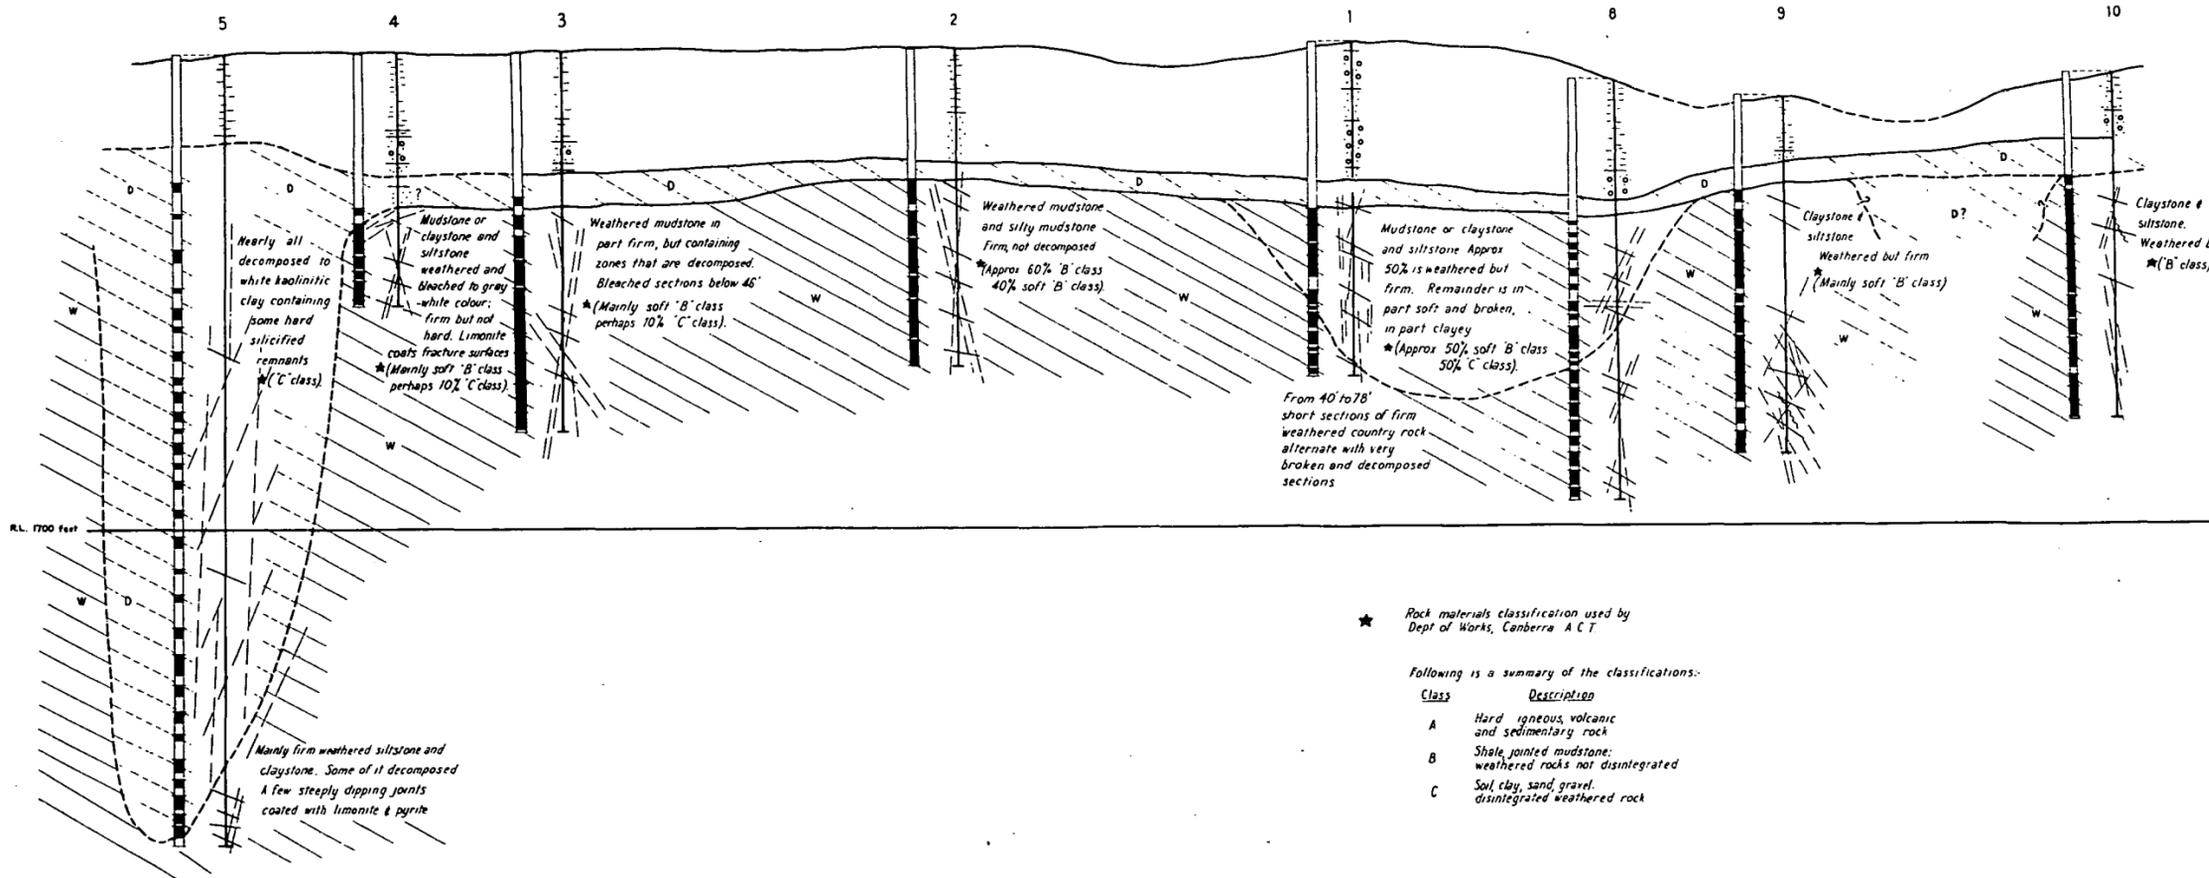
SECTION DETAILED (exaggerated vertical scale)

HORIZONTAL 0 50 100 150 200 250 Feet
VERTICAL 0 20 40 60 80 100 Feet

- Silt and organic silt
- Sand
- Gravel
- Alluvium
- Claystone & siltstone decomposed to plastic clay
- Claystone & siltstone, weathered, but retaining considerable strength and hardness.
- Geological boundary, position accurate.
- Geological boundary, position approximate.
- Drill hole: Percussion drilled through alluvium and decomposed bedrock, diamond drilled through weathered bedrock.
- Length drilled. Core recovery shown in black.

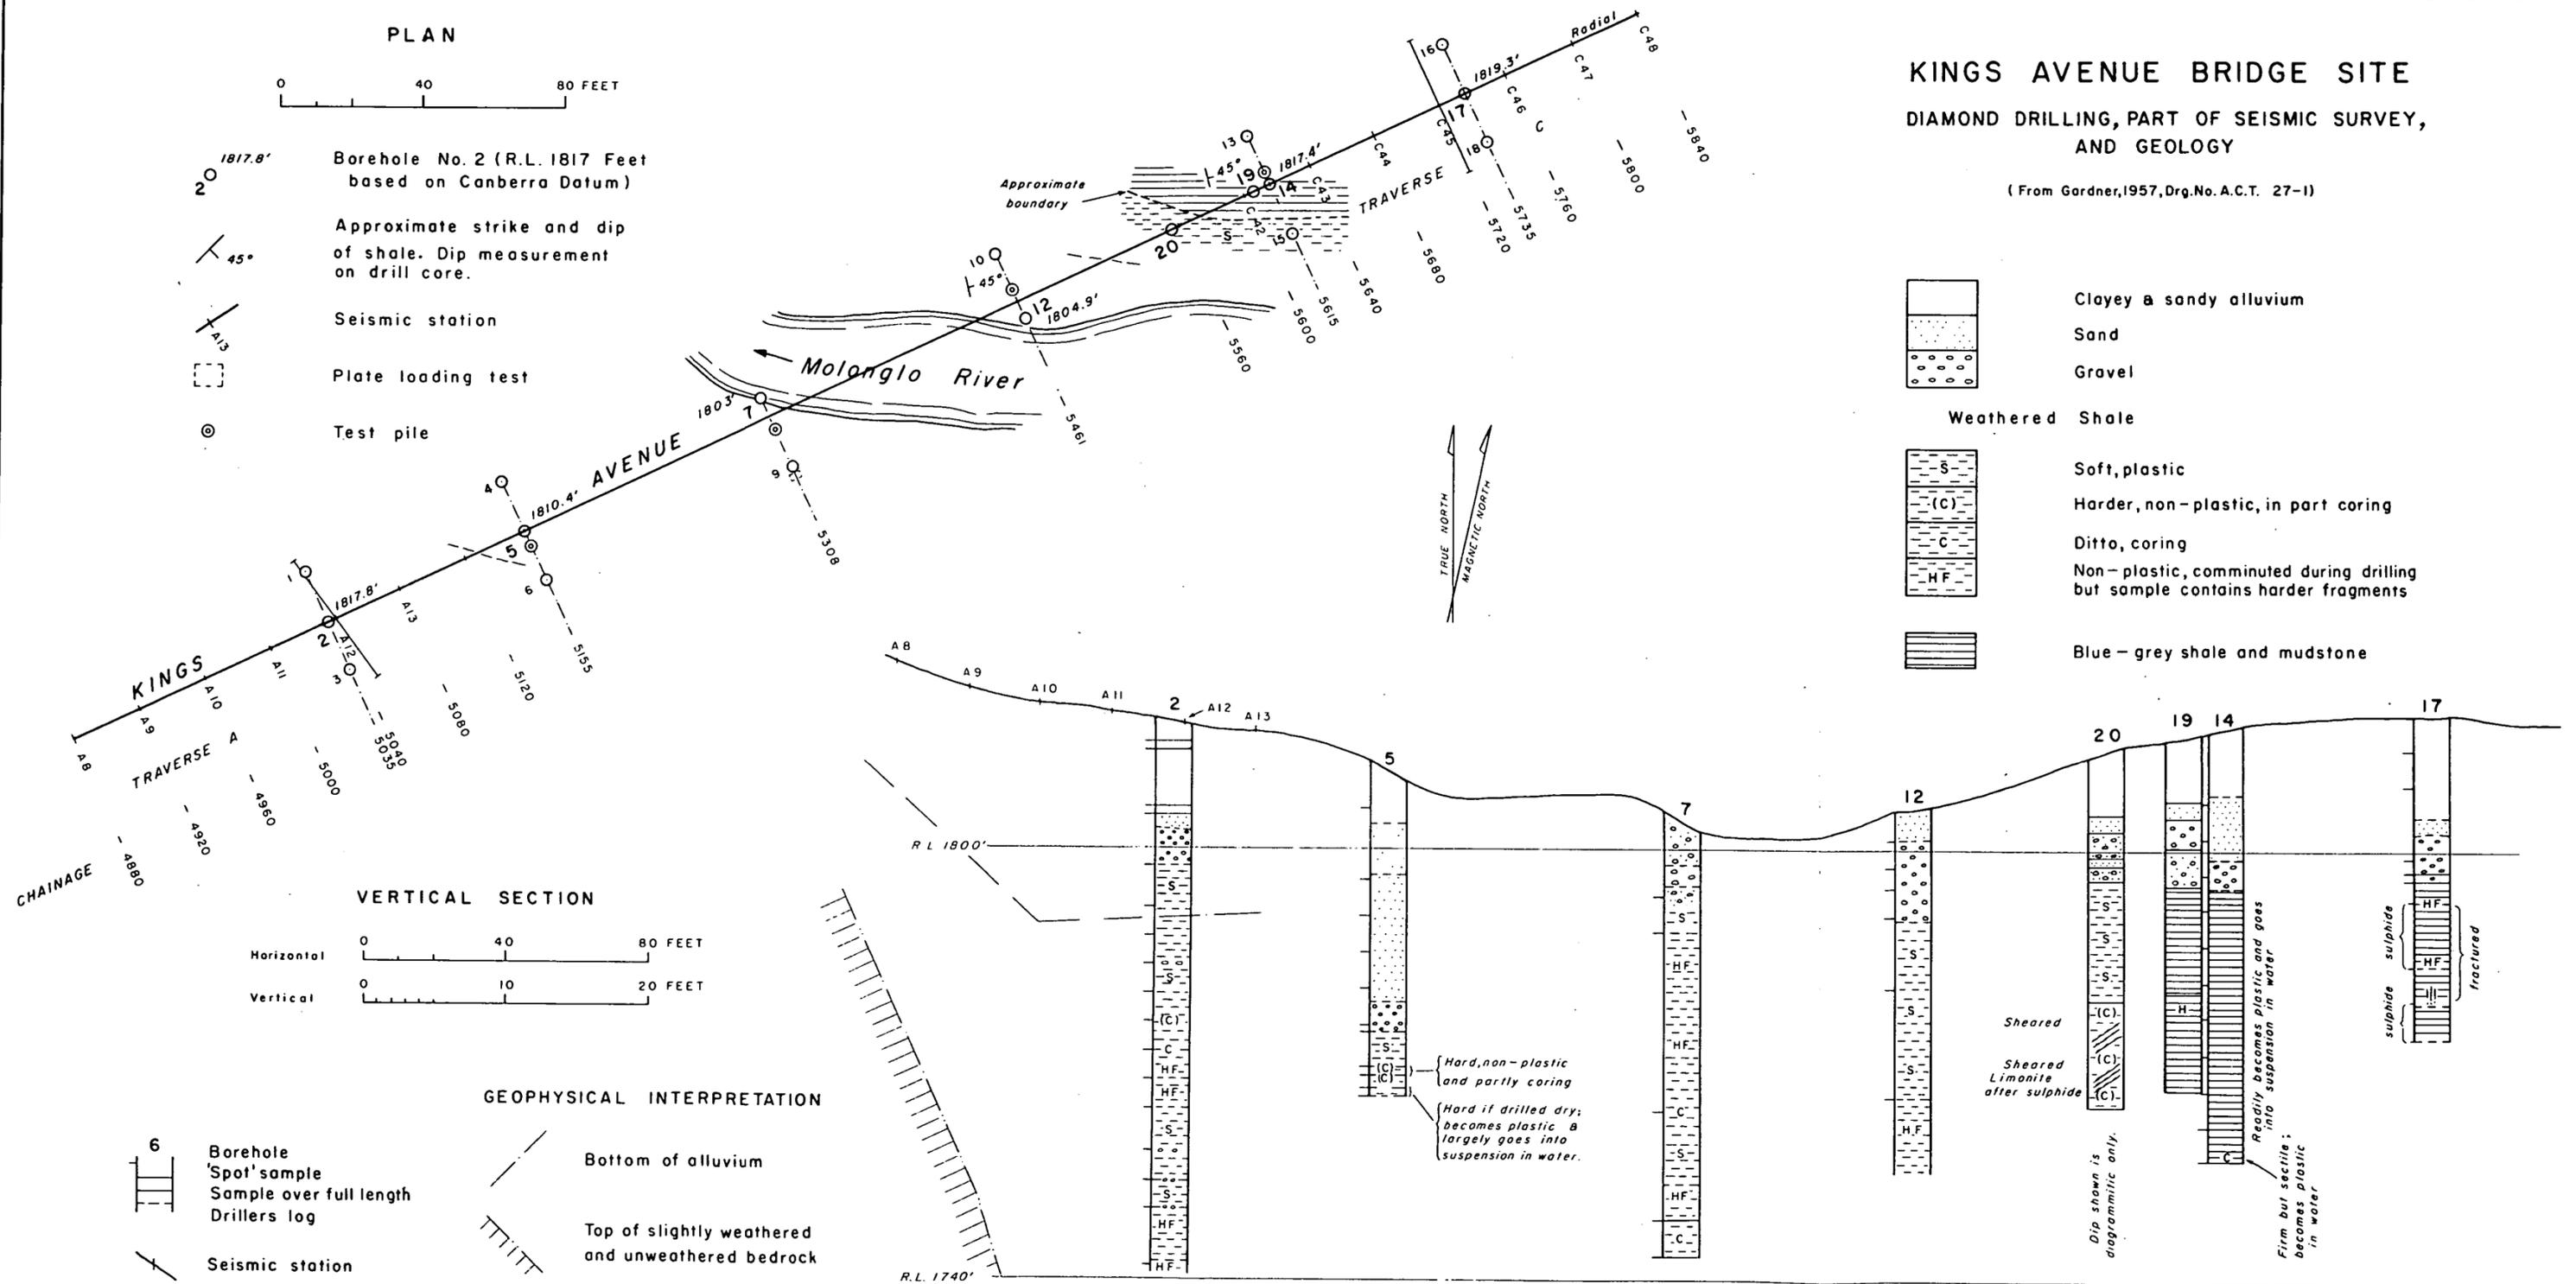
KINGS AVENUE BRIDGE SITE

DIAMOND DRILLING, PART OF SEISMIC SURVEY, AND GEOLOGY

(From Gardner, 1957, Drg. No. A.C.T. 27-1)

- Clayey & sandy alluvium
- Sand
- Gravel
- Weathered Shale**
- Soft, plastic
- Harder, non-plastic, in part coring
- Ditto, coring
- Non-plastic, comminuted during drilling but sample contains harder fragments
- Blue-grey shale and mudstone

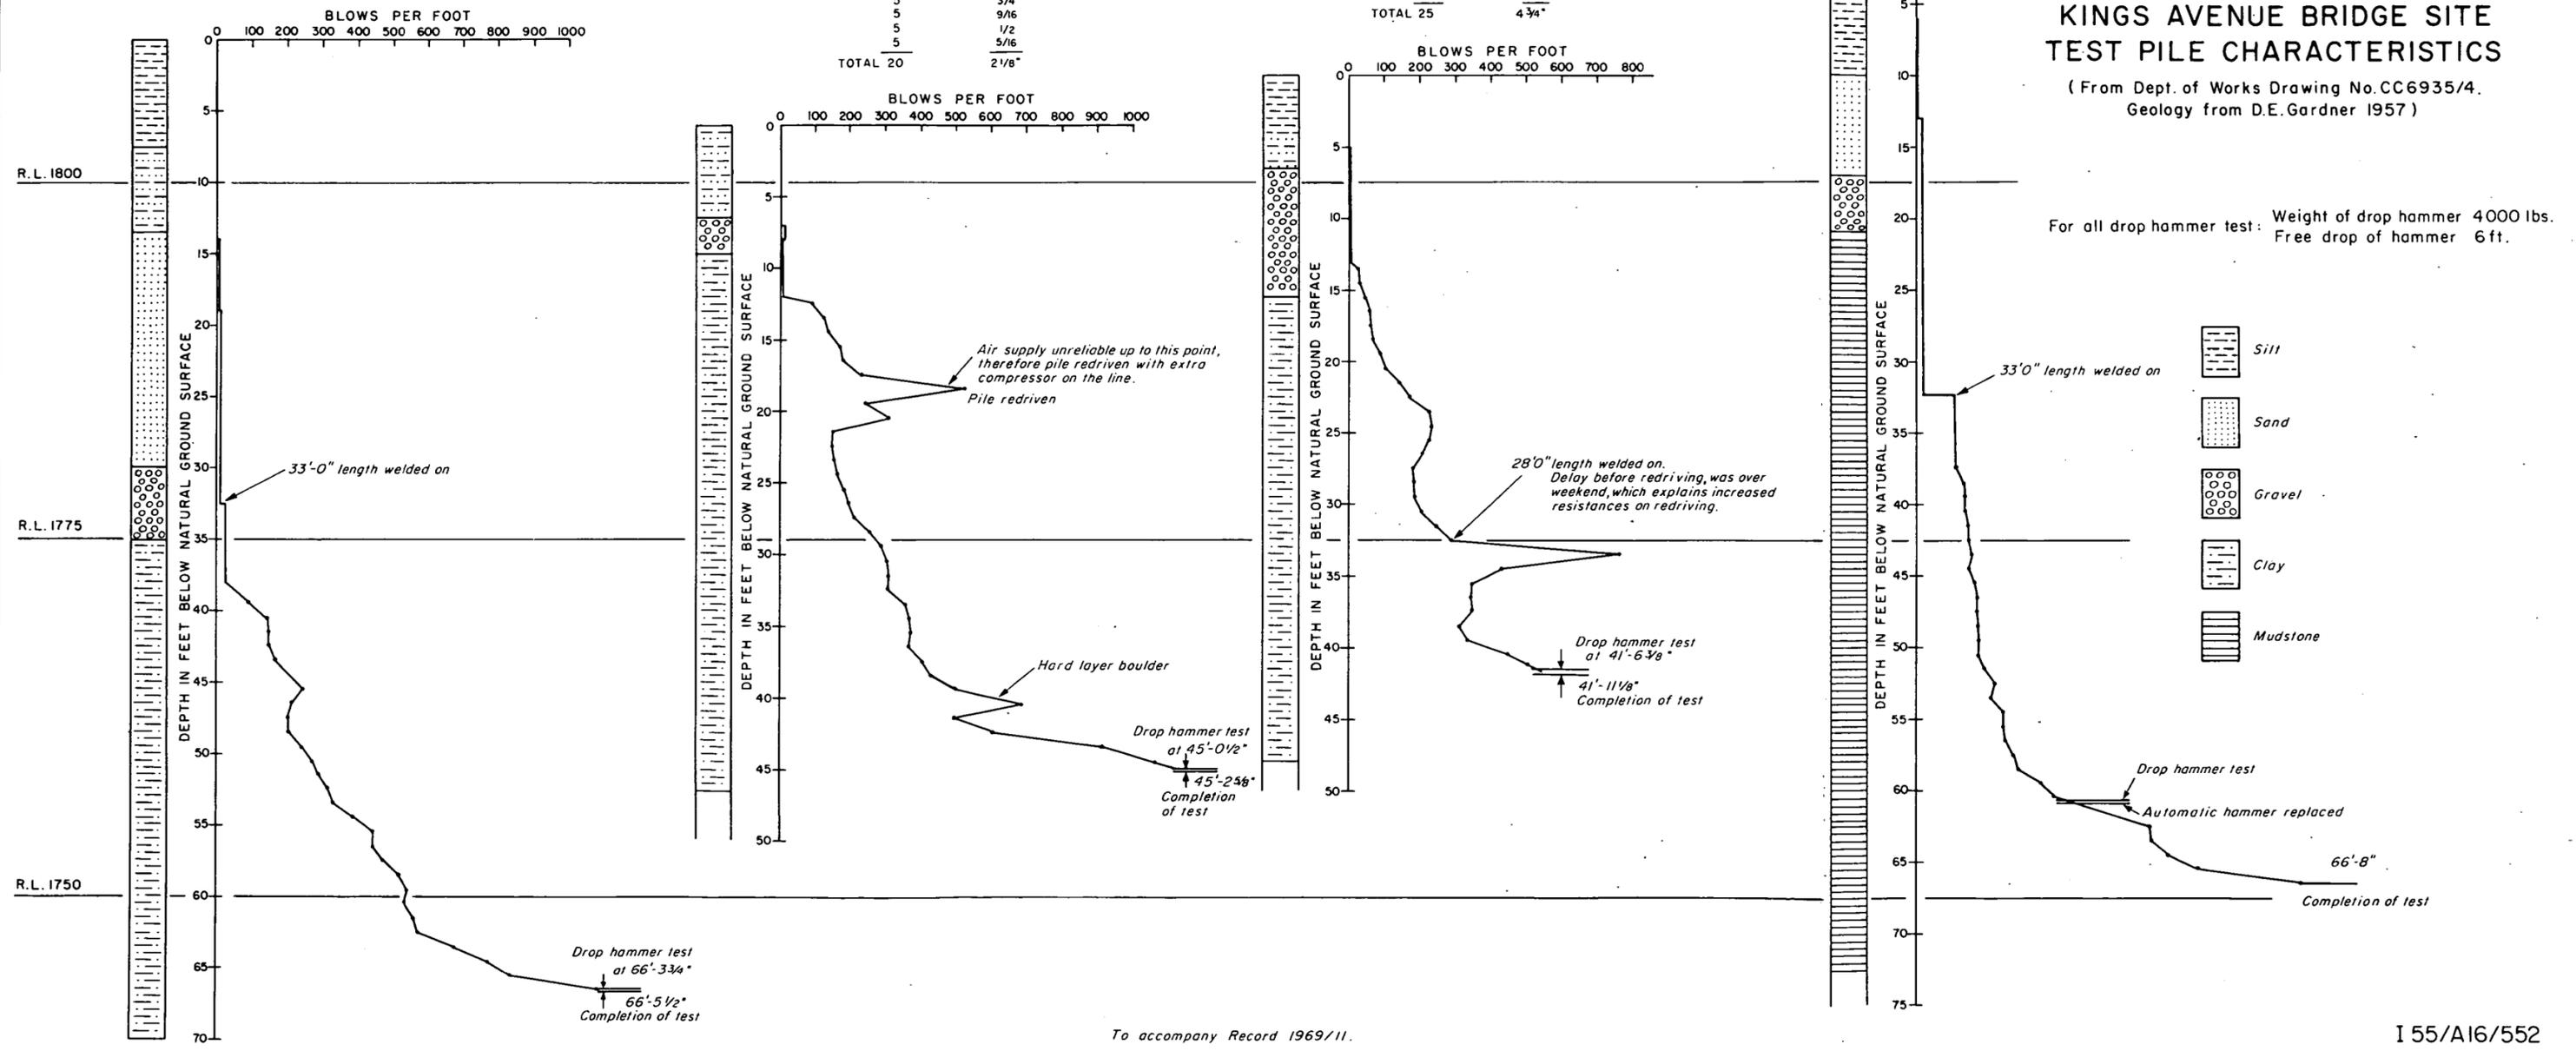
KINGS AVENUE BRIDGE SITE PLATE LOAD TESTS

TEST PILE No.4 AT CH. 5155
7 FT. SOUTH OF RADIAL

TEST PILE No.3 AT CH. 5615
7 FT. NORTH OF RADIAL

BLOWS	PENETRATION
5	7/8"
5	3/4"
5	3/4"
5	11/16"
TOTAL 20	3"

BY COMMONWEALTH DEPARTMENT OF WORKS, CANBERRA (CDW DRG.No. CC 6935/1,3)

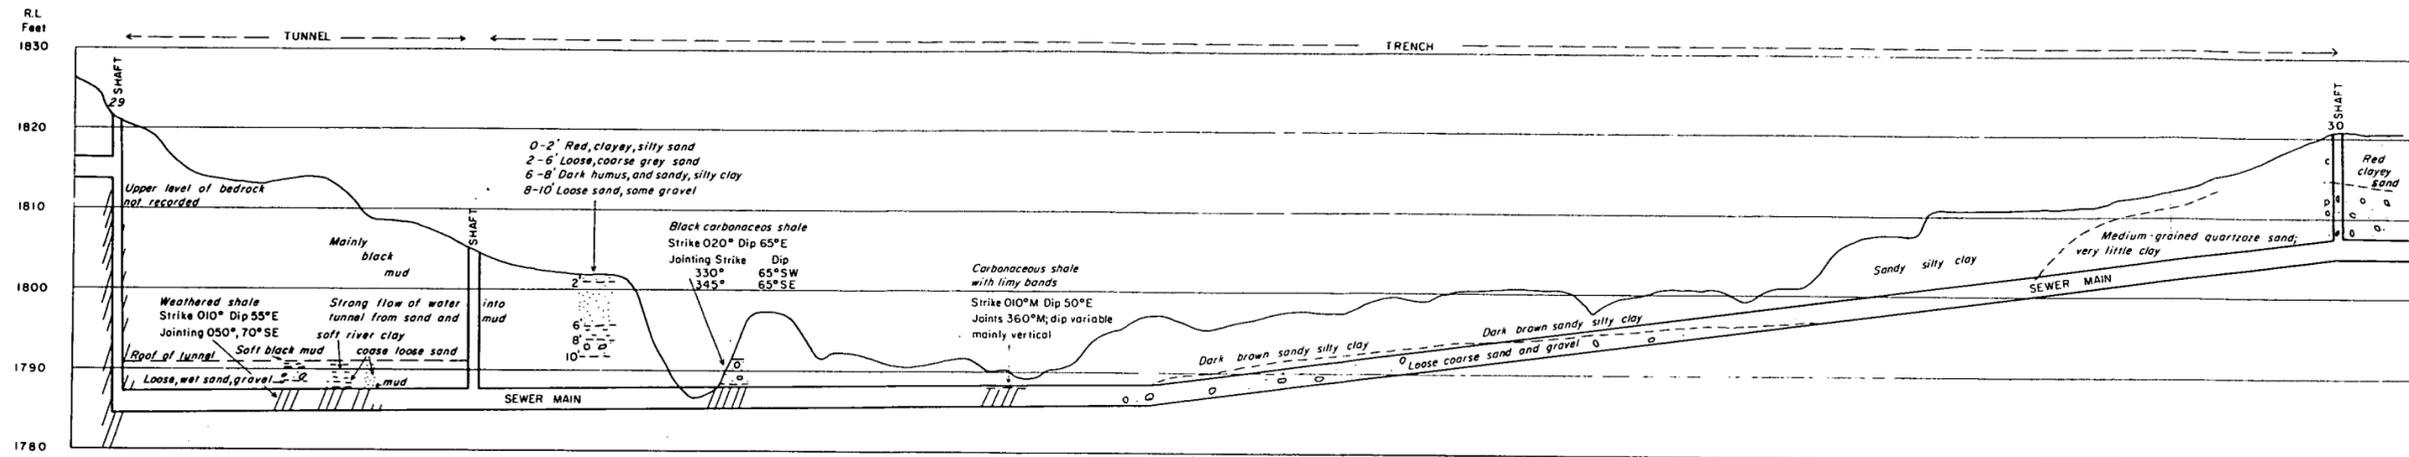
**GEOLOGICAL SECTIONS
ALONG PARTS OF NORTHERN SUBURBS
MAIN OUTFALL SEWER BETWEEN
MANHOLES 29 AND 33, ACTON**

HORIZONTAL SCALE 0 40 80 FEET
VERTICAL SCALE 0 10 20 FEET

Profile taken from Department of Works
Drawings No's CC 6313/4, CC 6704.P

The alluvium on the northern side of the river consists of loose wet sand, soft black mud and soft clay. While it was being excavated water streamed from the sandy beds, and wall and roof timbers had to be driven in ahead of the face to keep the tunnel intact (i.e. spiling or forepoling methods of tunnelling had to be used). South of the river almost to manhole 30, dark brown sandy silty clay rests on loose coarse sand and gravel.

Slightly north of manhole 30 the recent loose-textured river alluvium terminates against older alluvium which is covered by medium-grained windblown sand. The older alluvium consists of lenticular bands of sand and gravel in which the fragments have been derived from many types of rock. This polymict alluvium is represented in the accompanying drawings by the symbol P. During the period since the alluvium was deposited many of the rock fragments have weathered to friable earth and clay. Released iron oxide has coated the adjacent fragments and weakly cemented the alluvium. Clay has entered the pore spaces and reduced permeability. Locally the sandy beds are almost impermeable. The coarser bands, formed of granules and pebbles, are commonly slightly permeable; they permit slow seepage of water into the excavation during wet weather, and for some time afterwards when the groundwater table is high.

This section was tunnelled. The clay described in the preceding paragraph extends 130 feet southwards from manhole 31. At this point it gives place to sand and gravel, mainly loose and moist, with thin interbeds of clay, which continue southwards along the sewer excavation for 140 feet. The sand and gravel is considered to be an extension of the old alluvium which occurs between manholes 30 and 31. Continued seepage of water through it, probably draining from the catchment to the east between Capital Hill and Cork Hill, has washed out most of the inter-granular clay.

For the last 70 feet towards manhole 32 the sewer tunnel passes through wet, loose, coarse sand and gravel free of clayey bands. When this section was being excavated, after a period of rain, the ground-water was almost up to the top of the shaft at the site of manhole 32. Water flowing strongly from the sand and gravel was pumped from the shaft by an electric pump operating 24 hours a day. In this part of the tunnel, viz from manhole 32 northwards to the clay, a distance of 230 feet, the roof timbers had to be driven ahead of the working face, using spiling methods. Walls stood up fairly well, and were lightly timbered a short time after excavating.

The sewer passes through coarse sand and gravel, which is quite loose and uncemented, for at least 400 feet south of manhole 32. At a point 240 feet from the manhole the sand and gravel is poorly cemented and a small flow of water was seeping into the tunnel at the time of inspection. The roof had to be supported but the walls stood up satisfactorily. From about 80 feet north to 30 feet north of manhole 33 the soil to a depth of 2 feet 6 inches consists of red-brown clay. This is underlain by polymict sand and gravel essentially similar to that between manholes 30 and 31.

Fairly long stretches of the excavation between manholes 32 and 33 were not inspected. They include the portion extending from 40 feet to 240 feet south and 244 feet to 600 feet south. According to the foreman in charge of the job the excavation went through sand and gravel, which was loose down to the bottom of the trench, where it consisted of cemented alluvium.

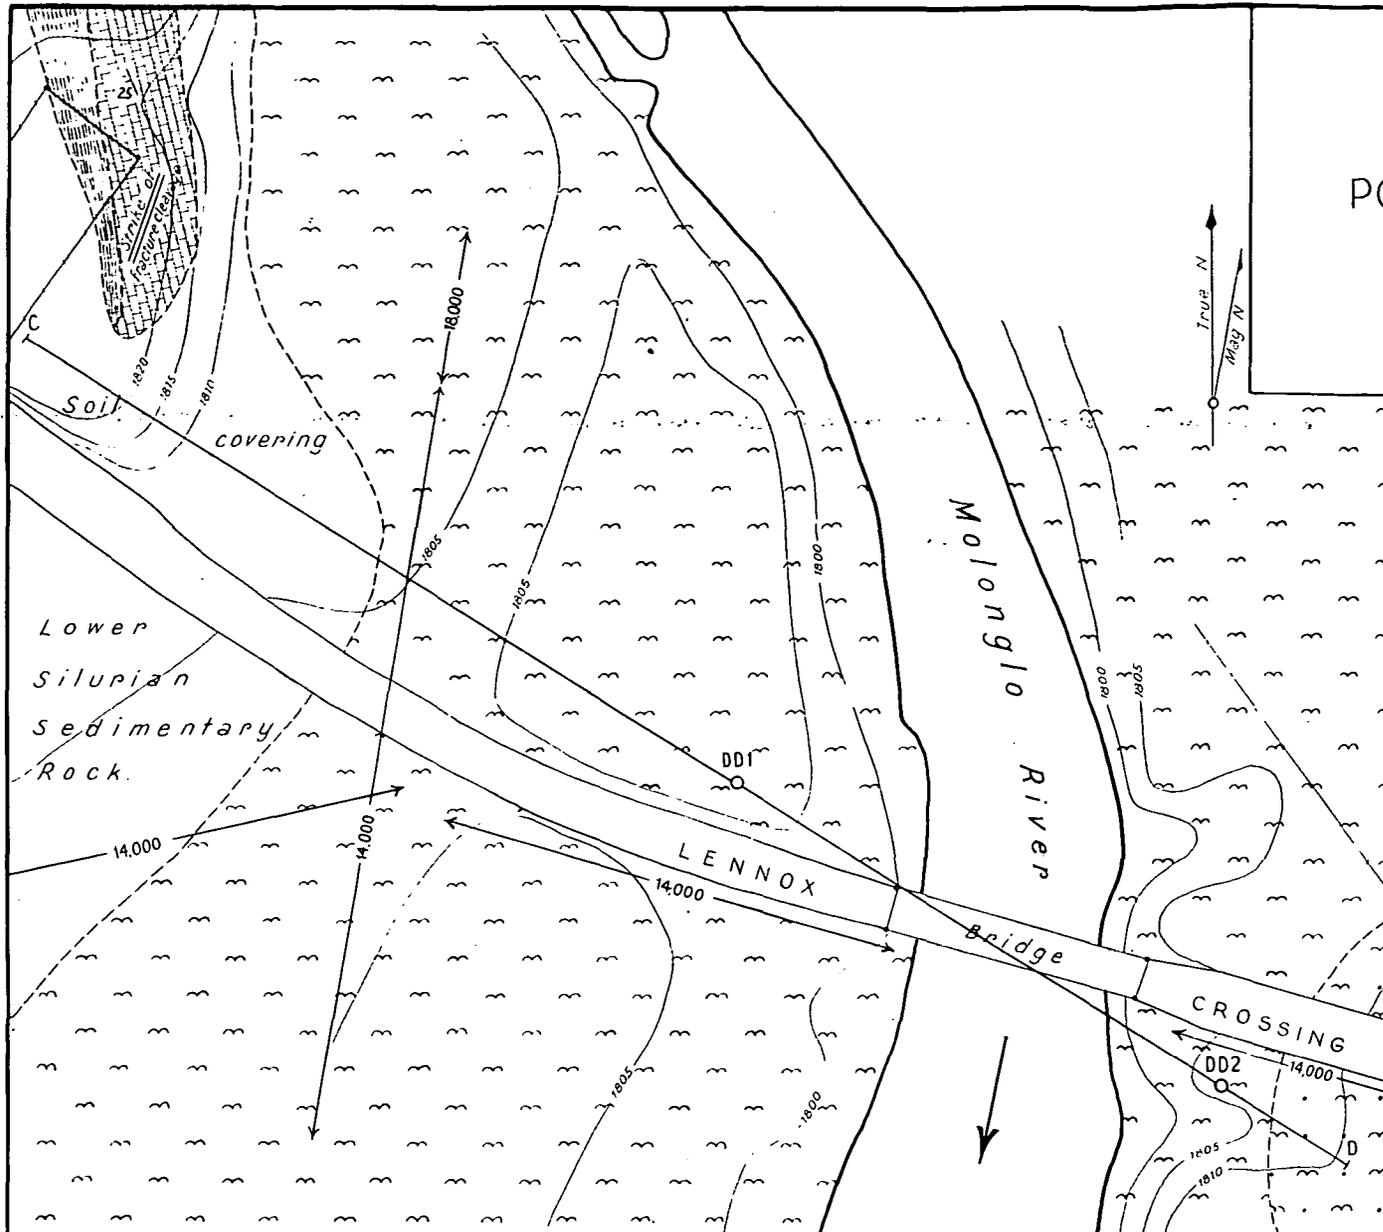
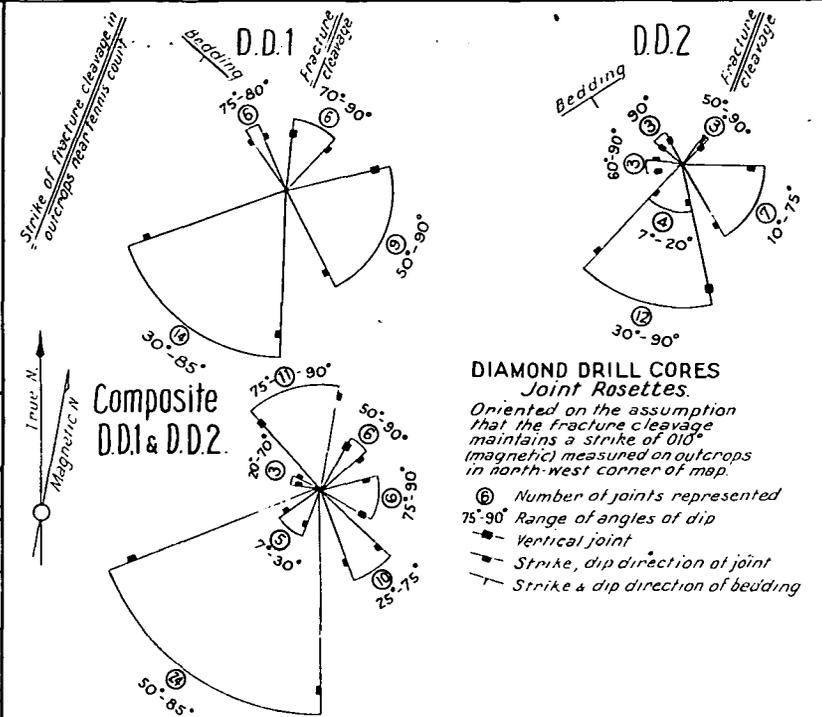
GEOLOGICAL MAP
ACTON WEIR SITE

GEOLOGY BY D.E. Gardner, J. Barry and H.B. Owen.

**DIAMOND DRILL CORES
Joint Rosettes**
Oriented on the assumption that the fracture cleavage maintains a strike of 010° (magnetic) measured on outcrops in north-west corner of map.

- ⊙ Number of joints represented
- 75°-90° Range of angles of dip
- Vertical joint
- Strike, dip direction of joint
- · - · Strike & dip direction of bedding

- RECENT River alluvium
- PLEISTOCENE Lacustrine sediment beneath a thin cover of sand
- LOWER SILURIAN Calcareous mudstone and siltstone
- Impure limestone
- Calcareous sandstone
- Geological boundary - position accurate
- · - · " " " approximate
- · - · " " " inferred
- Joint - semidiagrammatic
- 1800- Contour, based on Canberra datum
- SEISMIC DATA
- 1700 Seismic velocity in f.p.s.
- 18000- (shown on plan) in fresh bed-rock in f.p.s.
- Estimated position of base of alluvium
- · - · Possible lower level of slightly weathered bed-rock
- DD Diamond drill hole

The alluvium encountered in drill holes 1 and 2 (see Plates A5-1 & 2) on either side of the river, consists mainly of coarse, loose sand. Its thickness is approximately that estimated in the seismic survey. Towards the north-west the alluvium terminates against a steep slope leading up to the limestone outcrops near the tennis court. In a south-easterly direction the alluvium probably terminates a short distance past DD2 against higher ground underlain by sand and weathered alluvium.*

The outcrops in the vicinity of the tennis court (see Plates A5-1 & 2) consist of hard, black, impure limestone, overlain by soft weathered shale and mudstone. Probably the latter beds are relatively hard at a depth of 5 to 10 feet from the surface. Drill holes 1 and 2 intersected highly calcareous fine-grained sediment, comprising mudstone and siltstone, and coarser-grained calcareous sandstone. The fine-grained sediment exhibits distinct slaty cleavage or fracture cleavage. Joints are mainly tight. Some are smooth, clean and chloritic; others are lined by calcite and a thin coating of pyrite. The calcareous sandstone is very hard and not readily scratched with a knife. Cleavage is poorly developed or absent. Drill hole No. 1 passes mainly through very fine-grained sedimentary strata in which a few narrow sandstone beds are intercalated. No. 2 hole revealed a larger proportion of sediment of intermediate size, comprising silty mudstone and shale. The lime content of the rock when fresh was probably much lower than that of the calcareous strata of drill holes 1 and 2. Possibly it was closer in amount to that of the shale and mudstone near the tennis court. Drill hole No. 4 passed through weathered alluvium, into a plastic yellow-brown clay formed by decomposition in situ of the bedrock. A few fragments, up to 4 inches long, of black limestone may represent thin limestone interbeds partly removed by solution. At 30 feet the drill entered a cavity which persisted down to nearly 37 feet, where it entered hard, compact, impure limestone.

The limestone and the calcareous shale and mudstone near the tennis court display a slaty cleavage or fracture cleavage that trends 010° magnetic; the folds pitch southwards at a small angle. Core recovered from the diamond drill holes displays a similar slaty cleavage. In order to provide a basis for interpreting the structure of the bedrock at Lennox Crossing, the joints, bedding and fracture cleavage in the core from DD1 and DD2 were mapped in detail. The results are summarized in the joint rosettes of Plate A5-2. It can be seen that the two drill holes give almost identical joint patterns and when these are oriented similarly the cleavage directions coincide. Assuming that the cleavage remains constant throughout the area and has the strike 010° noted above, the strike and dip of the sedimentary strata in each hole is as shown on the joints rosettes. From the attitudes of the beds it is inferred that a minor anticline and a syncline, shown in section in Plates A5-1 & 2, are imposed on the eastern limb of the larger regional syncline (or western limb of the anticline). The position of the top surface of the limestone beneath the alluvium is indicated on the plan in Plate A5-1. This structural section is admittedly the result of interpretation but structures mapped in the limestone outcrop in the river by Pittman (1911) fit in with the interpretation from DD1 and DD2.

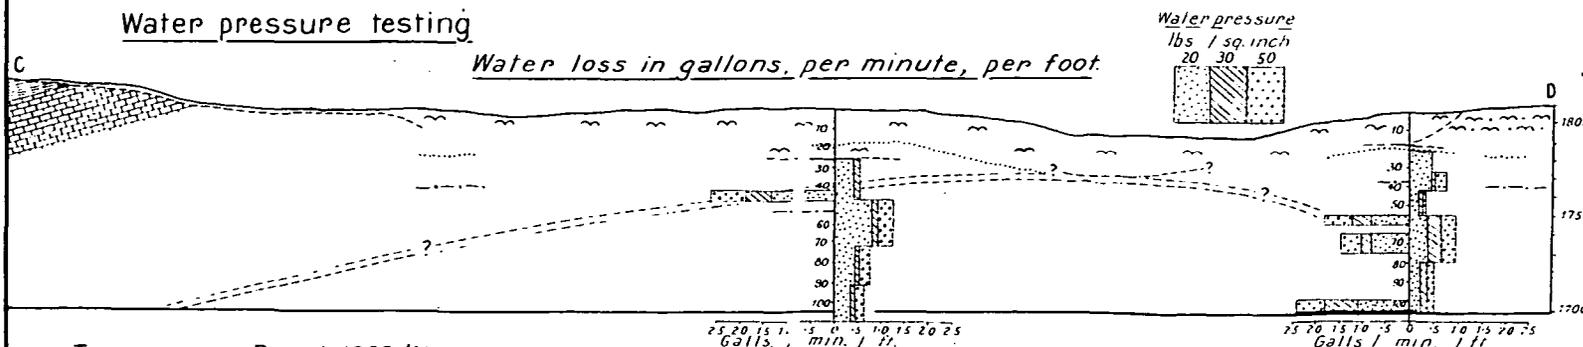
Water pressure testing

Water loss in gallons, per minute, per foot

The high clay content of the weathered alluvium suggests a low permeability. This is confirmed by water pressure tests in drill holes 3 and 4. Nevertheless it is possible that permeable gravel beds or gravel fillings of former channels are present, as were found a short distance away to the south-west during the excavation of a tunnel for the northern suburbs outlet sewer.

Water loss in drill holes 1 and 2 was considerable but could be stopped by grouting without undue trouble. It results from leakage through narrow open joints, narrow bands of fractured or crushed rock, and through cavities caused by solution of highly fossiliferous bands composed mainly of calcium carbonate. Drill hole No. 4 entered a cavity between 30 feet and 36 feet above massive impure limestone. Apparently it was caused by solution of the upper part of the limestone. The water pressure testing, summarized on the diagrams on Plate A5-2, shows excessive water loss, but the potential loss may be even higher. Immediately after the hole had been drilled water running at full pressure from a $\frac{3}{4}$ " hose placed inside the collar of the hole escaped freely from the cavity. If the interpretation of structure already given is correct, and providing the limestone forms a continuous bed, cavernous limestone could form a folded outcrop more than 2000 feet long beneath permeable river alluvium.

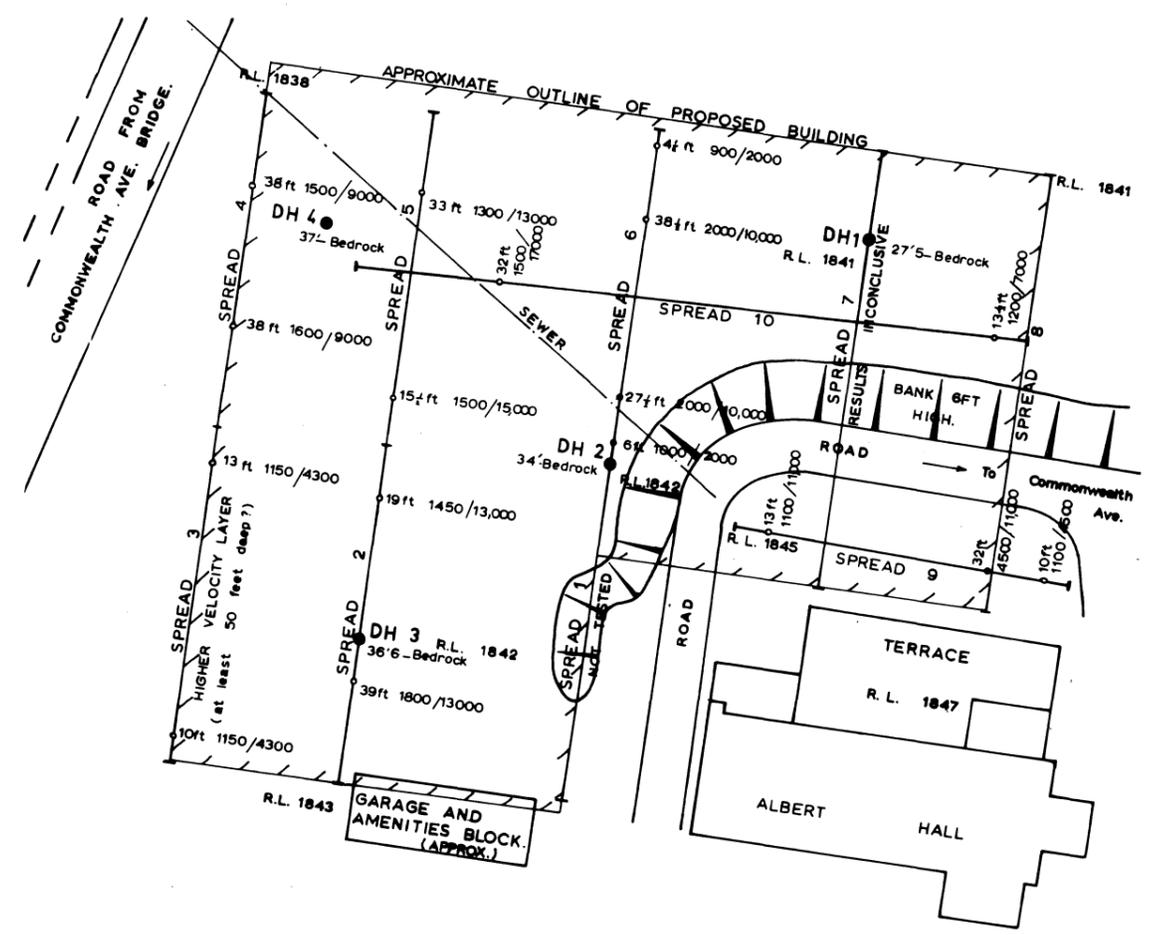
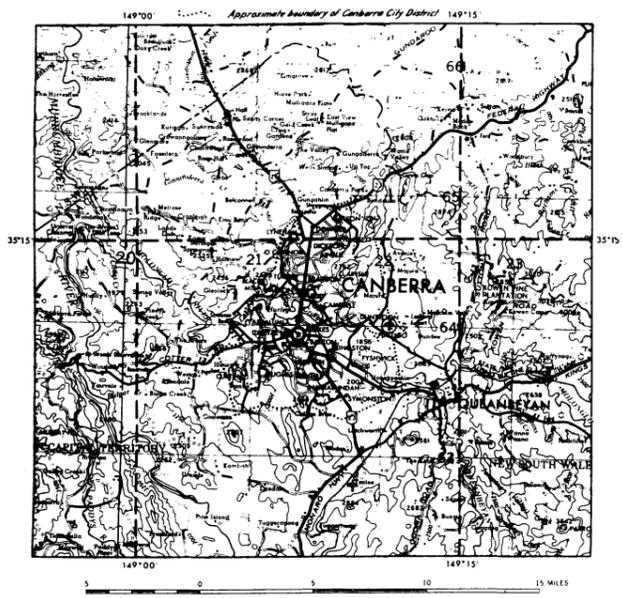
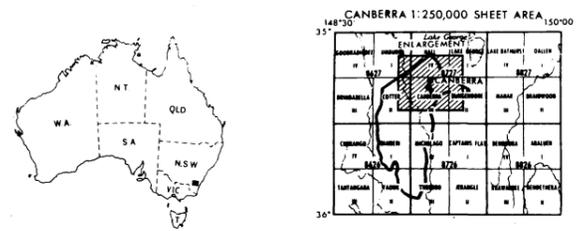
MAP SHOWING SITE OF PROPOSED CONFERENCE CENTRE, WITH SEISMIC TRAVERSES AND DIAMOND DRILL HOLES.

- APPROXIMATE BOUNDARY OF PROPOSED BUILDING.
- SEISMIC SPREAD, SHOWING DEPTHS TO VELOCITY-DISCONTINUITIES WITH VELOCITIES IN FEET PER SECOND ABOVE AND BELOW DISCONTINUITY.
- FIRST DISCONTINUITY.
- SECOND DISCONTINUITY.
- DH1 DIAMOND DRILL HOLE N° 1.
- R.L. APPROXIMATE REDUCED LEVELS, BASED ON CANBERRA DATUM.
