DEPARTMENT OF NATIONAL DEVELOPMENT

Record No. 1969 / 11

Geology of the Central Area
of Canberra, A.C.T.

With Section on Groundwater by G.M. Burton

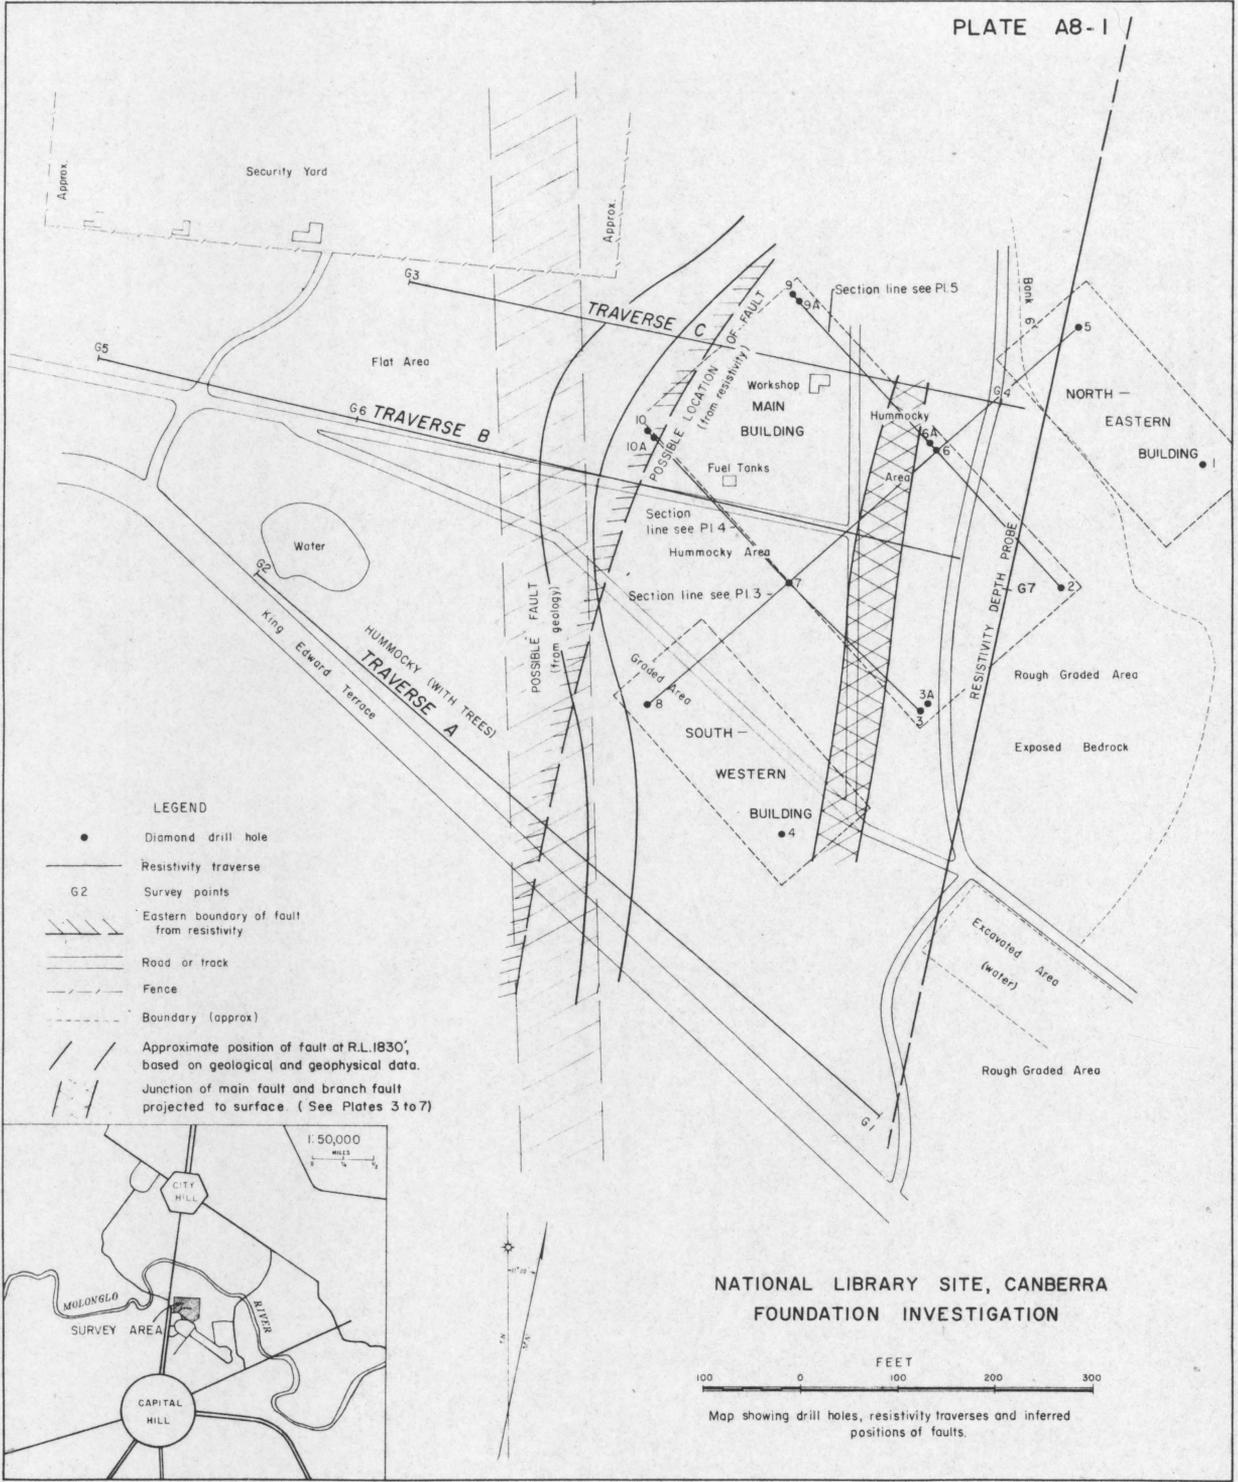
NATIONAL LIBRARY SITE, CANBERRA
FOUNDATION INVESTIGATION

Map showing drill holes, resistivity traverses and inferred positions of faults.

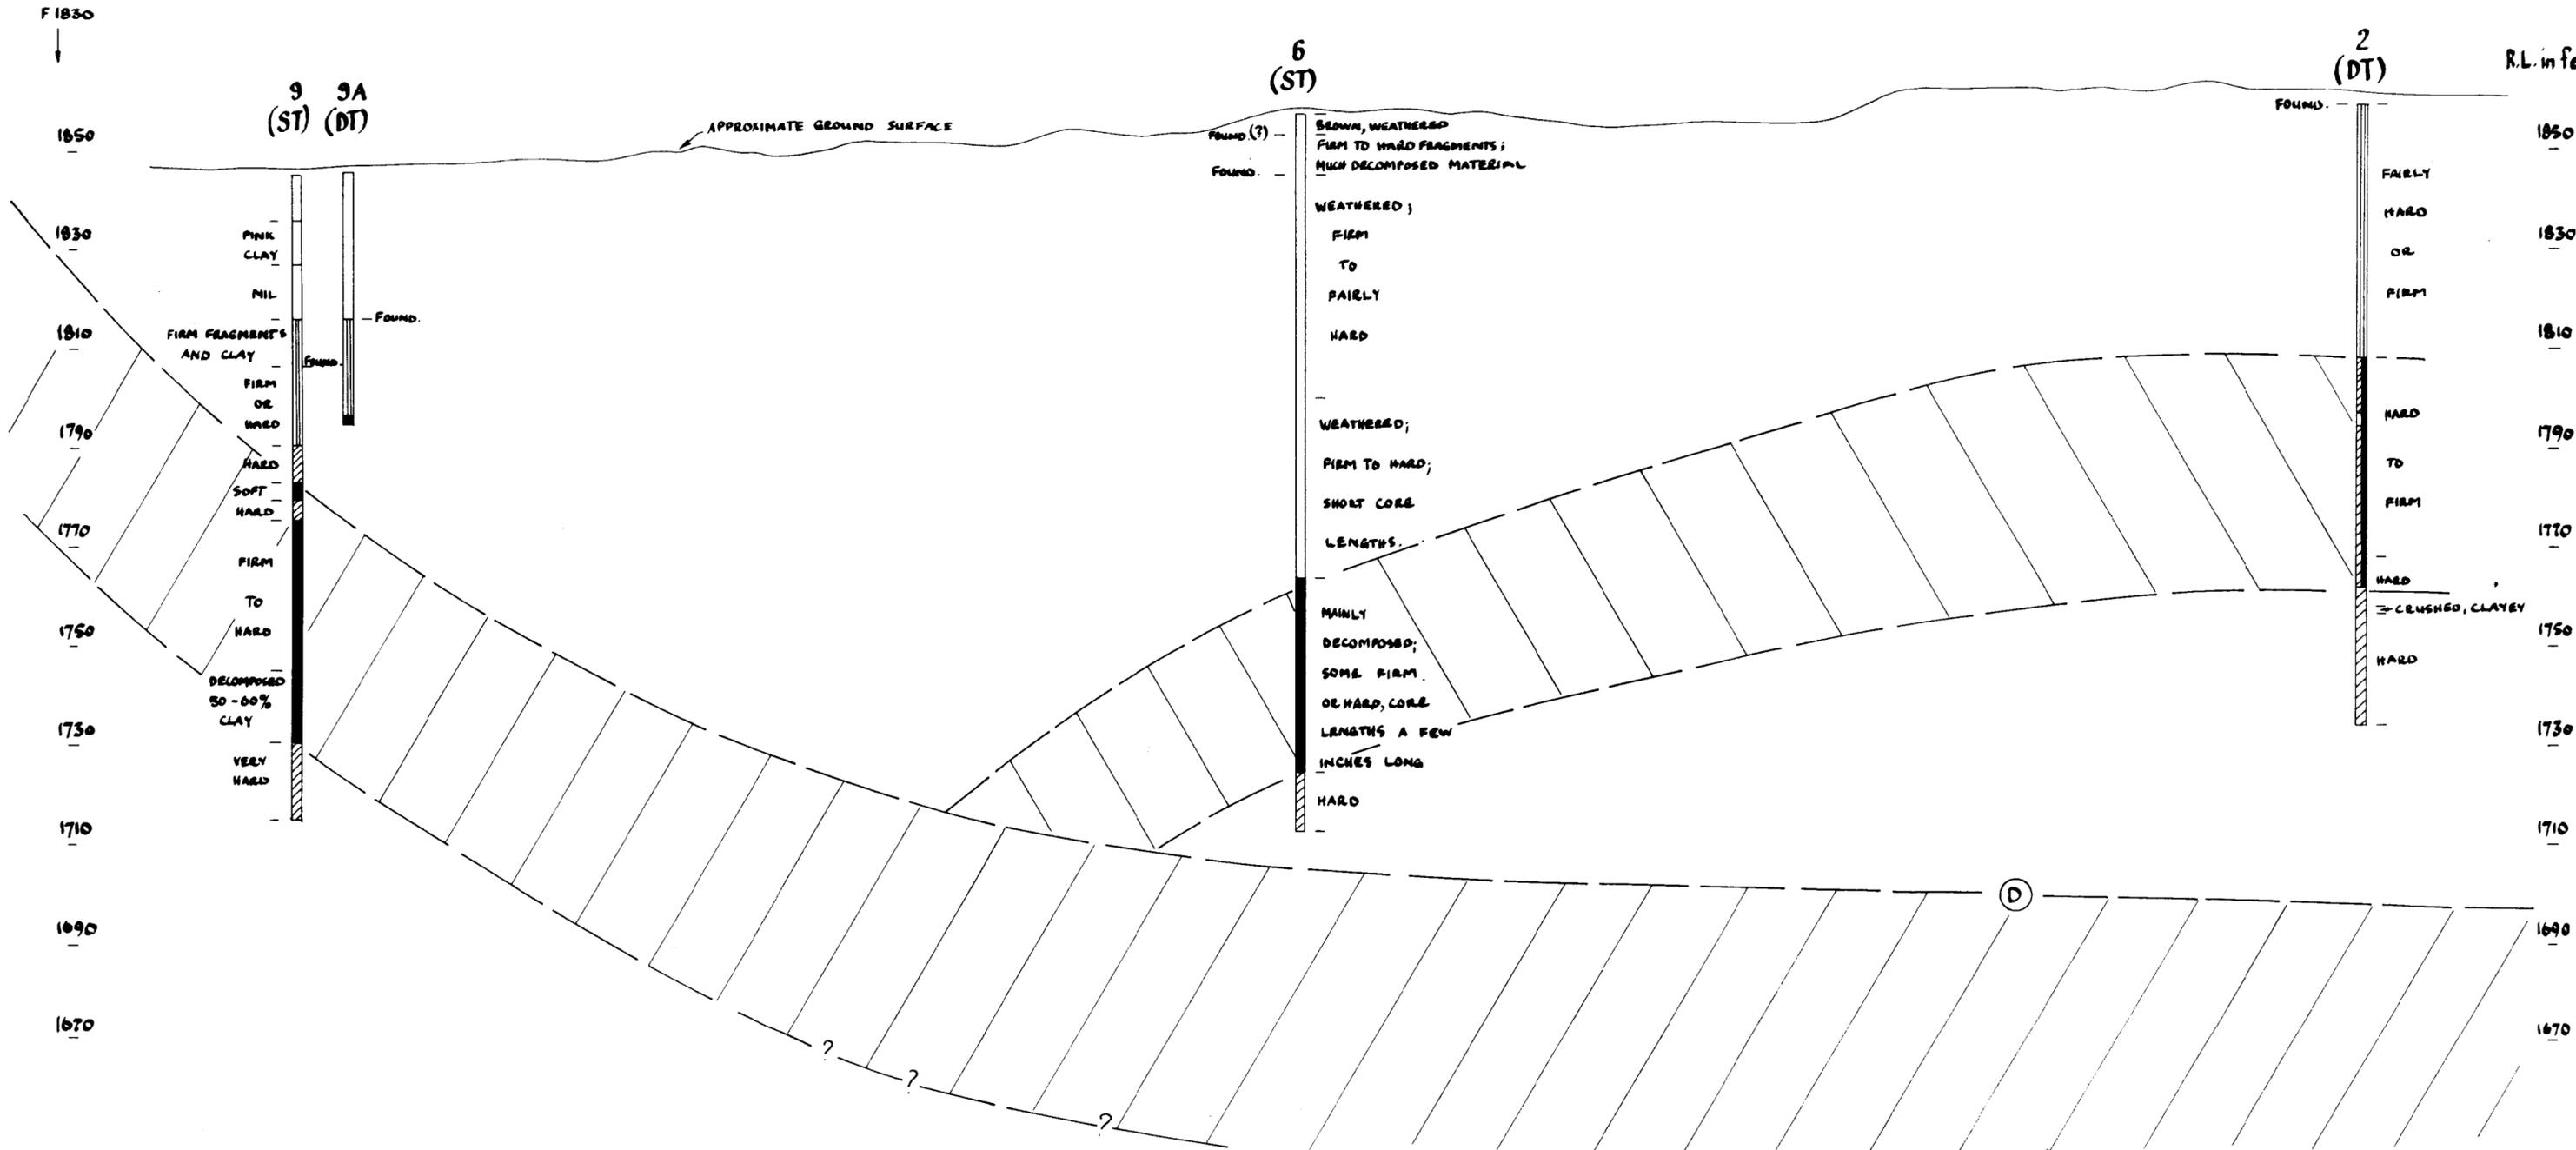
NATIONAL LIBRARY SITE GEOLOGICAL SECTIONS OF DRILL HOLES

MAINTLY CLAY
HARD; BROKEN

BROKEN;
CLAYEY IN PART

BROKEN FRAGMENTS, FIRM TO HARD;
PROBABLY MUCH CLAY WASHED OUT.

BROKEN AND SHORT CORE LENGTHS.

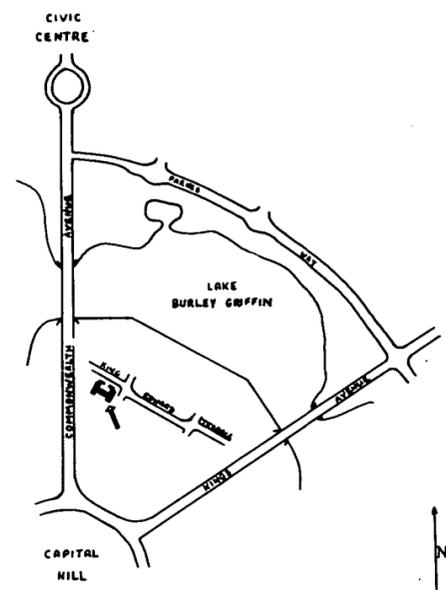
SECRETARIAT SITE
PLAN OF DRILL HOLES.

15, 67 Number of drill hole
 Depth to limestone (feet).
U-U' Line of geological cross-section.

The Secretariat building is located near the junction of King Edward Terrace with Commonwealth Avenue, Canberra, A.C.T. (see Plate A9-1). The building consists of five sections, designated A, B, C, D, and E; Section A has seven storeys, Sections B and C have six storeys each, and Sections D and E are three-storey wings to the main building. Construction is being carried out in two stages, the first of which was completed early in 1967. Piling for the foundations of the second stage (Sections C, D and E) started in August, 1967.

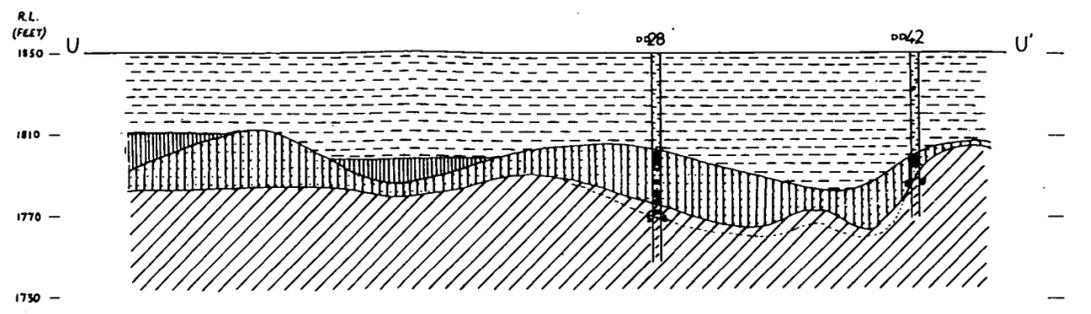
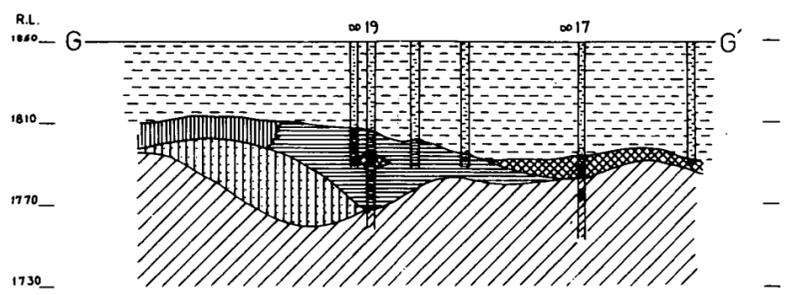
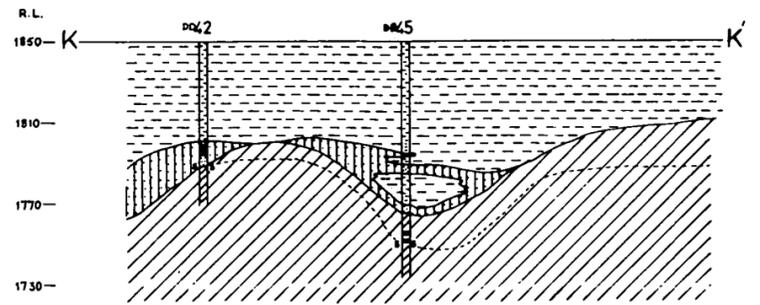
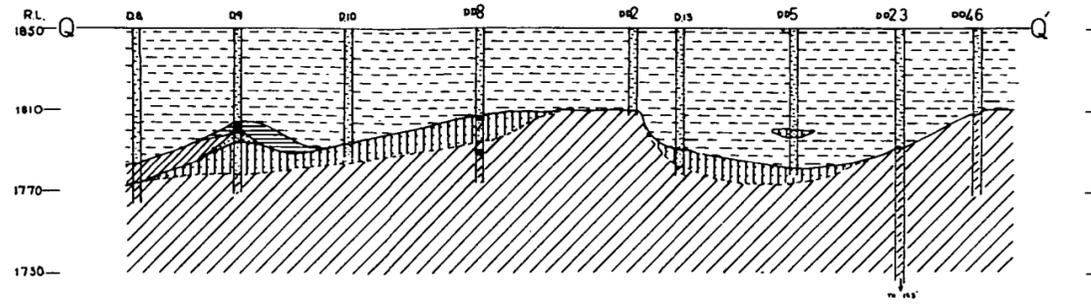
- Brown & yellow-brown weathered shale.
- Grey-green & grey shale.
- White leached shale.
- Brown weathered limestone.
- Slightly weathered limestone, stained brown near solution joints.
- Massive, blue-grey fresh limestone.
- Cavity.
- Black carbonaceous siltstone.
- DD5 Drill hole (triple tube core barrel).
- DD9 Drill hole (single tube core barrel).
- 19 Drill hole, numbered as on accompanying plan.

In some areas, the shale and clay have been bleached white or pale grey by percolating mineral solutions. Bleaching is particularly common below Section D and the northern end of Section B. In other areas, bleaching is commonly restricted to a few joint planes. Partial bleaching was also noted in a few drill holes.

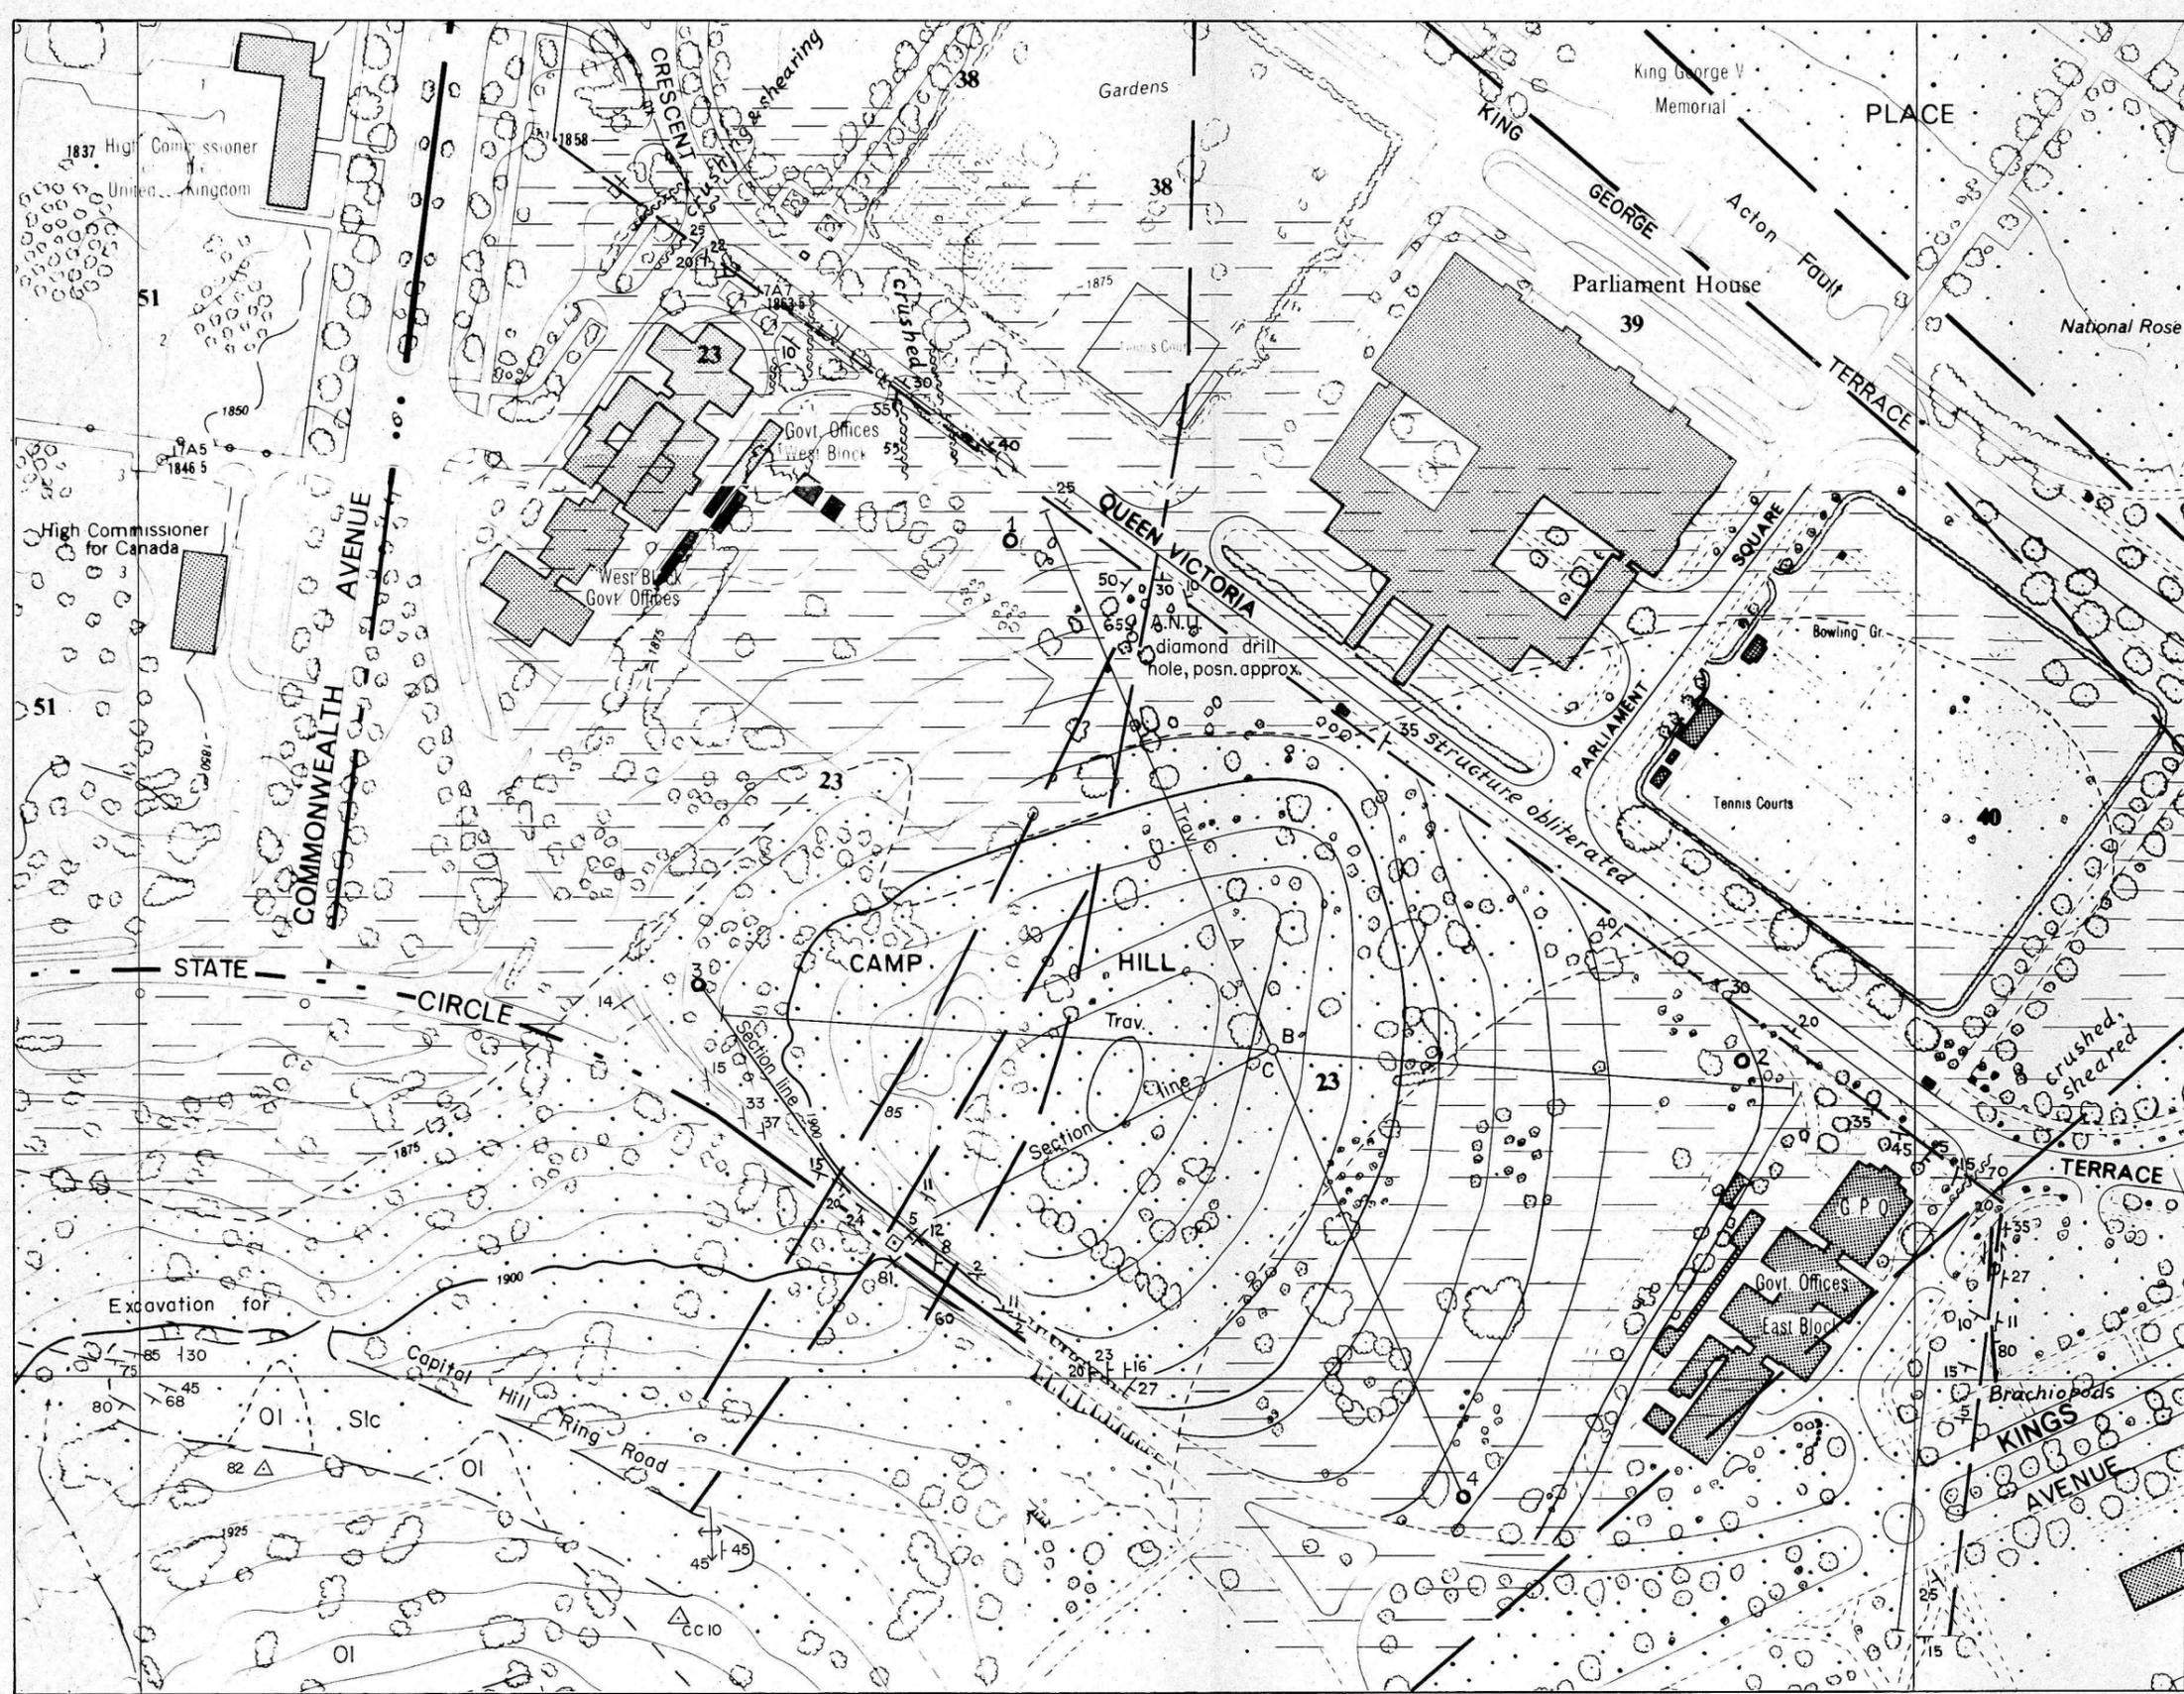
- Shale
- Sandstone
- Dip and Strike of Bedding
- Shear Zone
- Surface Trace of Sewer Tunnel
- Seismic Traverse
- Diamond Drill Hole

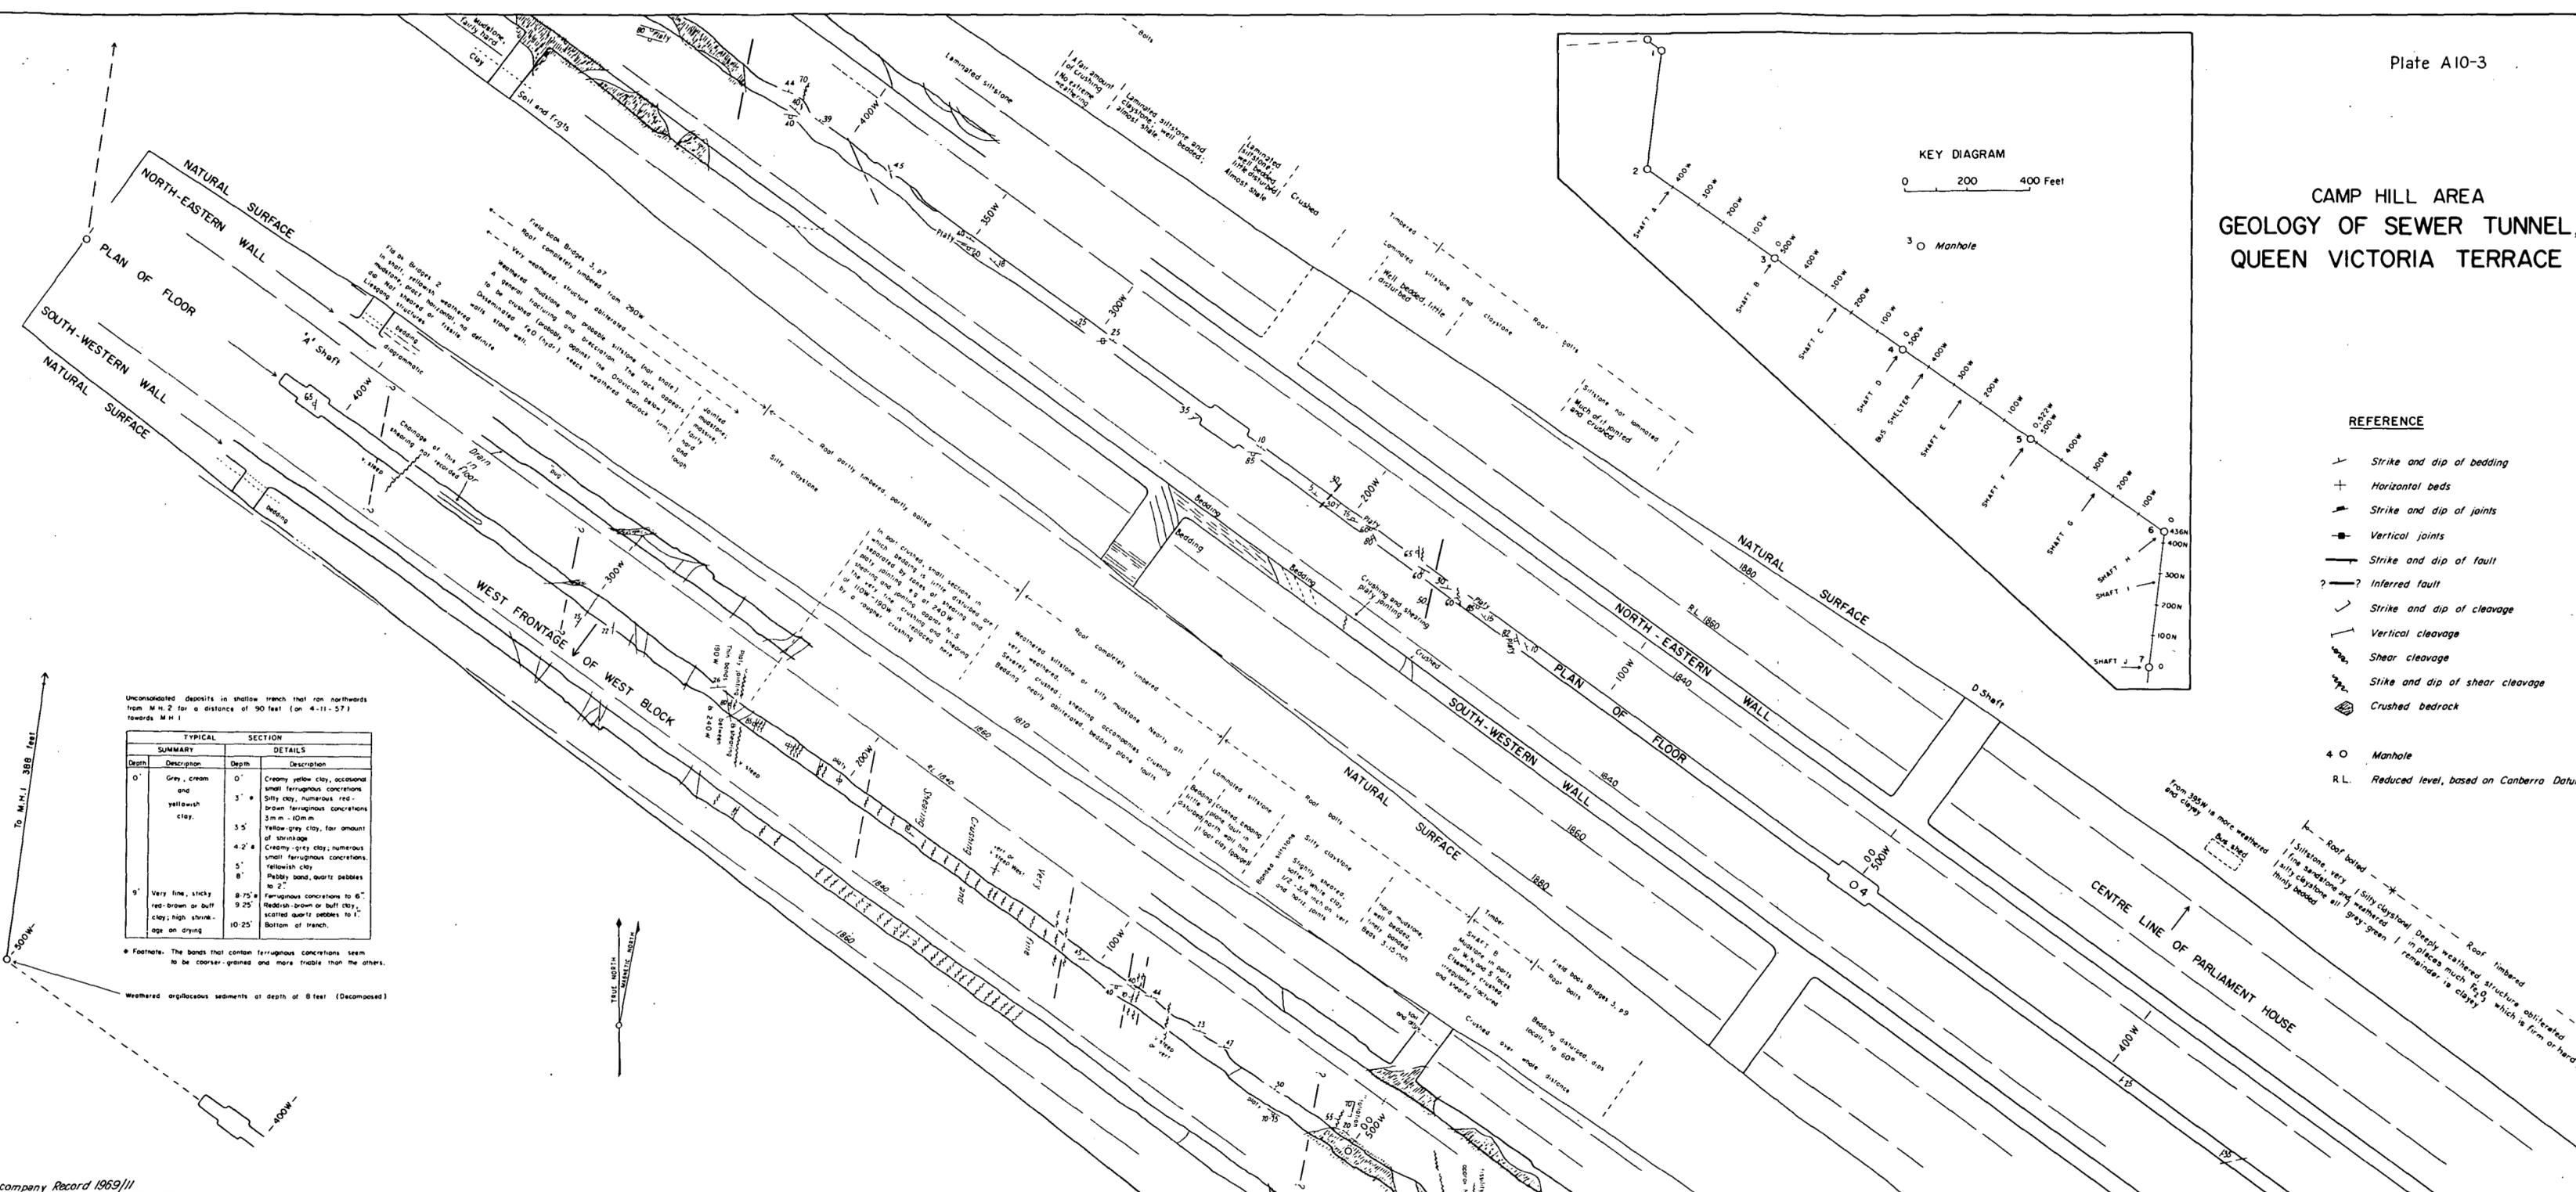
- Strike and dip of bedding
- Horizontal beds
- Strike and dip of joints
- Vertical joints
- Strike and dip of fault
- Inferred fault
- Strike and dip of cleavage
- Vertical cleavage
- Shear cleavage
- Strike and dip of shear cleavage
- Crushed bedrock
- Manhole
- Reduced level, based on Canberra Datum

Unconsolidated deposits in shallow trench that ran northwards from M.H. 2 for a distance of 90 feet (on 4-11-57) towards M.H. 1

SUMMARY		DETAILS	
Depth	Description	Depth	Description
0'	Grey, cream and yellowish clay.	0'	Creamy yellow clay, occasional small ferruginous concretions
		3'	Silty clay, numerous red-brown ferruginous concretions 3mm - 10mm
		5.5'	Yellow grey clay, fair amount of shrinkage
		4.2'	Creamy grey clay; numerous small ferruginous concretions, reddish clay
		5'	Pebbly sand, quartz pebbles to 2"
		8'	
		8.75'	Ferruginous concretions to 6"
		9.25'	Reddish-brown or buff clay, scattered quartz pebbles to 1"
		10.25'	Bottom of trench.
