BUREAU OF MINERAL RESOURCES, GEOLOGY AND GEOPHYSICS

SUMMARY NOTE ON THE GEOLOGY OF THE CENTRAL
AND CAPITAL HILL AREAS OF CANBERRA.

Record 1969/38

Plate 1 : Geological map of extended Central Area,
Canberra. Scale 1 inch : 1000 feet.

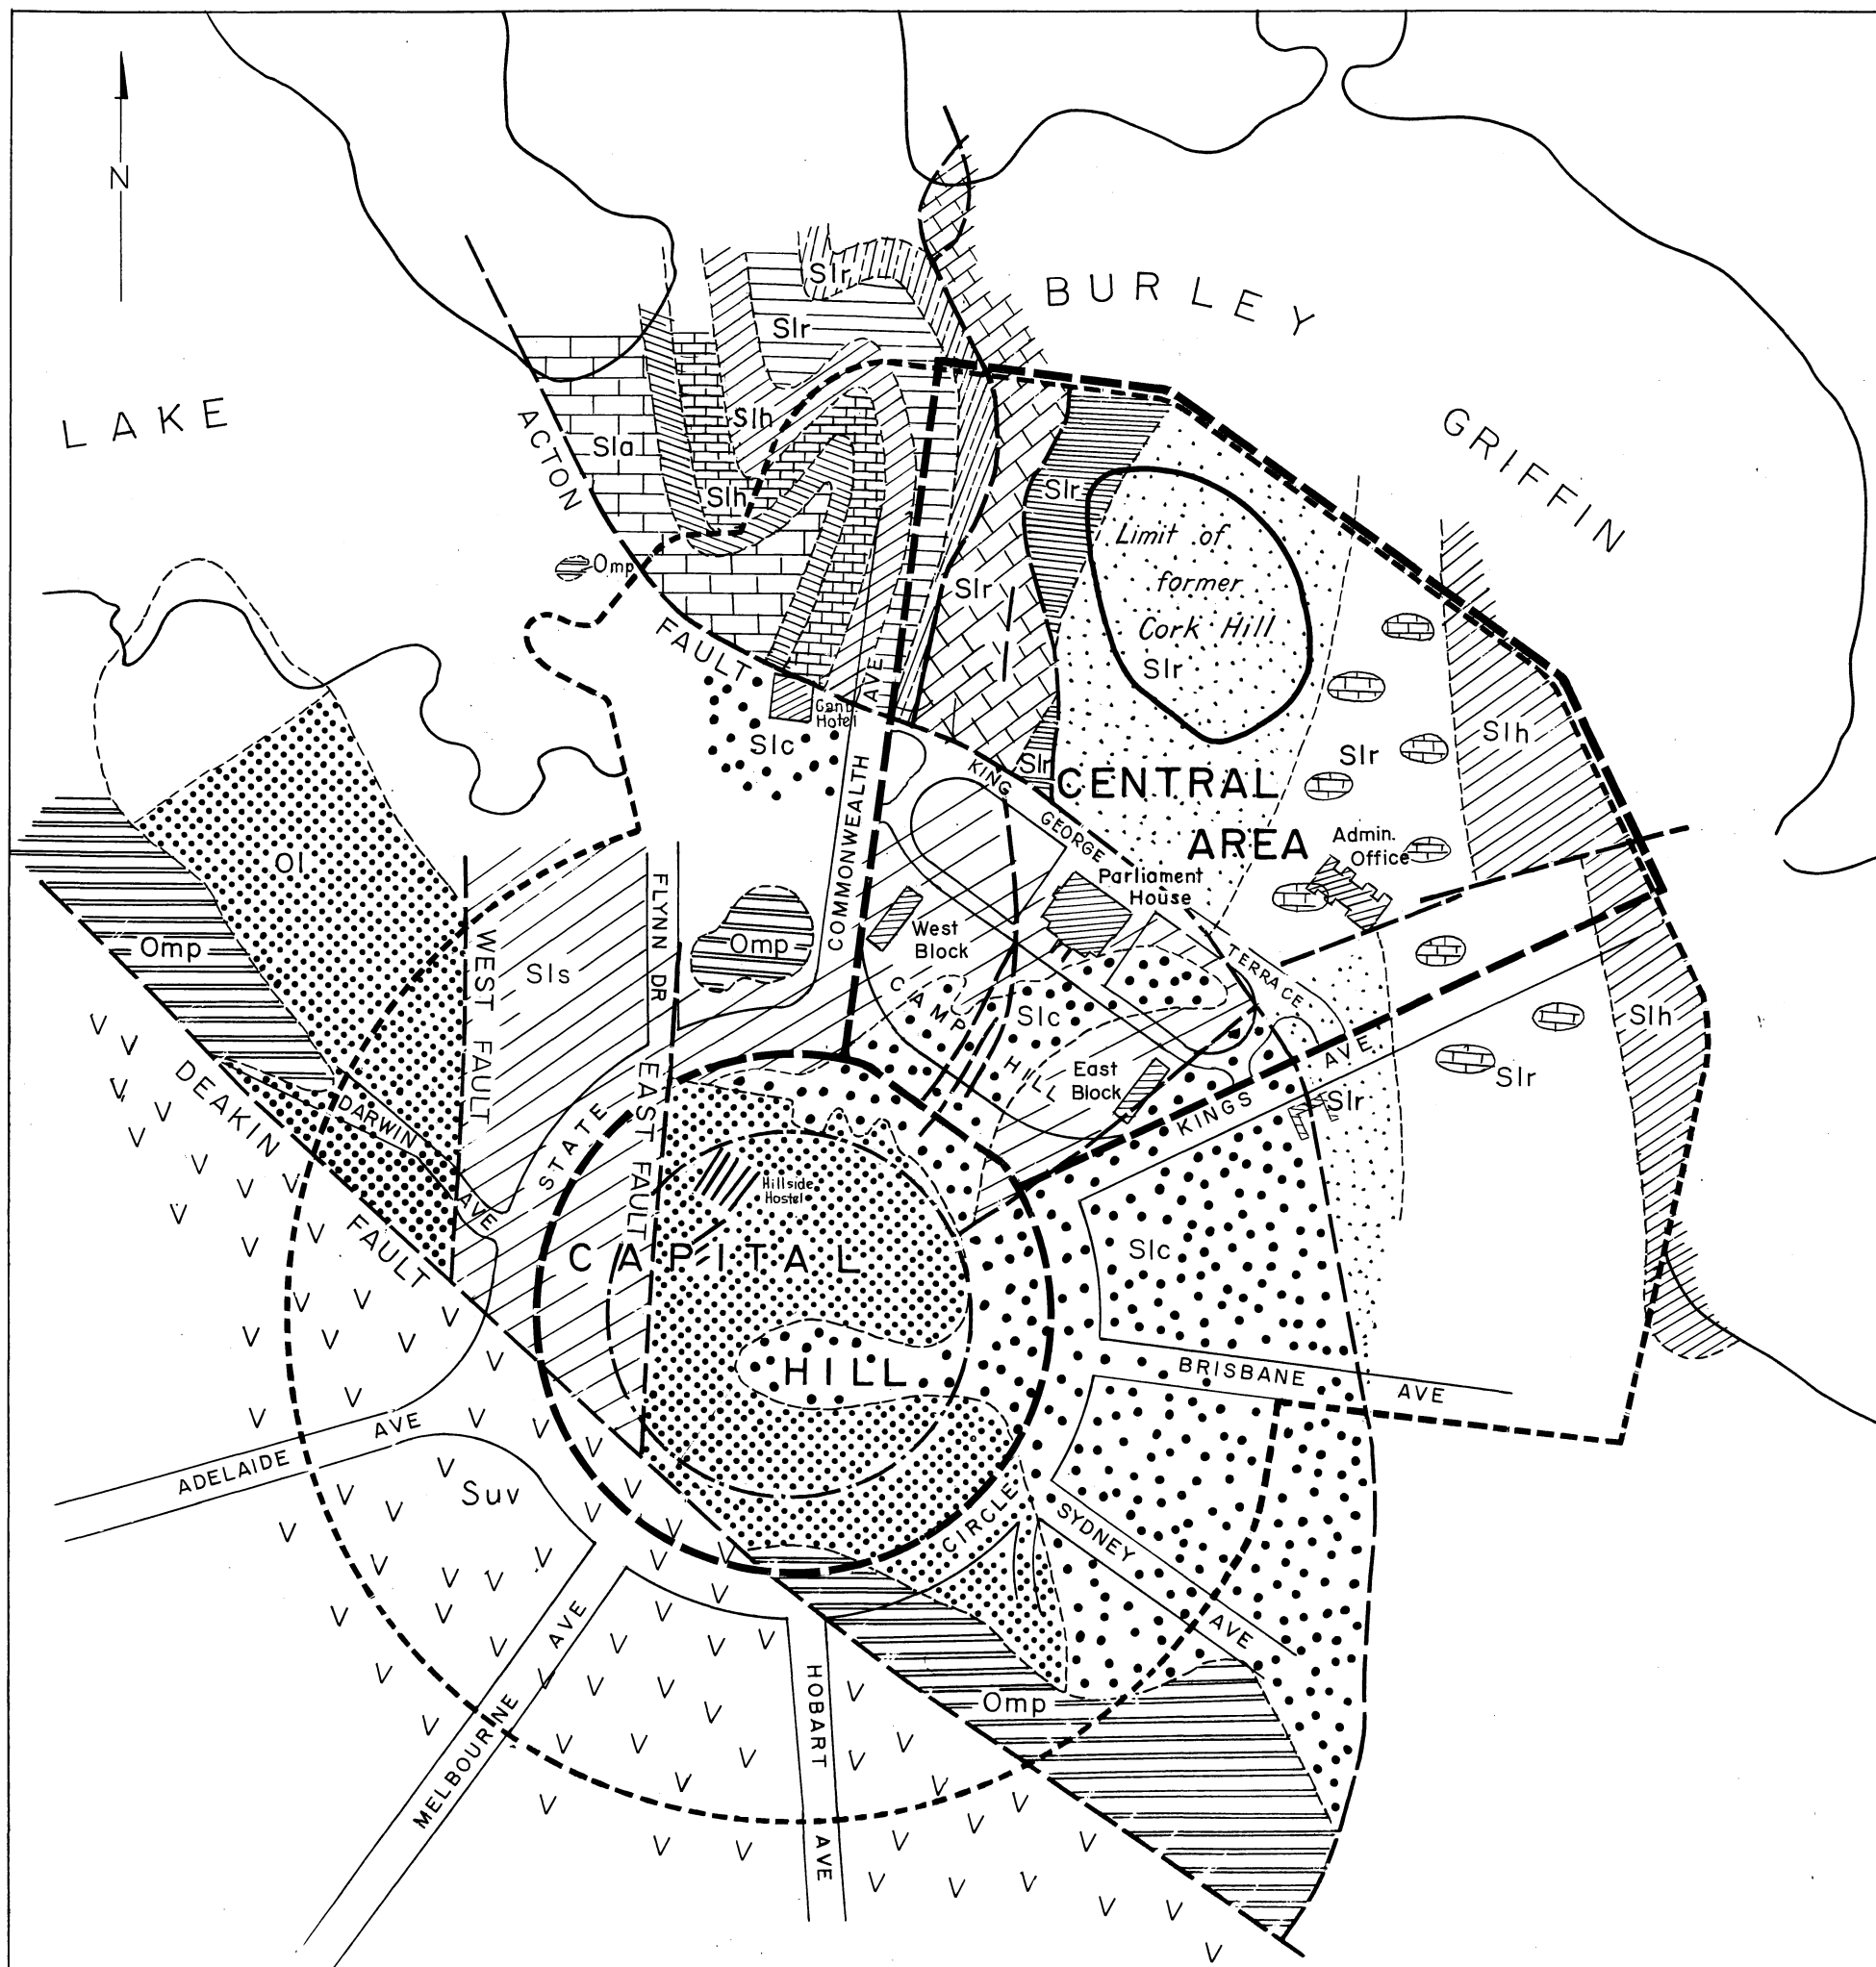
- Fault
- - - Geological boundary, generally approximate
- - - - Boundary of extended central area
- - - - Boundaries of Central and Capital Hill Areas
- - - - Proposed ring road
