BUREAU OF MINERAL RESOURCES, GEOLOGY AND GEOPHYSICS

Record 1978/83

THE ESTABLISHMENT OF A LEACHATE MONITORING SYSTEM
AT THE WEST BELCONNEN LANDFILL SITE, ACT, 1976-77

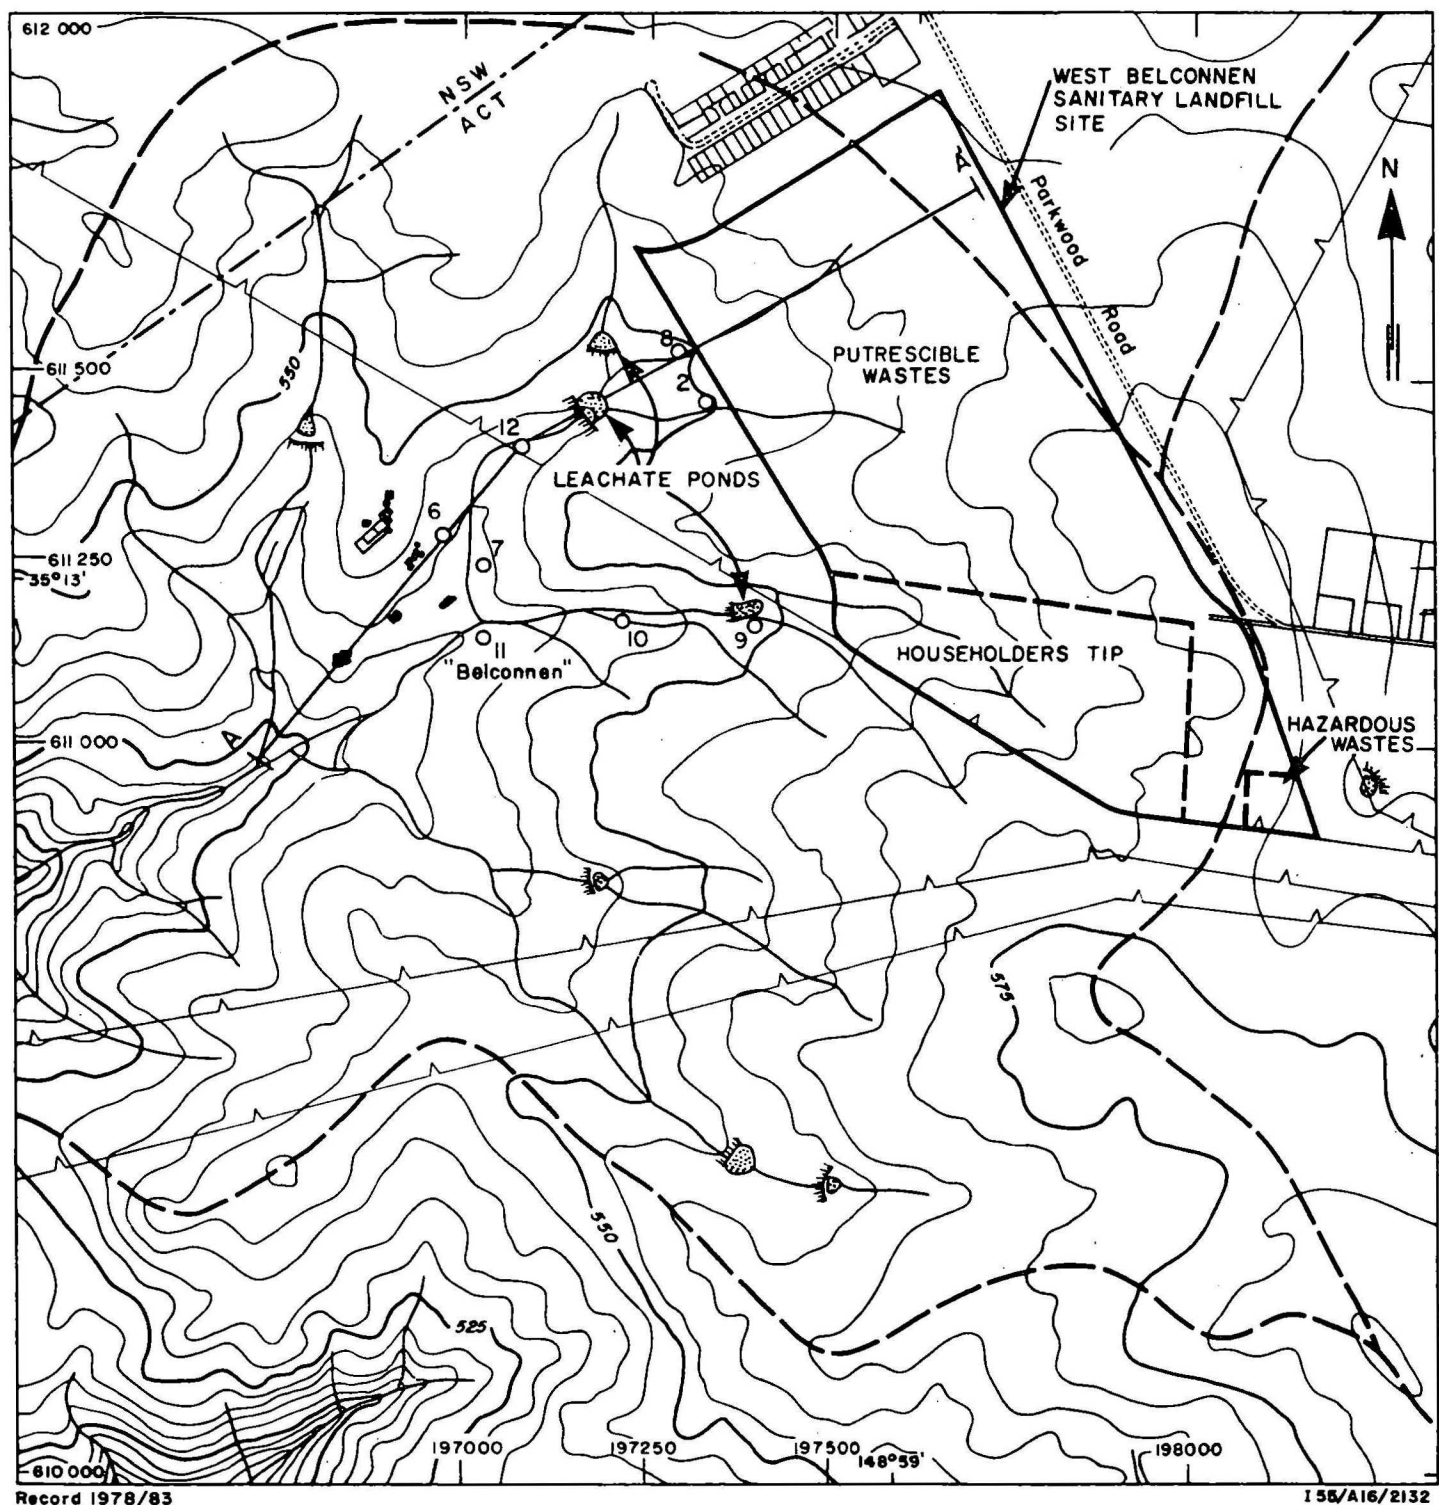
Fig.2 West Belconnen Sanitary Landfill Site

The site (Fig. 2) is about 50 ha in area and is drained to the west by a tributary of the Murrumbidgee River.

Three existing farm dams below the site are intended to serve as leachate collection and evaporation ponds. The monitoring bores have been sited so as to intersect groundwater flow containing leachates.
