Record 1978/99

GEOLOGICAL INVESTIGATIONS FOR THE SULLIVANS
CREEK SEWER TUNNEL, CANBERRA CITY, ACT 1978

P.H. Vanden Broek, D. Ramsay, & G. Sparksman

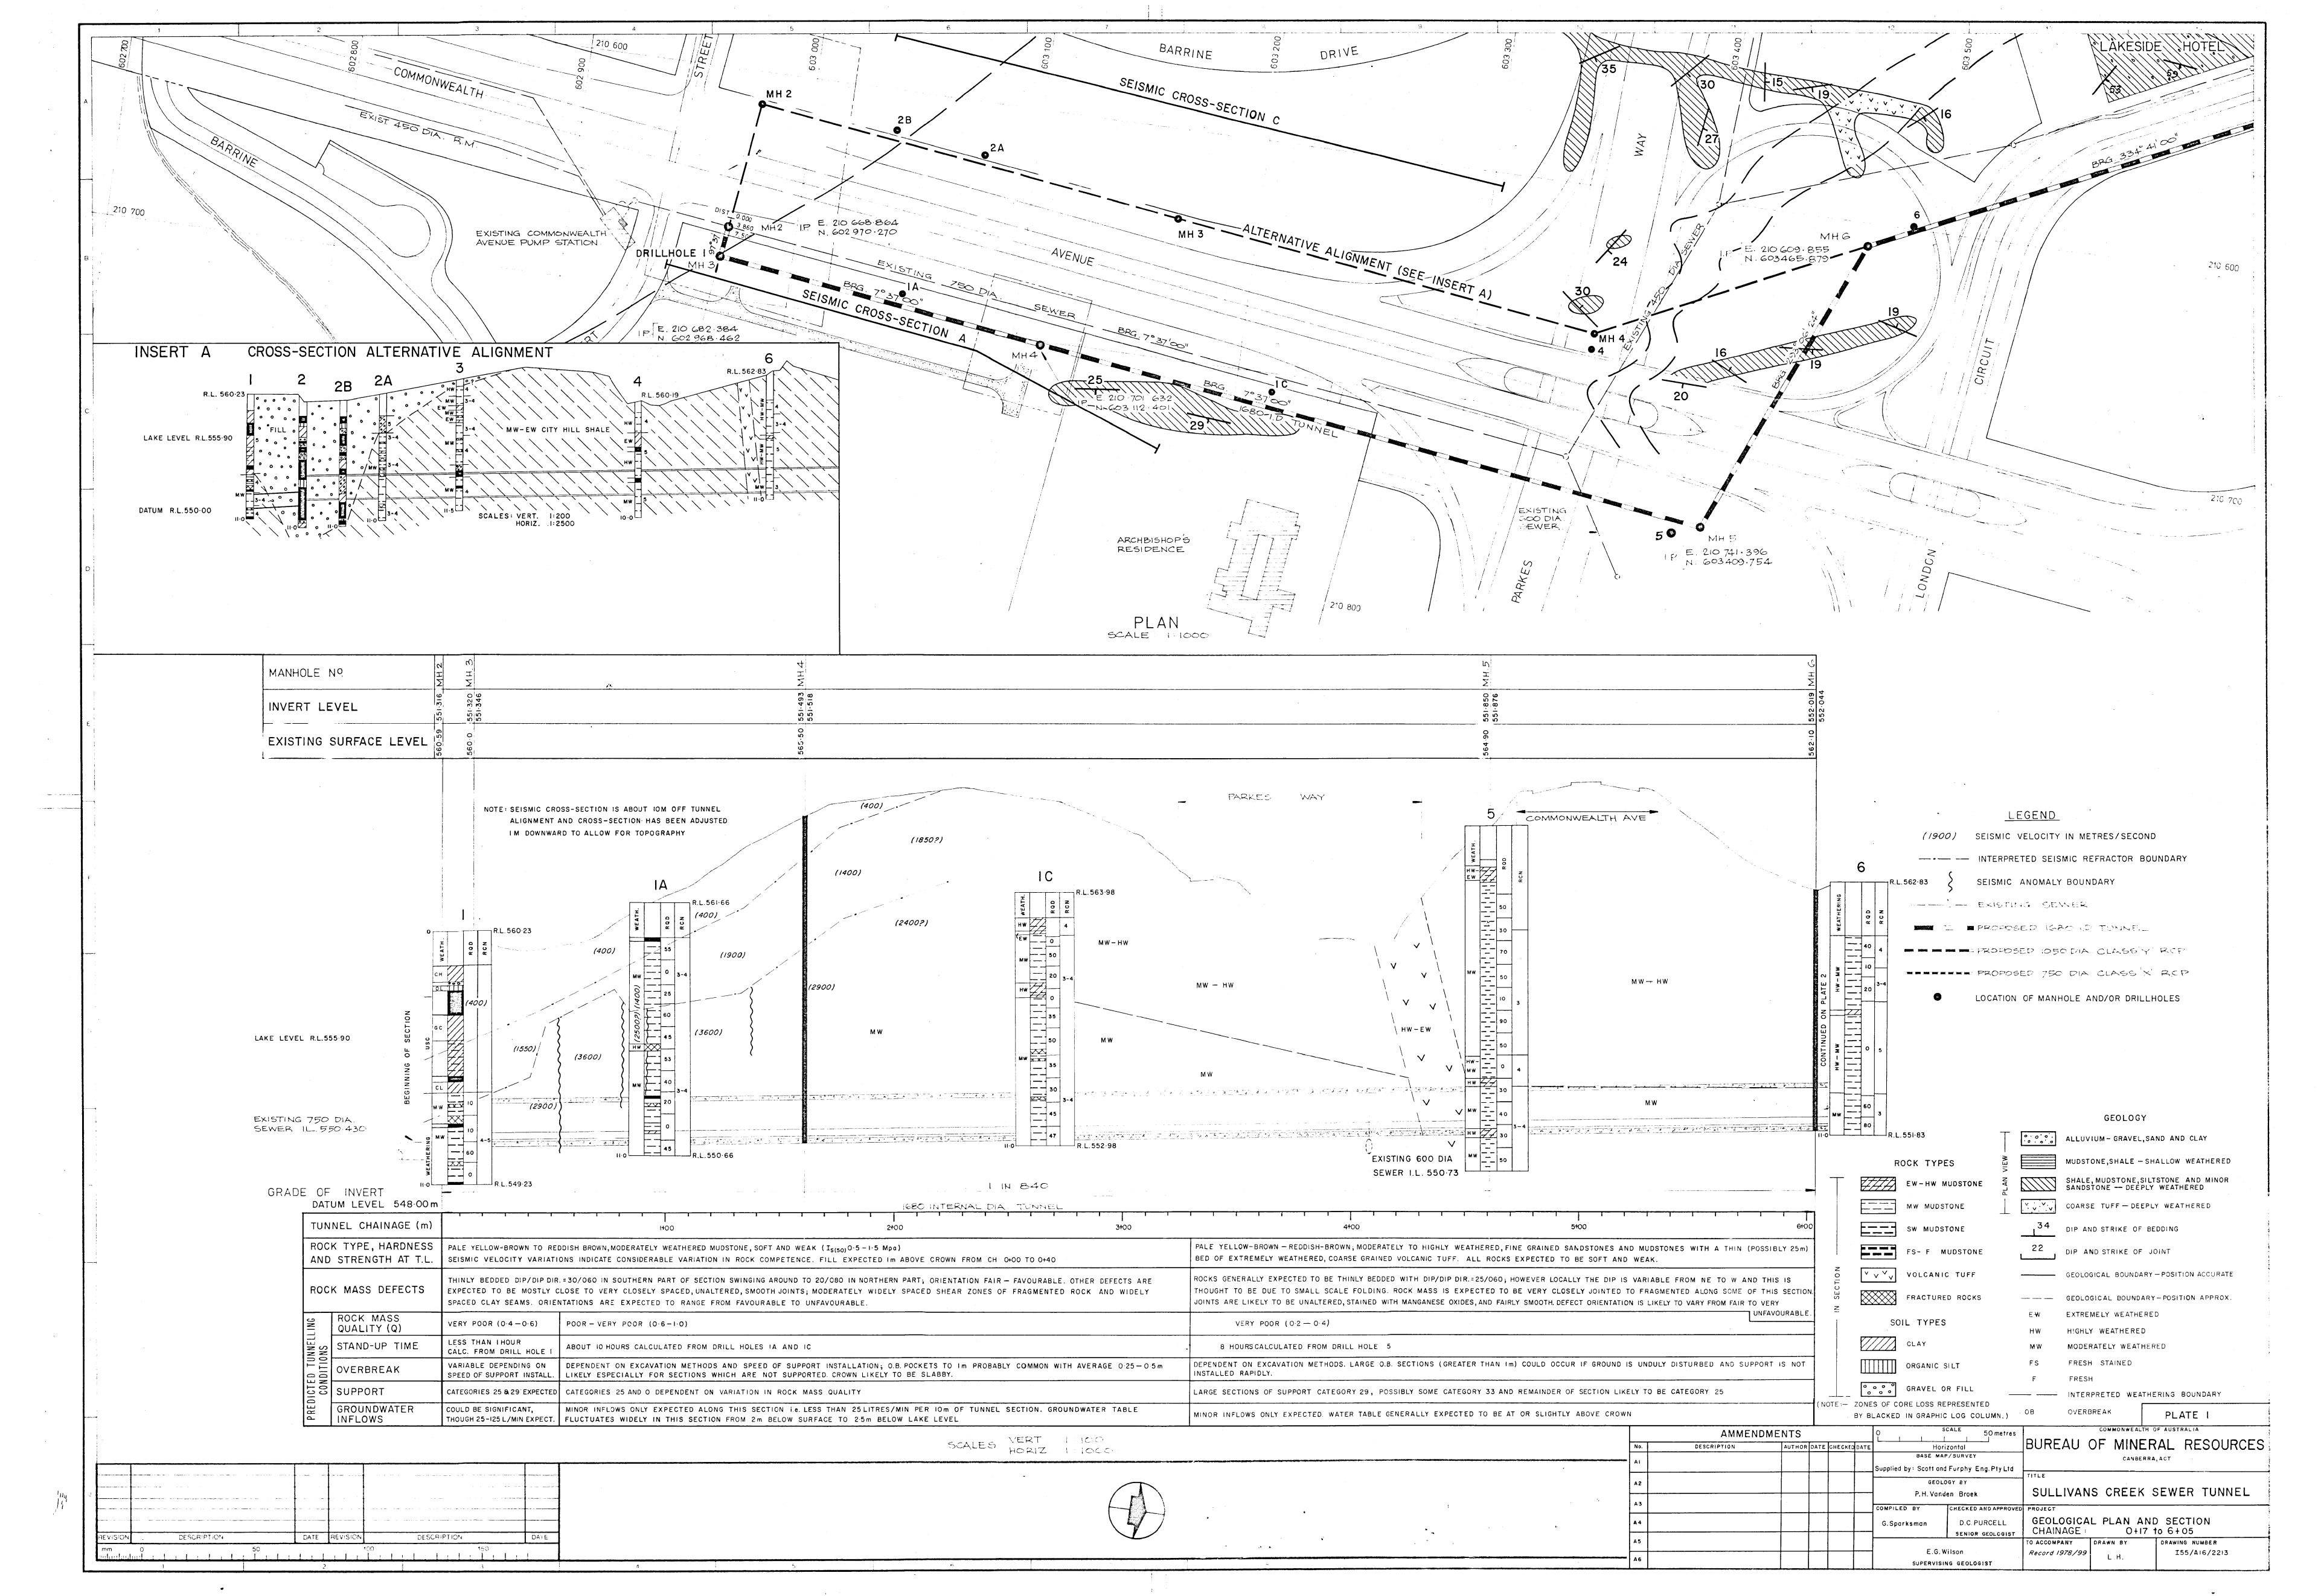
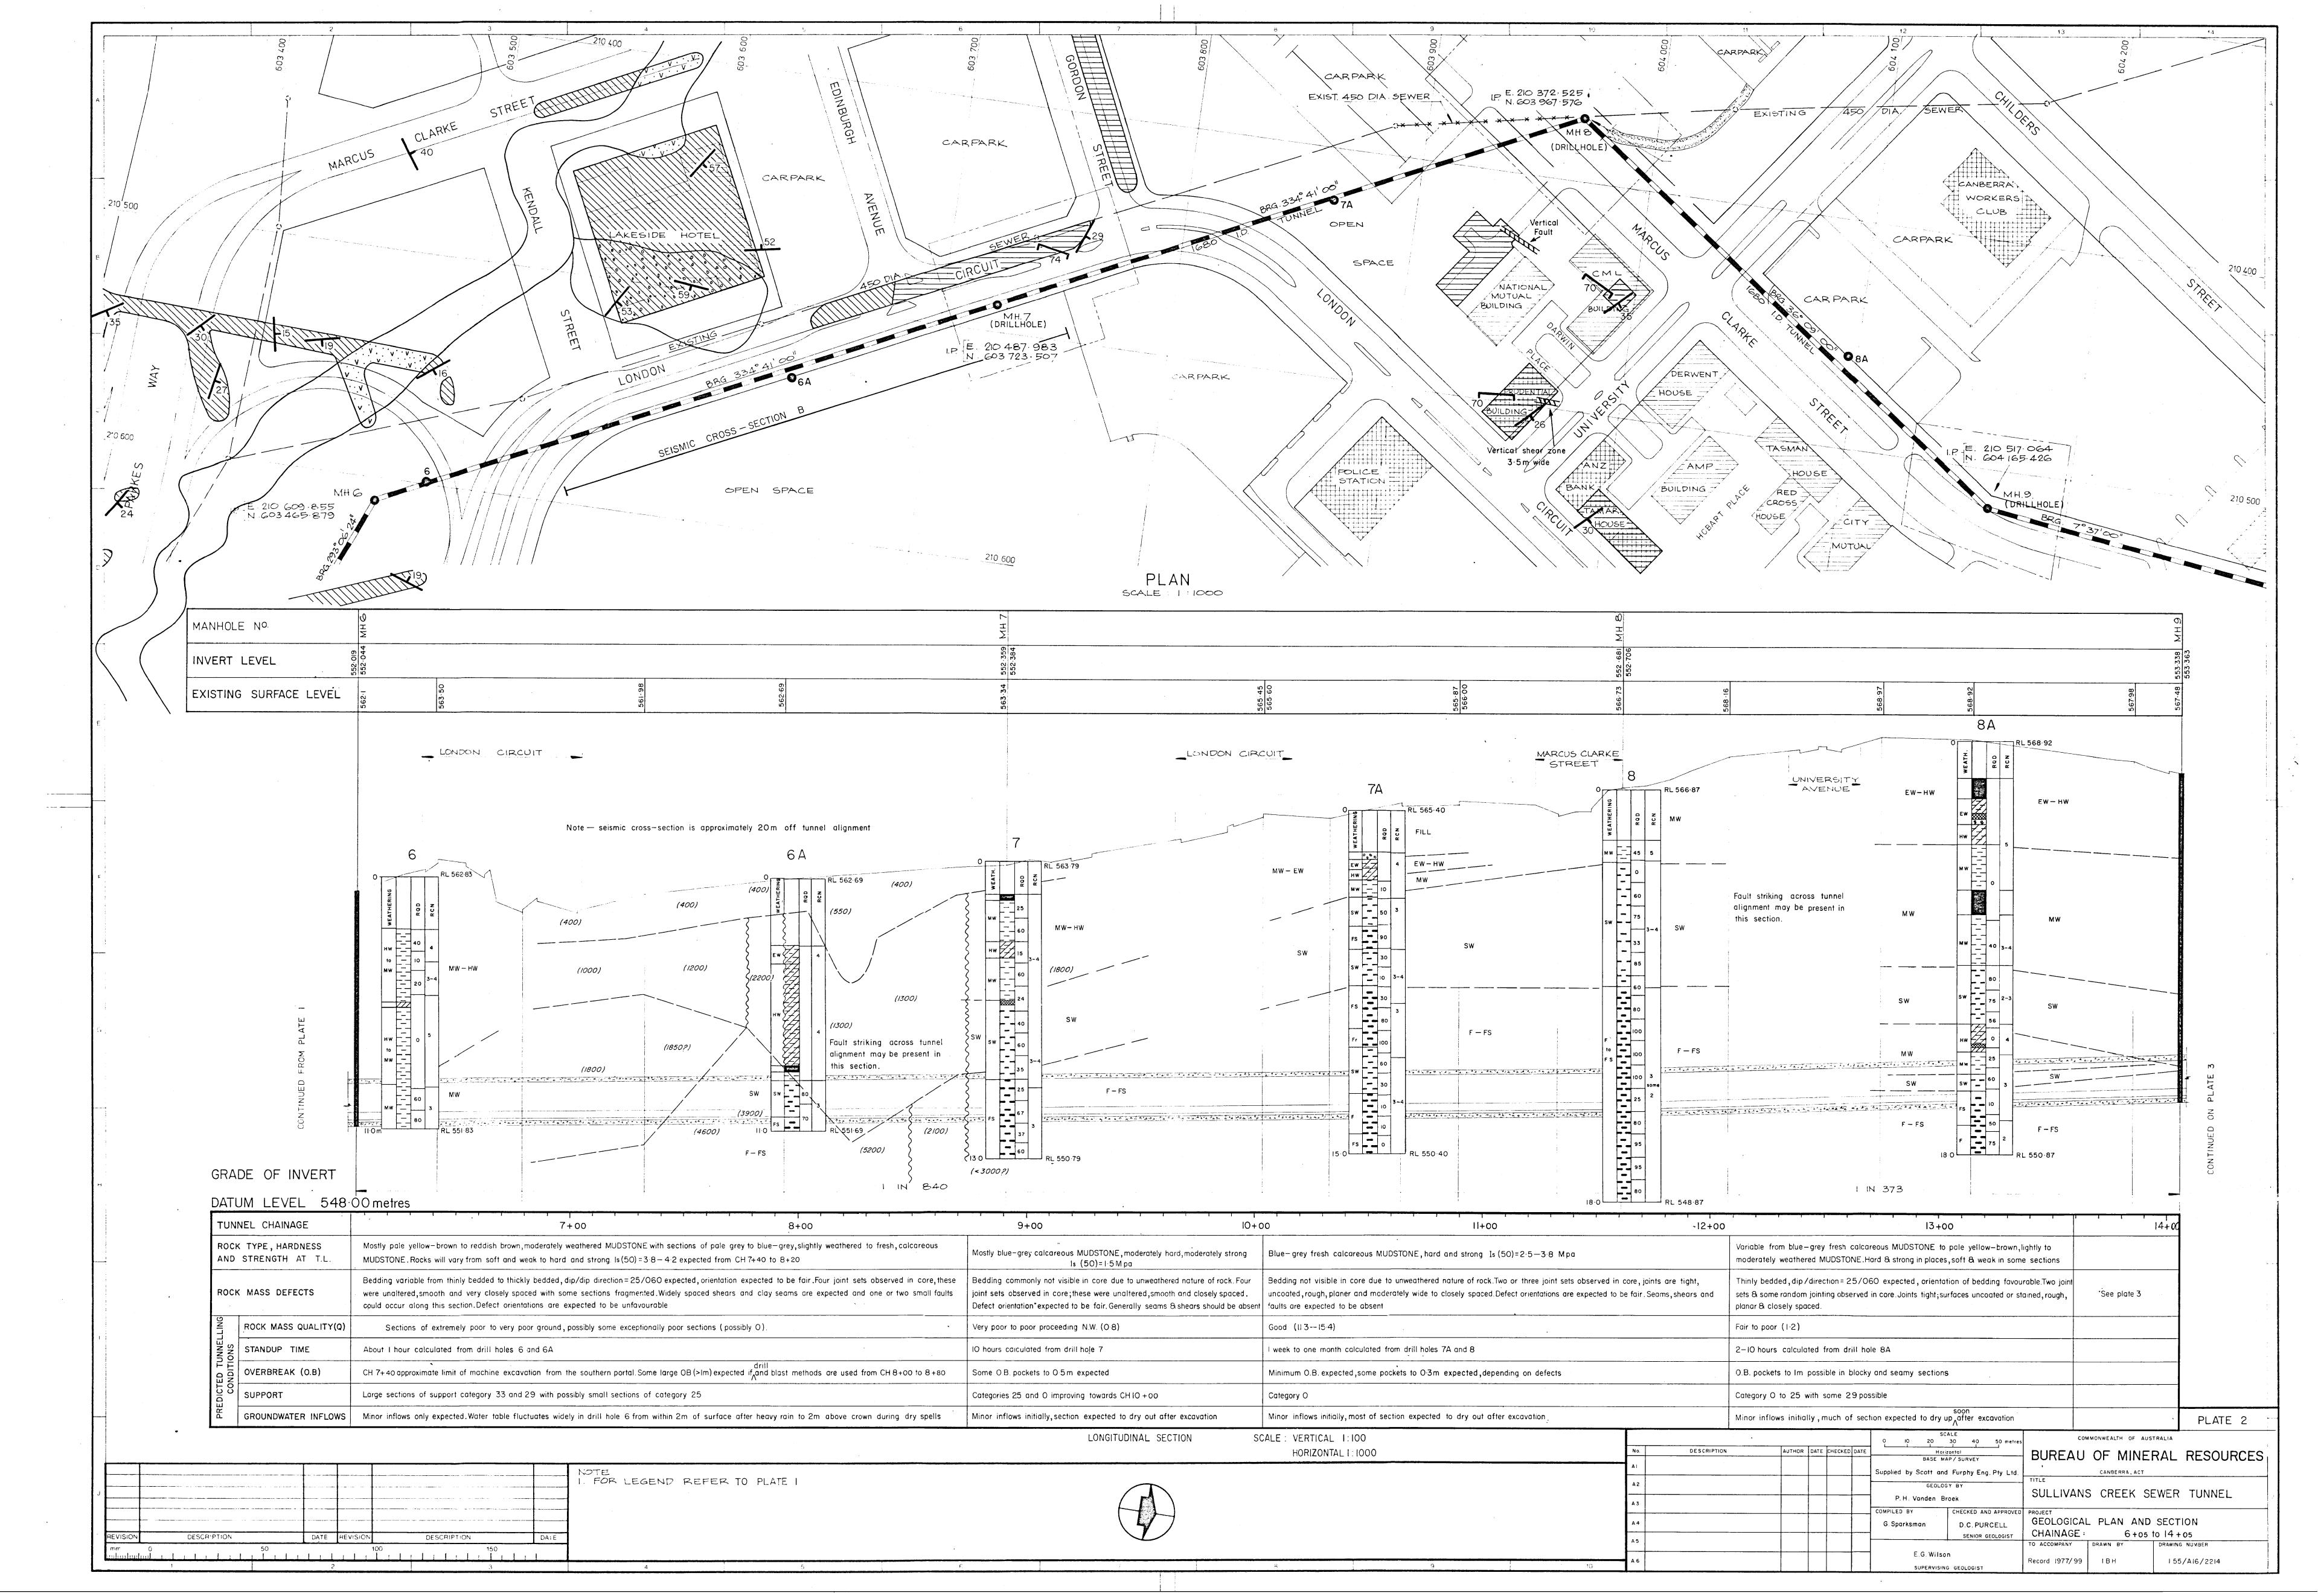
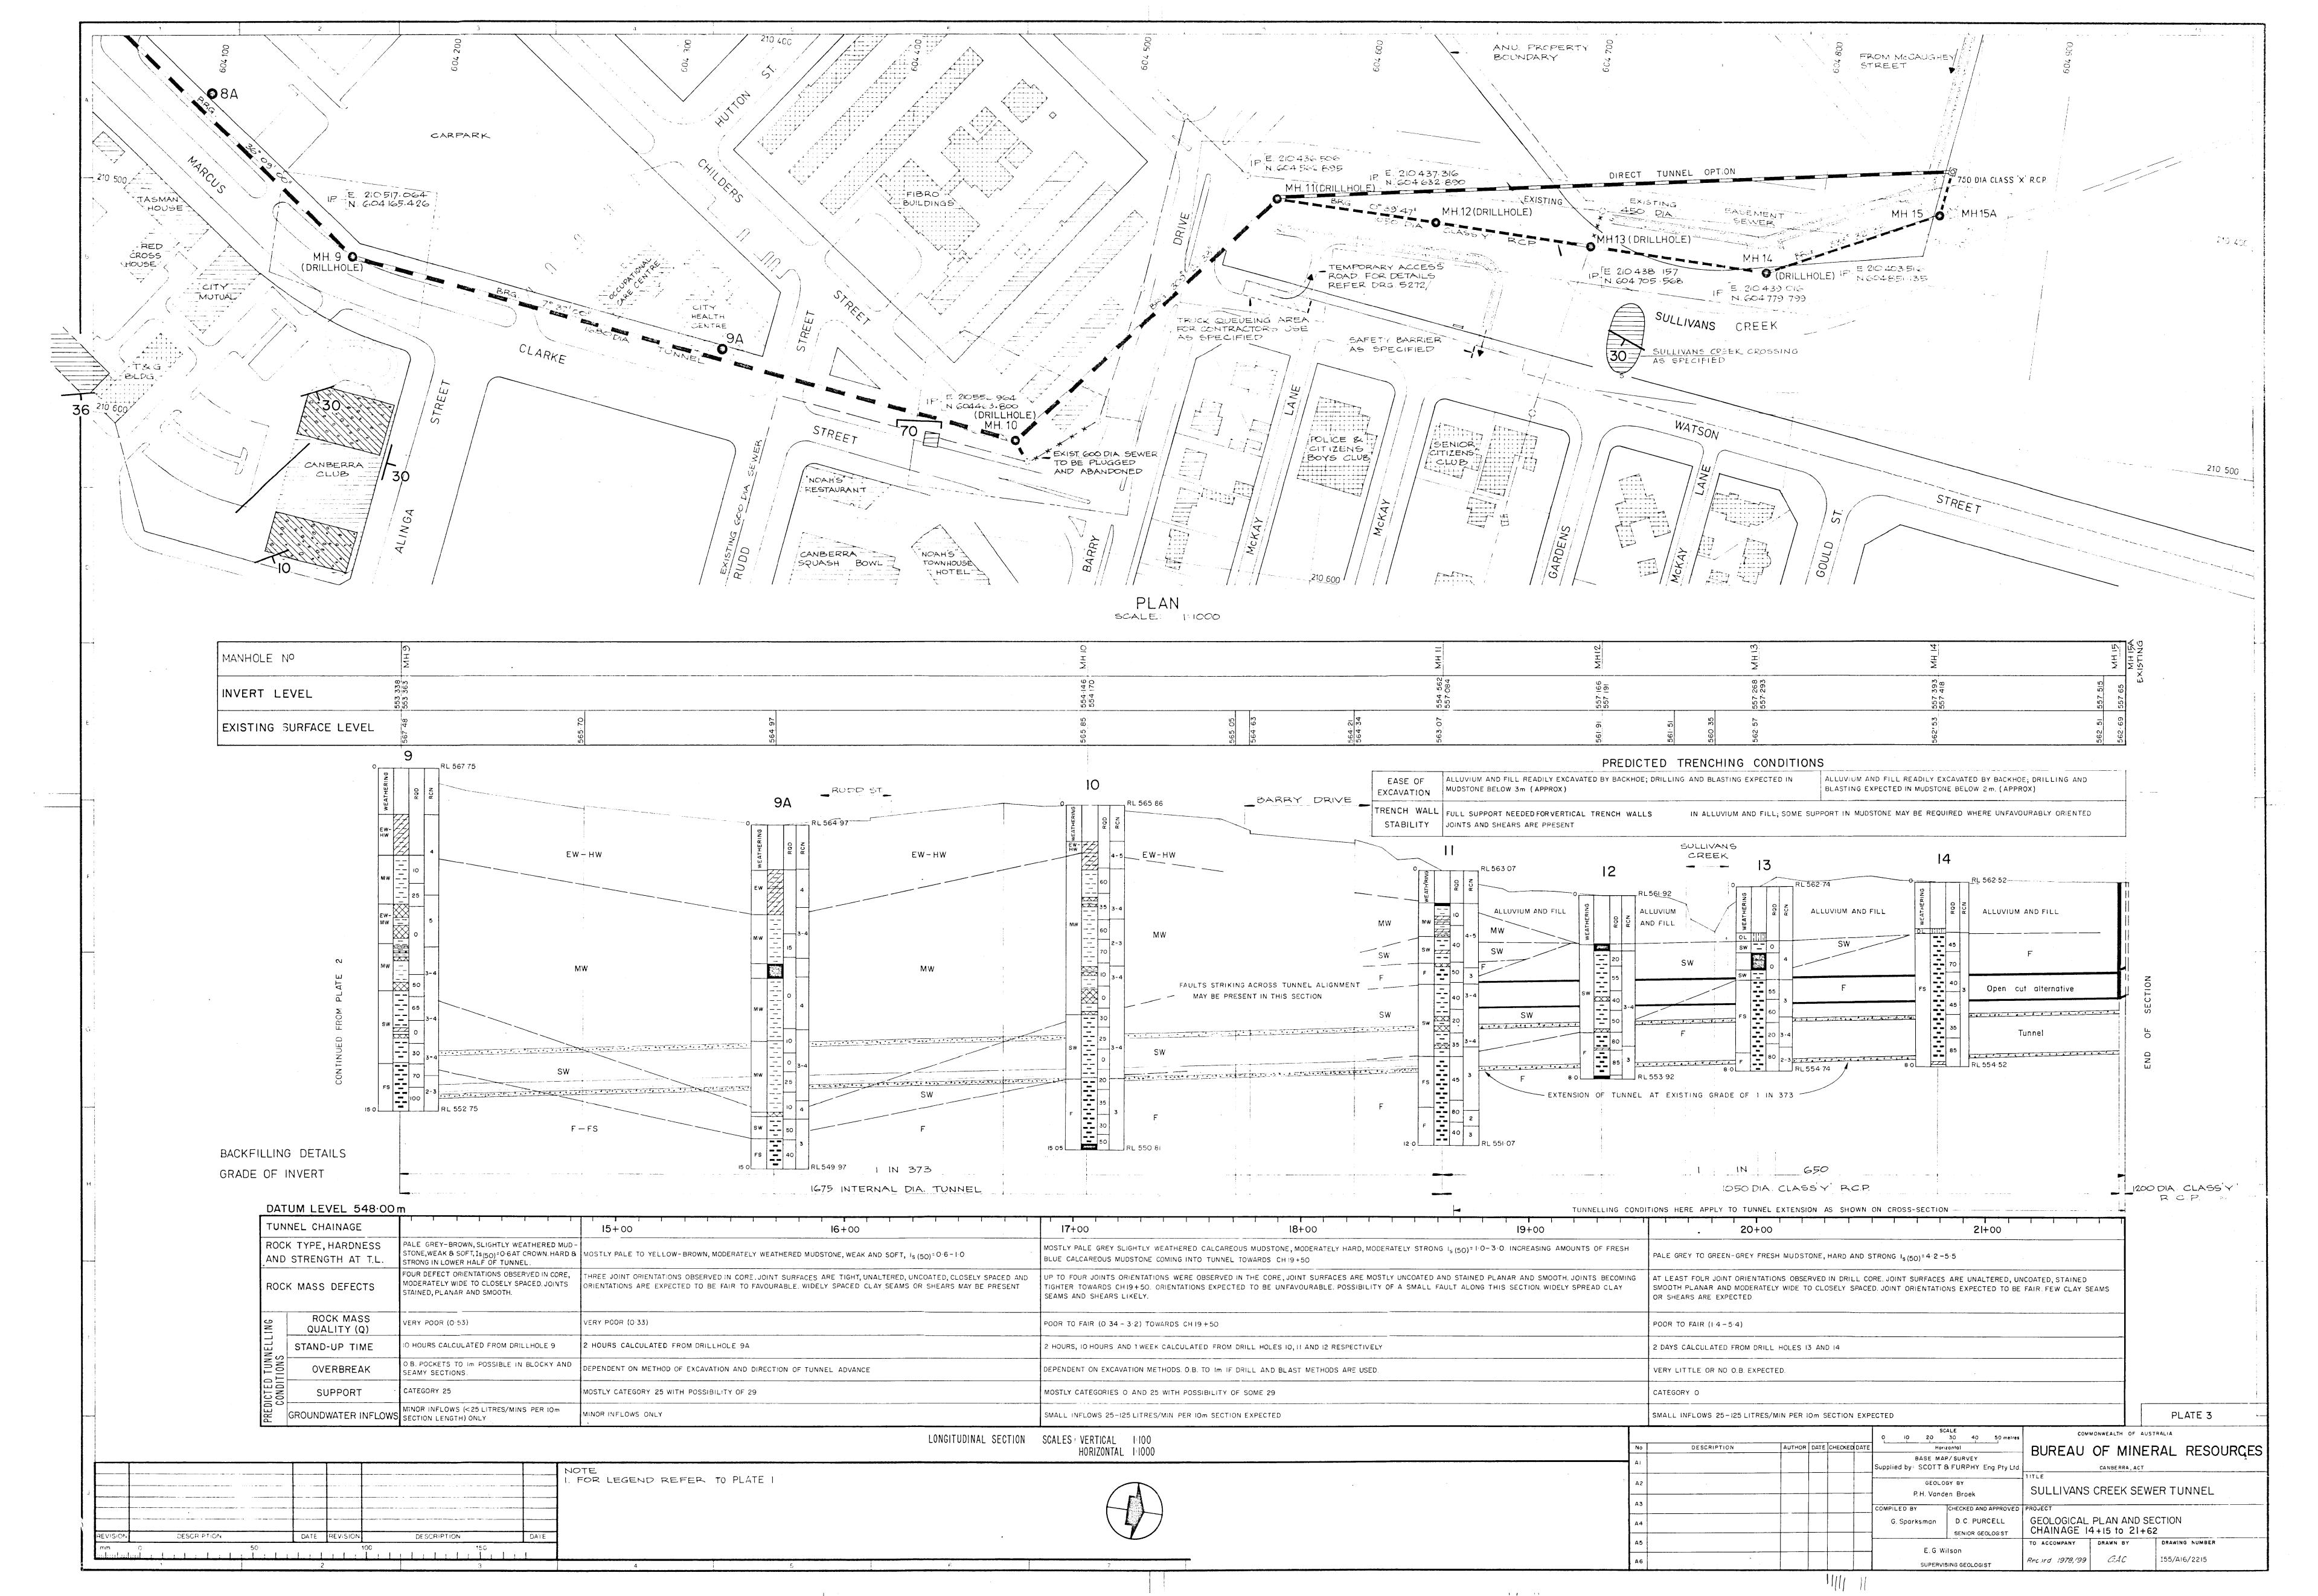
Predicted tunnelling conditions based on a calculated rock mass quality, degree of weathering, standup times, RQD, and RCN are given in Plates 1, 2, and 3. Rock mass quality, roof support pressures, and support requirements at tunnel level have been estimated by using the methods proposed by Barton, Lien, & Lunde (1974), and are set out in Tables 4 and 5.

A tunnelling option is available between manholes 11 and 15 via manholes 12, 13, and 14, and the expected geological conditions are shown in Plate 3. Alternatively a direct tunnelling option is available for the section north of manhole 11, thereby eliminating manholes 12, 13, and 14. The direct tunnel option would diverge by up to 40 m from the proposed alignment; however, from the limited information available, the rock intersected is likely to be similar to that along the proposed alignment, and tunnelling conditions would not be expected to diverge greatly from those of the proposed alignment.
