CONDITIONS IN THE CANNING BASIN DESERT.

D.M. Traves & J.N. Casey

Records 1954/56

This record gives a brief account of the conditions encountered in a geological reconnaissance of the south-western portion of the Canning Basin - an area covered mostly by sand and seif dunes, interspersed by scattered low rock outcrops.

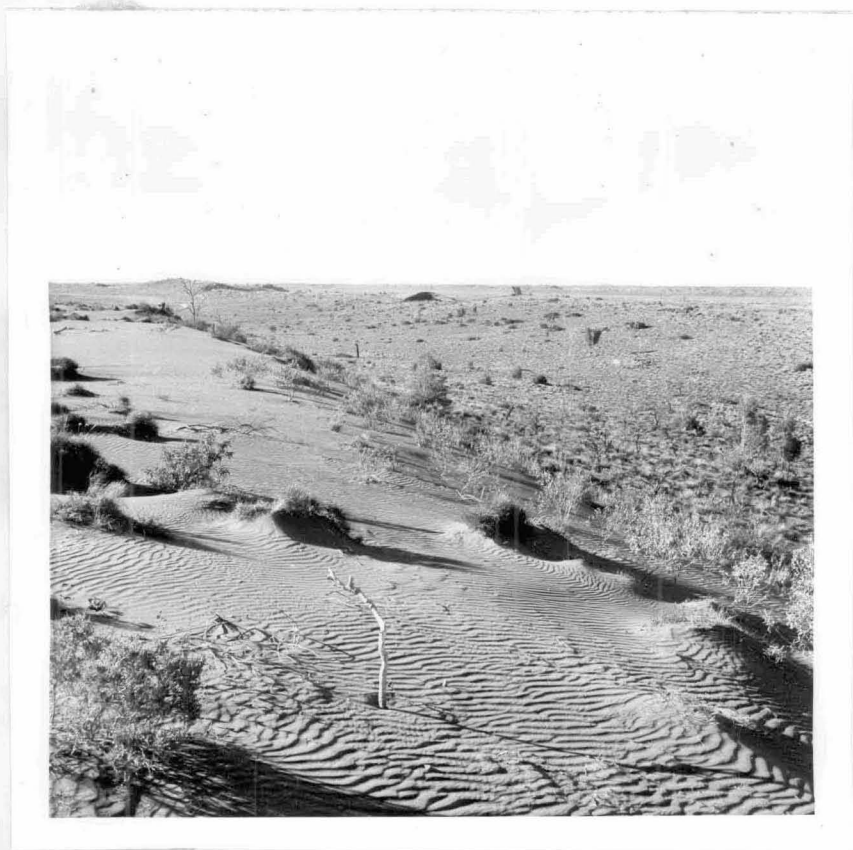
Sand dunes west of Mt. Crofton looking SSE. The  
summit is usually only partially fixed, and there is  
a tendency for the sand to move towards the west.

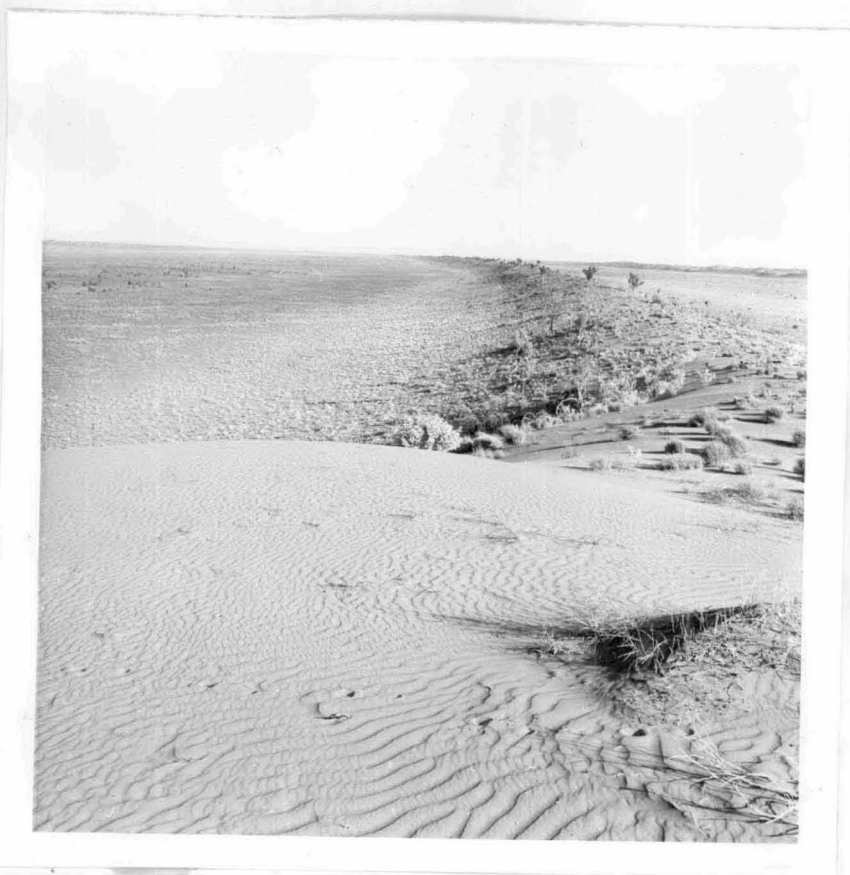
Sand dunes west of Mt. Crofton looking NW. Height of the dune here is 120 ft. The troughs between the dunes are flat and covered with spinifex and sand; after a fire the humps of sand are flattened and travelling becomes fair.

Where the dunes are high, defined and persistent, and spaced about half a mile to a mile apart, the inter-dune travelling is fair, and distances up to 45 miles were covered per day. The closer the dunes, the rougher and slower the travelling. On recent fire burns, the hummocked sand around spinifex clumps has been dispersed and travelling is good.

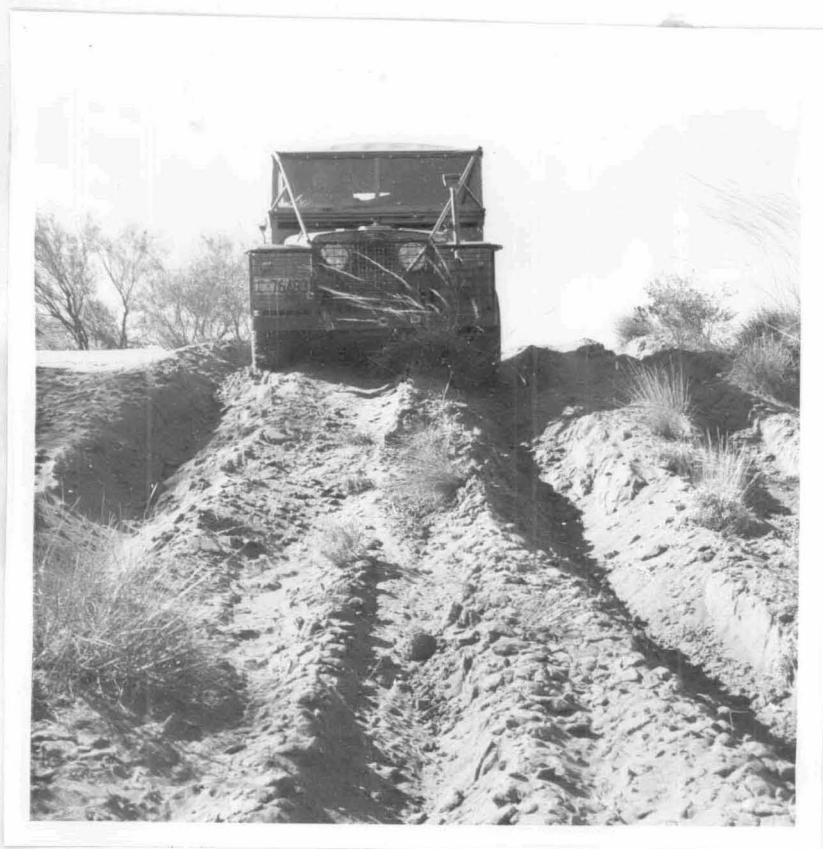
The Landrover descending a dune. There is a certain amount of "surface compaction" on the dune, but if this is broken, the sand is soft and slightly damp underneath. This is shown in this photo where the Commer truck had crossed leaving deep tracks of fine, soft, red sand.

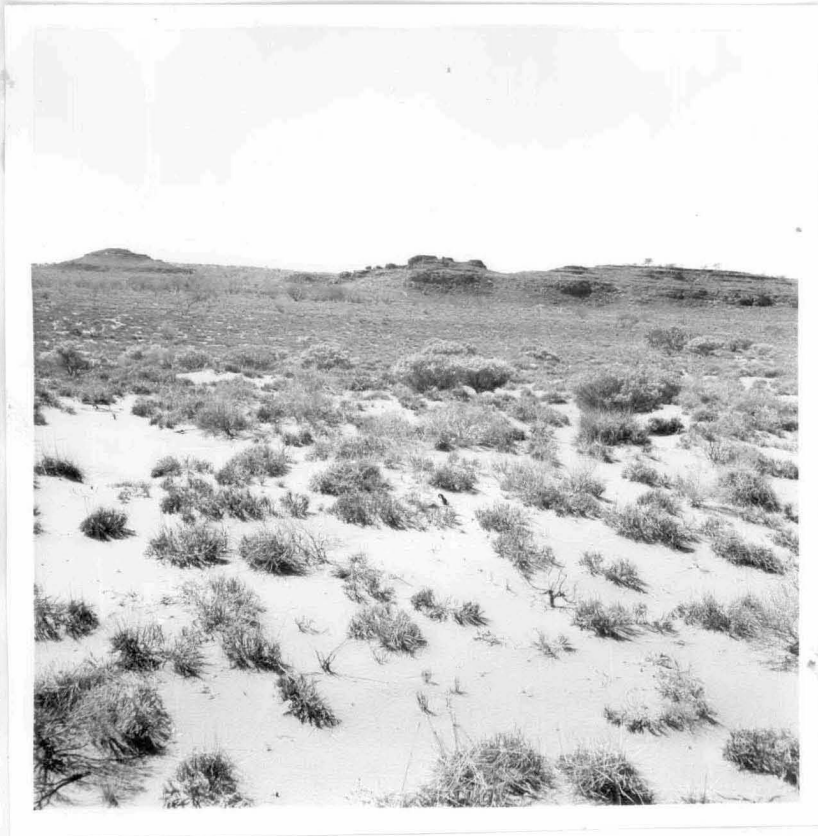
East of Lake Woolloomber, showing typical Mesozoic outcrops of ferruginized sandstone 120 ft. high. The foreground is the end of a dune. There is a small rock hole on the top of the outcrop at right hand side of the photo.

These were found on the top of flat-topped hills in areas of Permian and Mesozoic outcrop. They have a small opening at the surface - about 6 ins. to 1 ft. in width and 2 ft. to 3 ft. long with a depth of 3 ft. to 4 ft. They generally contain only a small supply of water, varying from dry to about 40 gallons. The supply is obtained by natural catchment of rainwater.

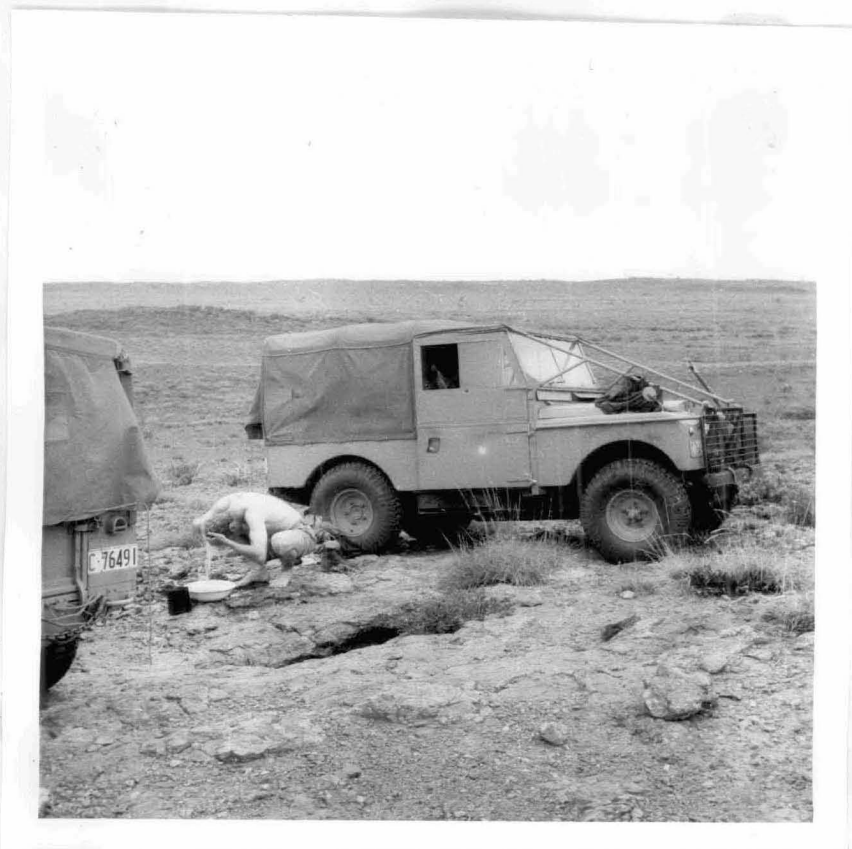
At a small rock hole on the top of a flat topped Mesozoic hill, east of Lake Waukarlycarly.

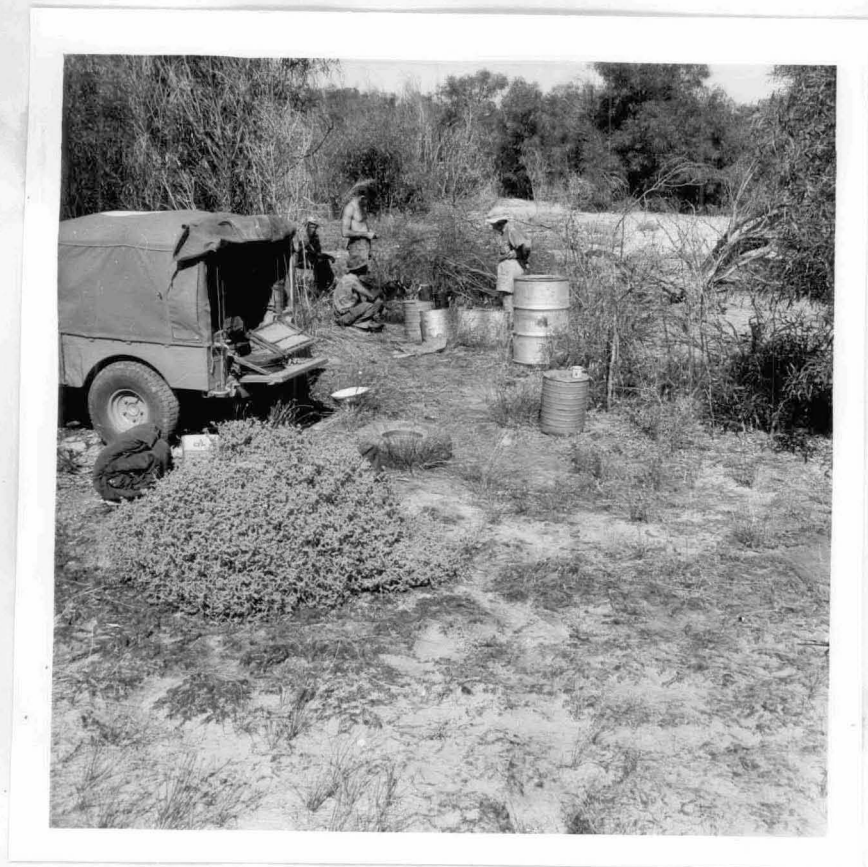
Dunn's Soak, 5 miles east of Lake Dora. Surrounded by very green and large broad-leaved Acacia trees. Yield of 60 g.p.h. of excellent water. Soak is at the junction of the Permian sandstone and underlying shale.

A number of soaks were found which yielded a good supply of water when cleaned out. Dunn's Soak, 3 miles east of Lake Dora, when cleaned out and cased with a 44 gallon drum with the ends removed, yielded 60 gallons of good drinking water per hour. The soaks should be dug out in the evening and allowed to build up and settle overnight.

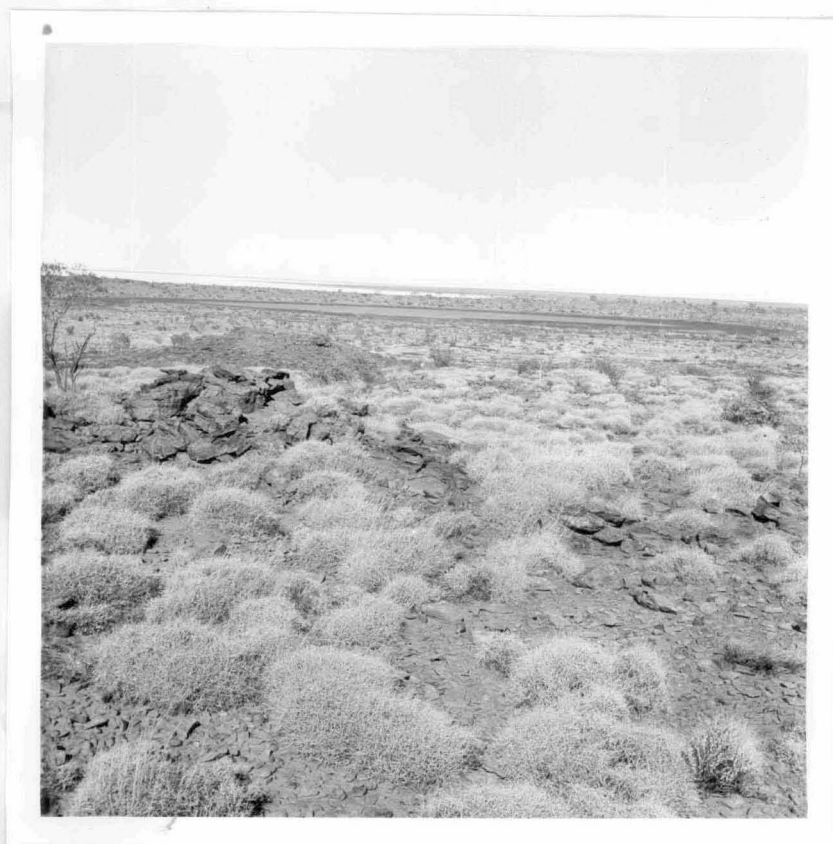
Looking south from the north east end of Lake Dora. Permian wood-bearing sandstone in the foreground; "emergency landing ground" claypan in middle distance, separated by eight sand dunes from the white salt lake in the background.

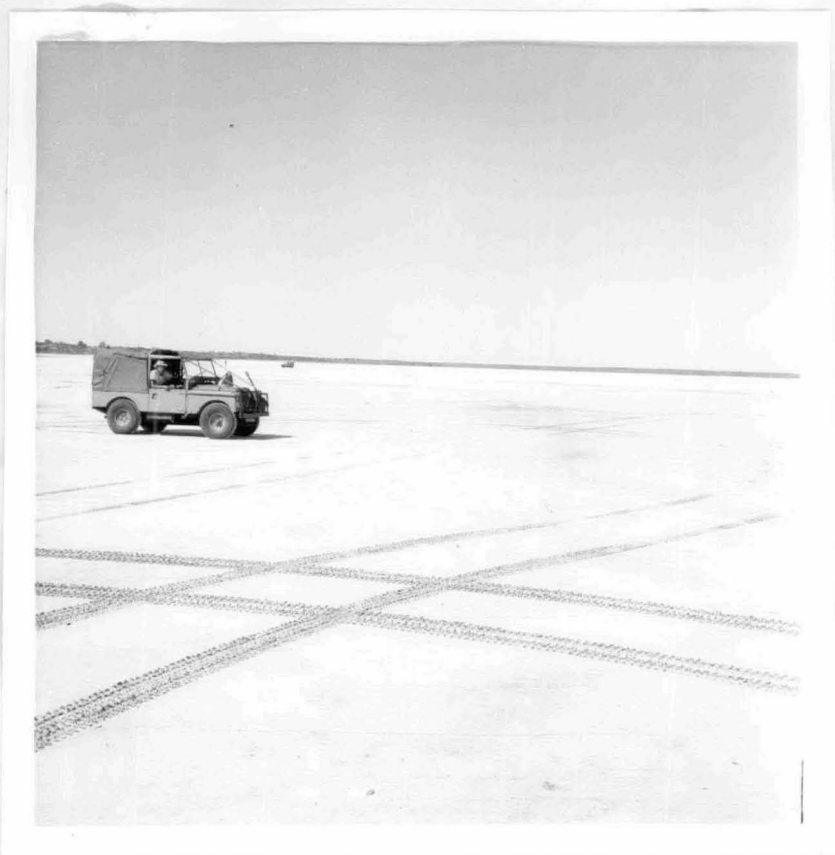
Lake Dora, showing the thin  $\frac{1}{8}$ " layer of salt on the surface, overlying 2 ft. of black mud containing Permian foraminifera. Once the surface is broken a vehicle will sink.

Most of the lakes such as Lake Dora, Lake Blanche, Lake Auld, and Lake Woolloomber are salt pans, and although they contain no water on the surface, they are too soft for a vehicle except in places round the extreme edge. The area around the lakes provides the worst travelling conditions; the sand dunes are small and not defined, the sand is generally in hummocks and in many places recent travertine makes travelling very difficult. Daily milages through this type of country were as low as 20 miles; the best route here is around the extreme edge of the salt pan, but even then caution must be taken when rounding the ends of sand dunes that encroach onto the salt surface, because drainage from the dunes makes the salt pan very boggy. Where the edges of the salt pan are straight the travelling is relatively good, but where the edges are indented by encroaching sand dunes the extra milage and the concentrated drainage make conditions very bad. In other words, the west side of Lake Woolloomber and Lake Dora-Lake Blanche system is comparatively good travelling over fine, dry, unconsolidated, samphire covered, light coloured "caliche".

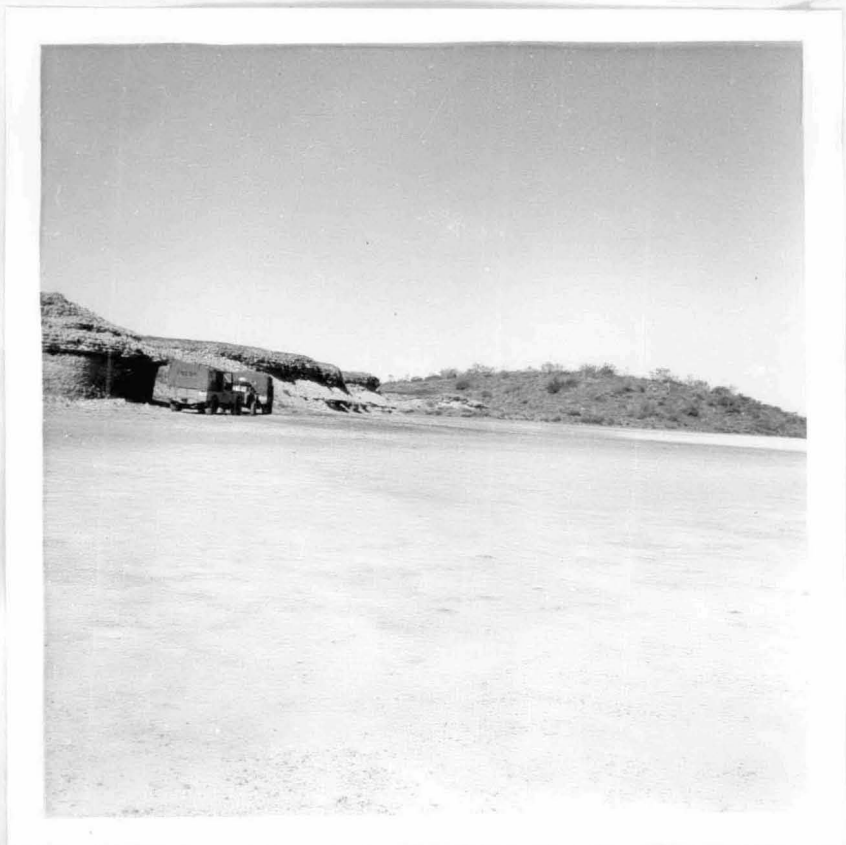
North-eastern edge of Lake Dora, with Permian shales outcropping on the margin; end of a sand dune on the right side of the photo.

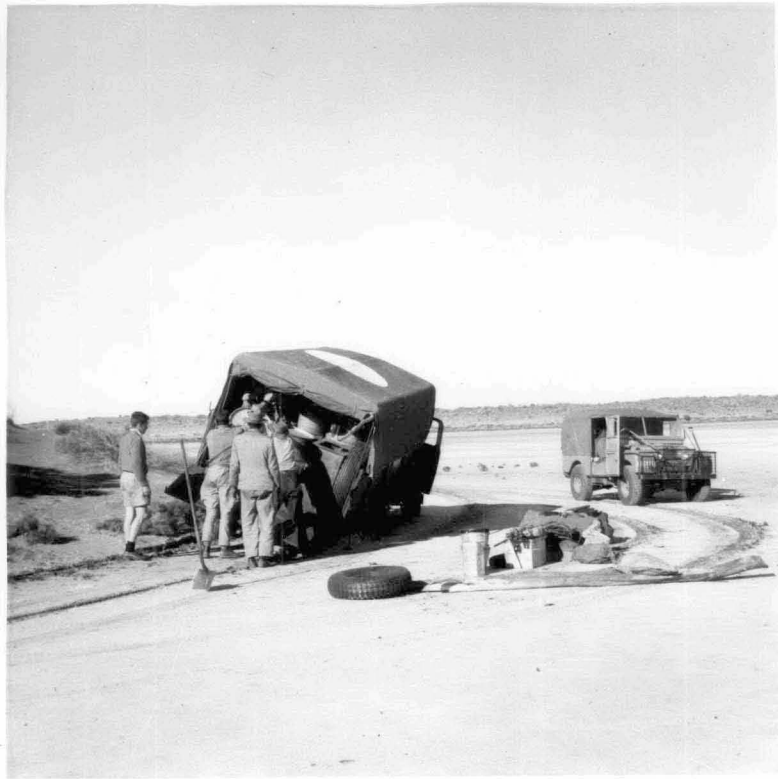
The Commer truck broke through the surface salt crust on a small lake NW of Lake Dora. It is particularly treacherous at the point of a dune (shown on the left of the photo) where seepage adds to the softness of the salt crust.

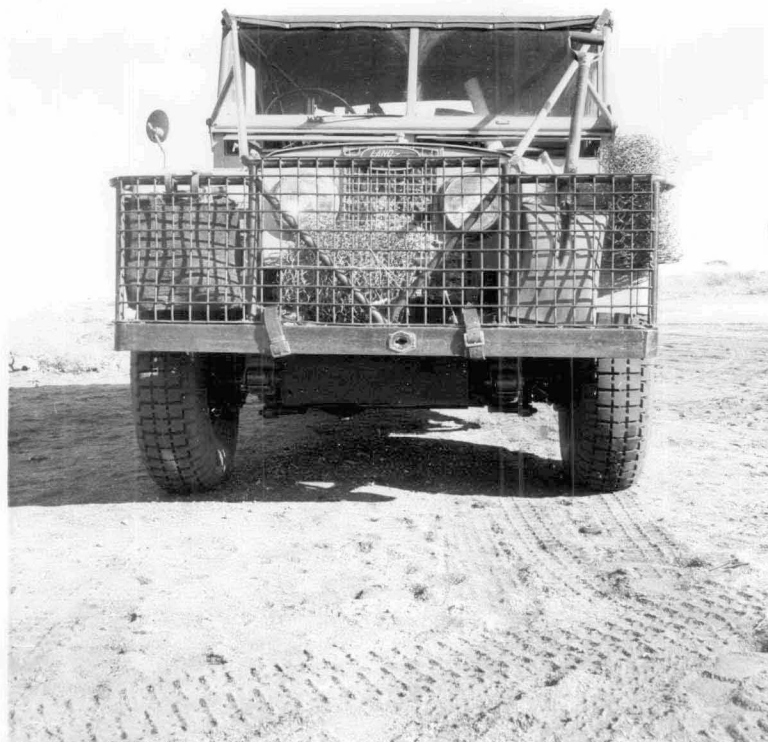
Front of the modified landrover; tyres are sand type 900 x 13; front coarse mesh with scrub deflectors continuing to the hood; steel plate between the springs to protect the steering linkages; spare spring strapped across the front. The rolls of wire were never used.

6. The Landrover trailer coupling was replaced by a jeep type coupling.
7. The tyres were sand track type 9.00 x 13, low pressure and were found suitable for normal sand and rock work. Tyre

4. Heavy type two-way shock absorbers. The standard shock absorbers lasted only one or two days before they became inefficient.
5. Heavier front springs. Five main front leaves were broken during the survey but no back springs were broken, although a heavily laden trailer was attached to one Landrover most of the time. Most of the front leaves broke at the forward anchor pin, probably because of the backward thrust on encountering numerous spinifex clumps.
