Port Refuge Unidentified (Cocos Keeling Islands) Inspection Report

M. McCarthy

Site Name: The Port Refuge unidentified wreck.

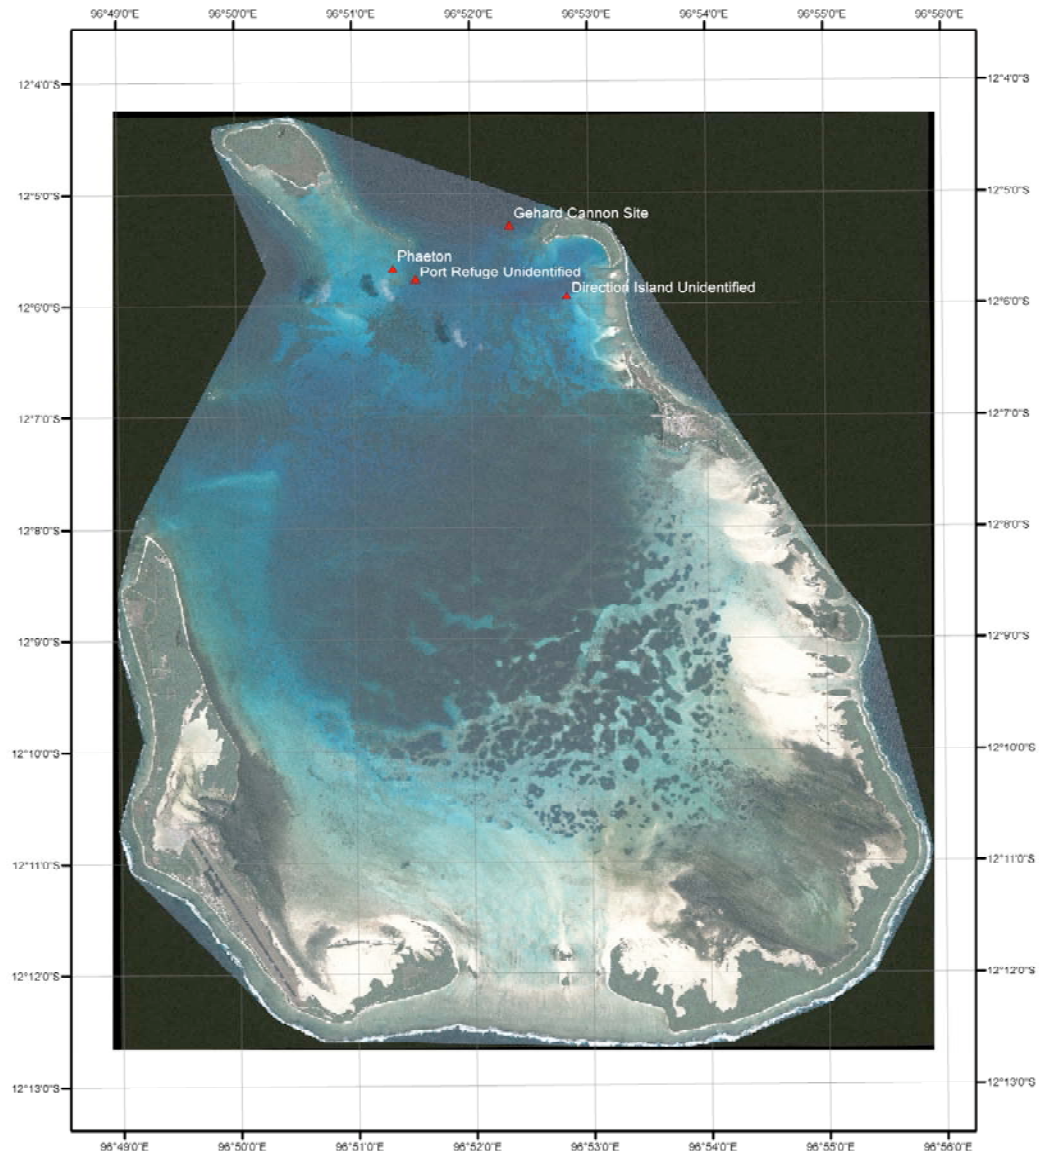
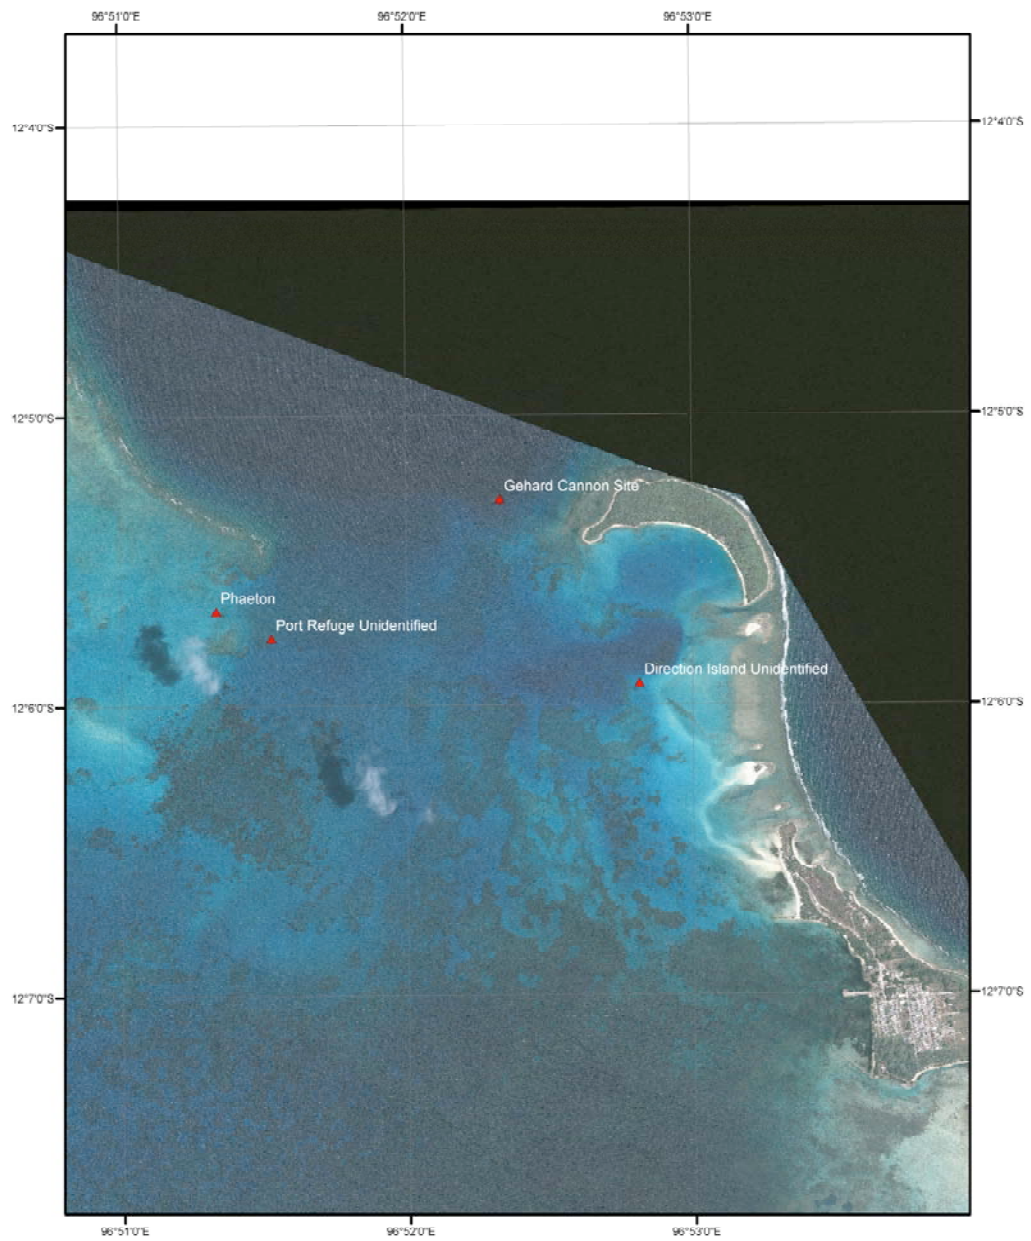
Satellite photograph showing access to Site

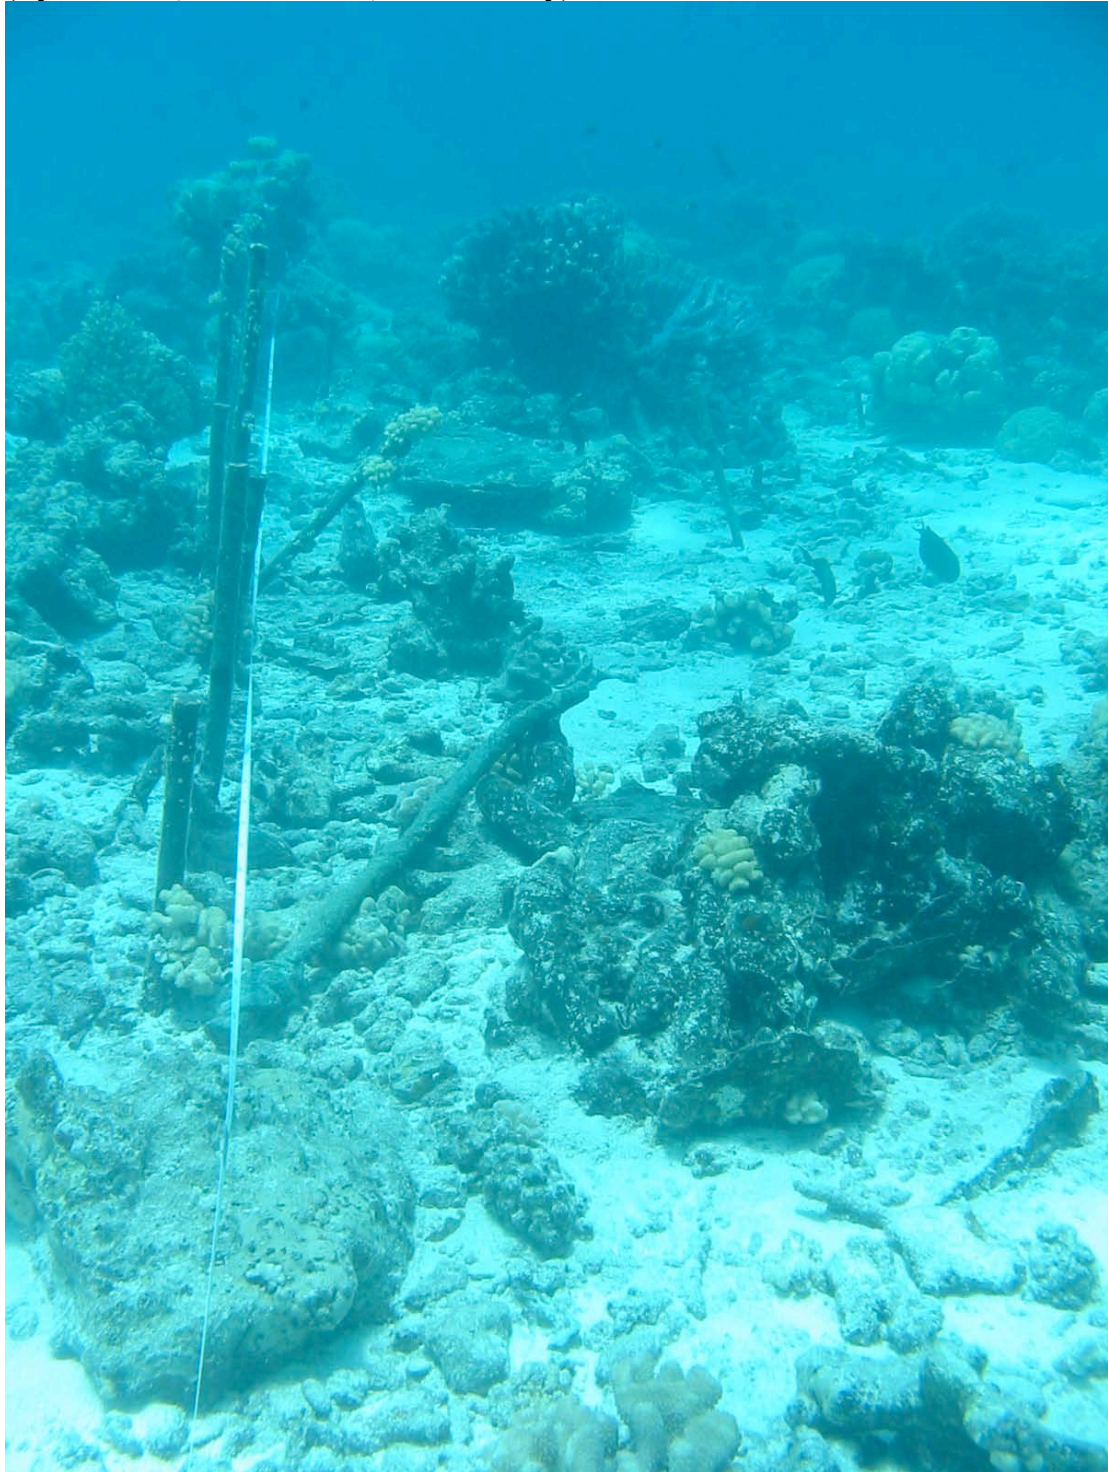
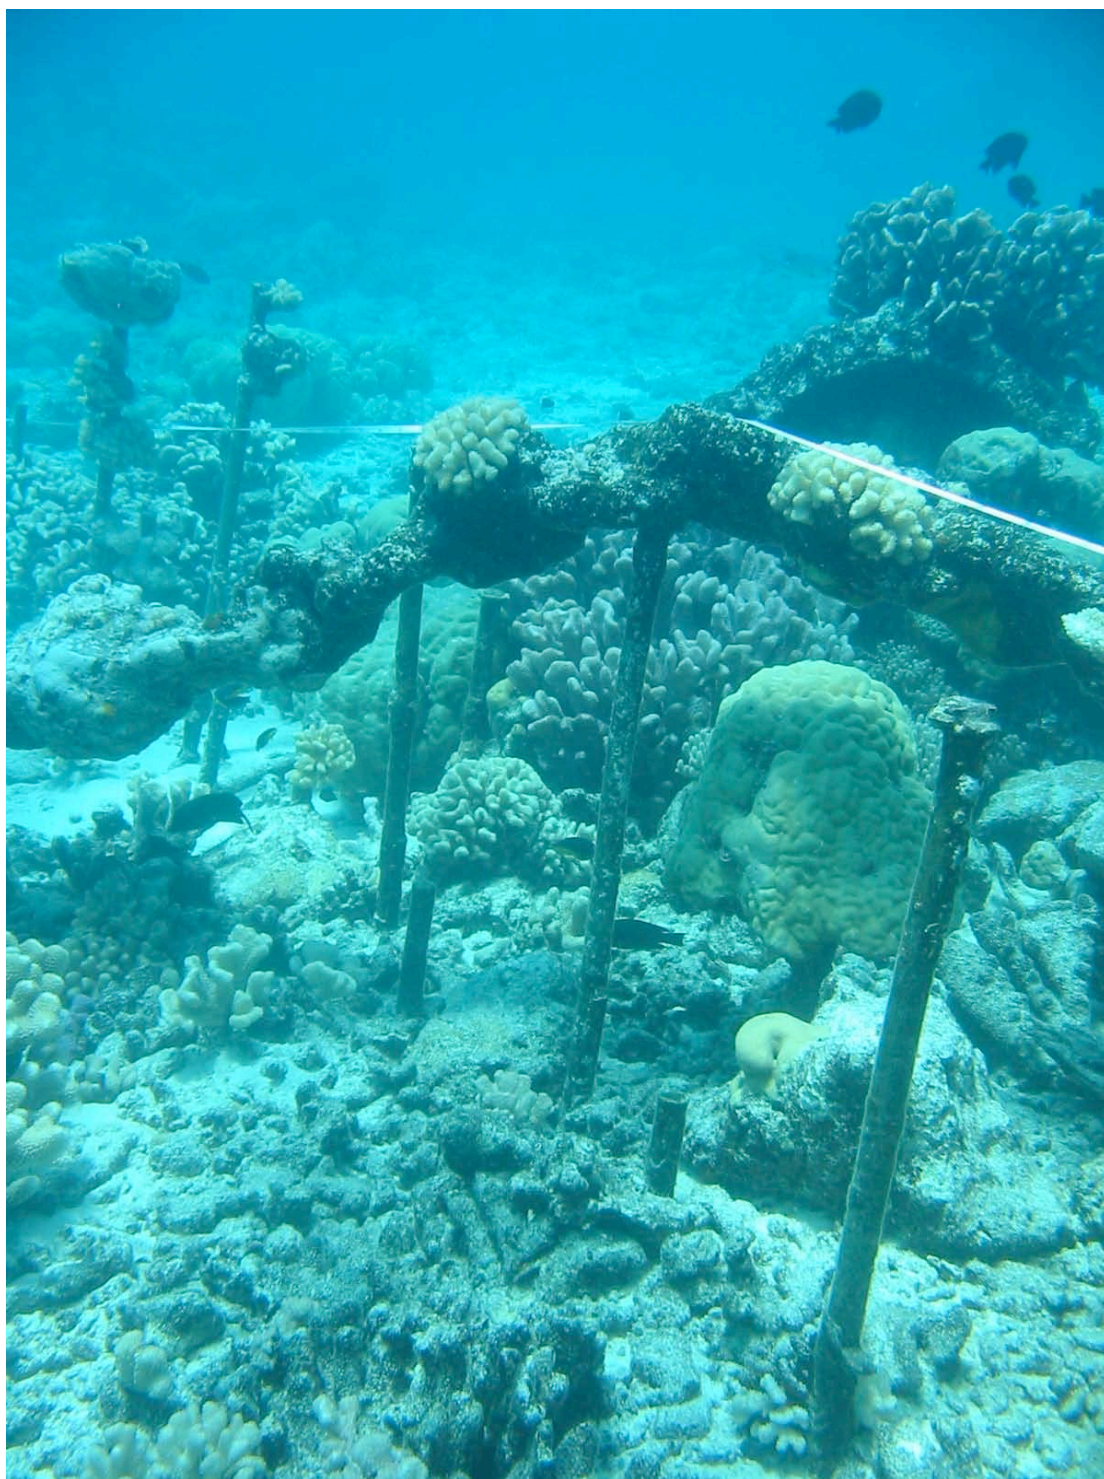
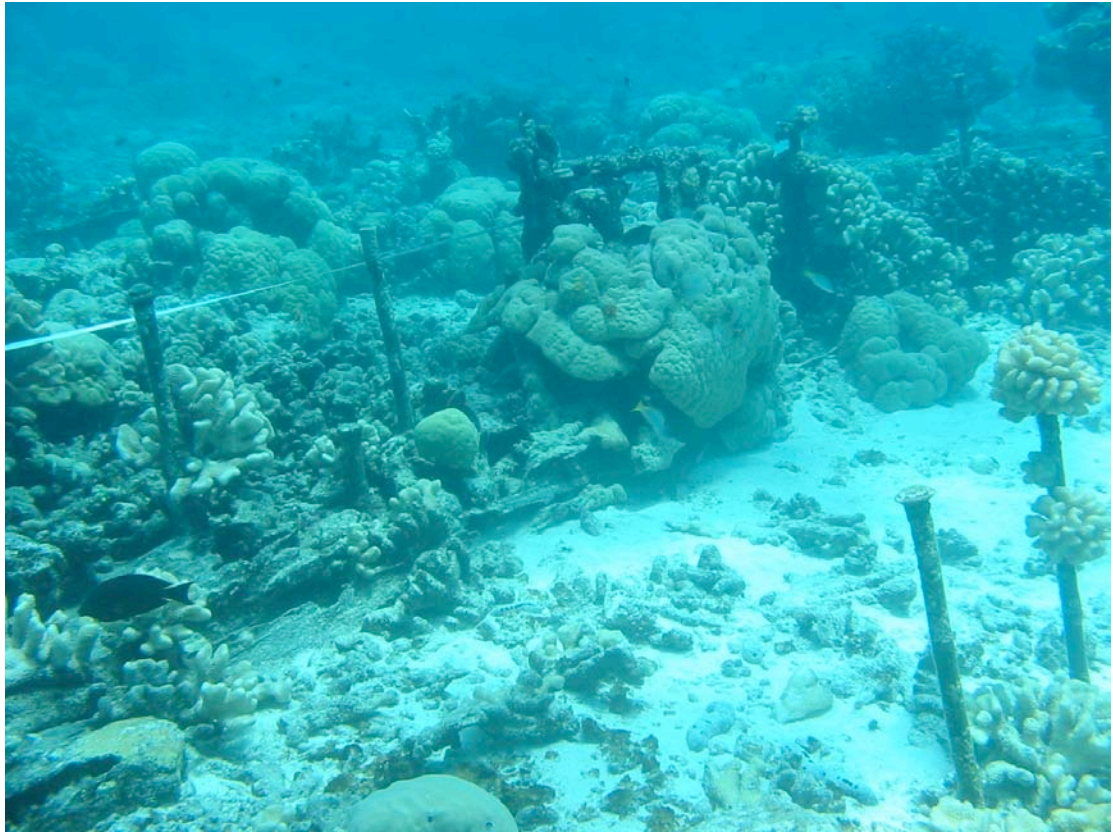
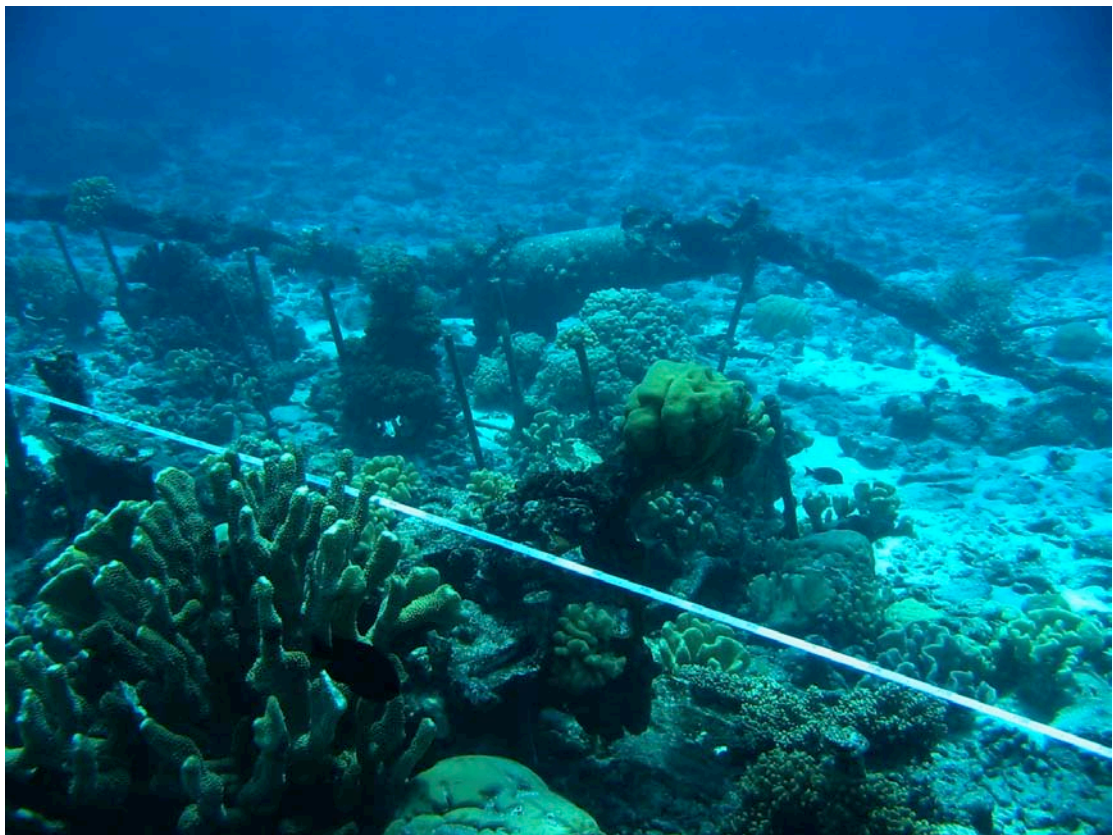
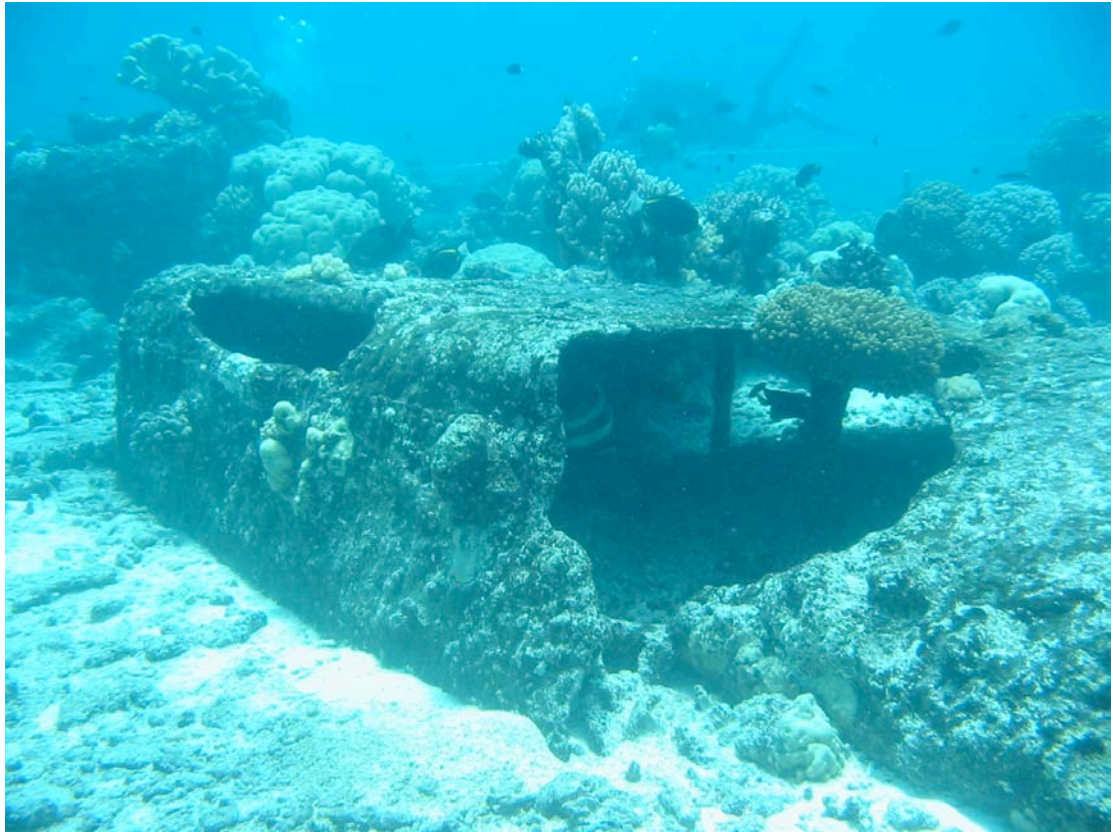
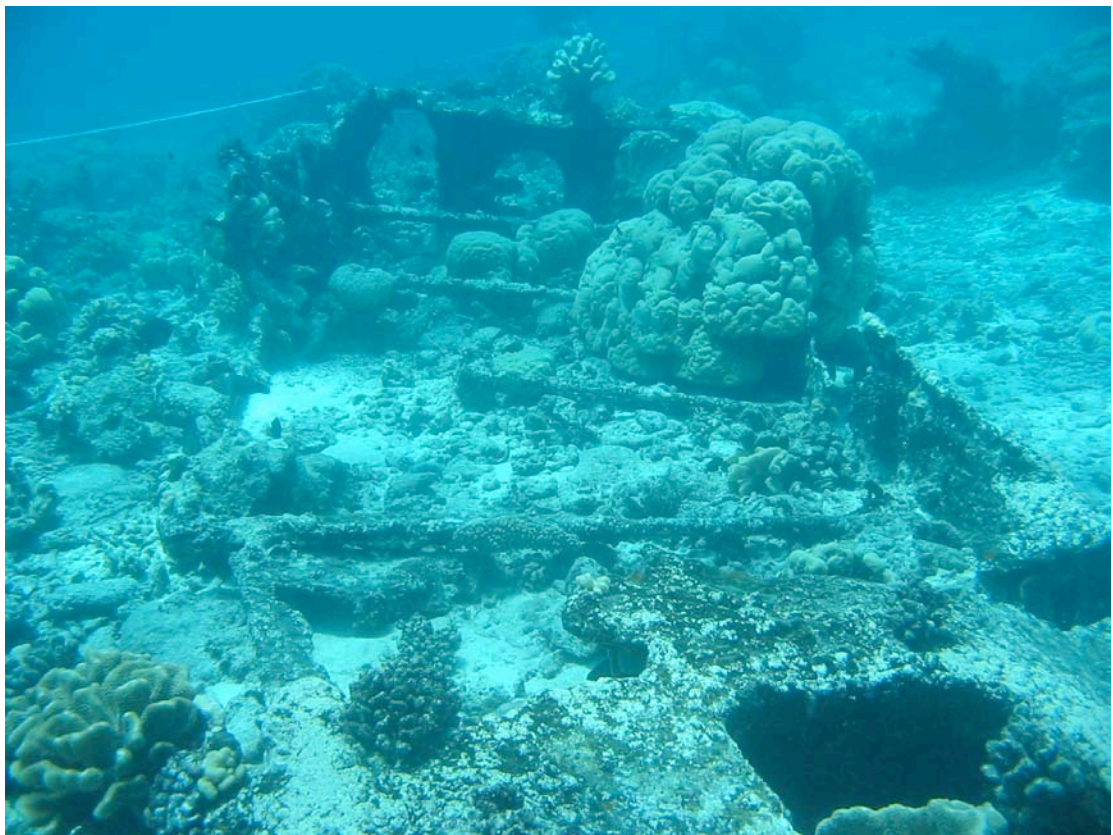
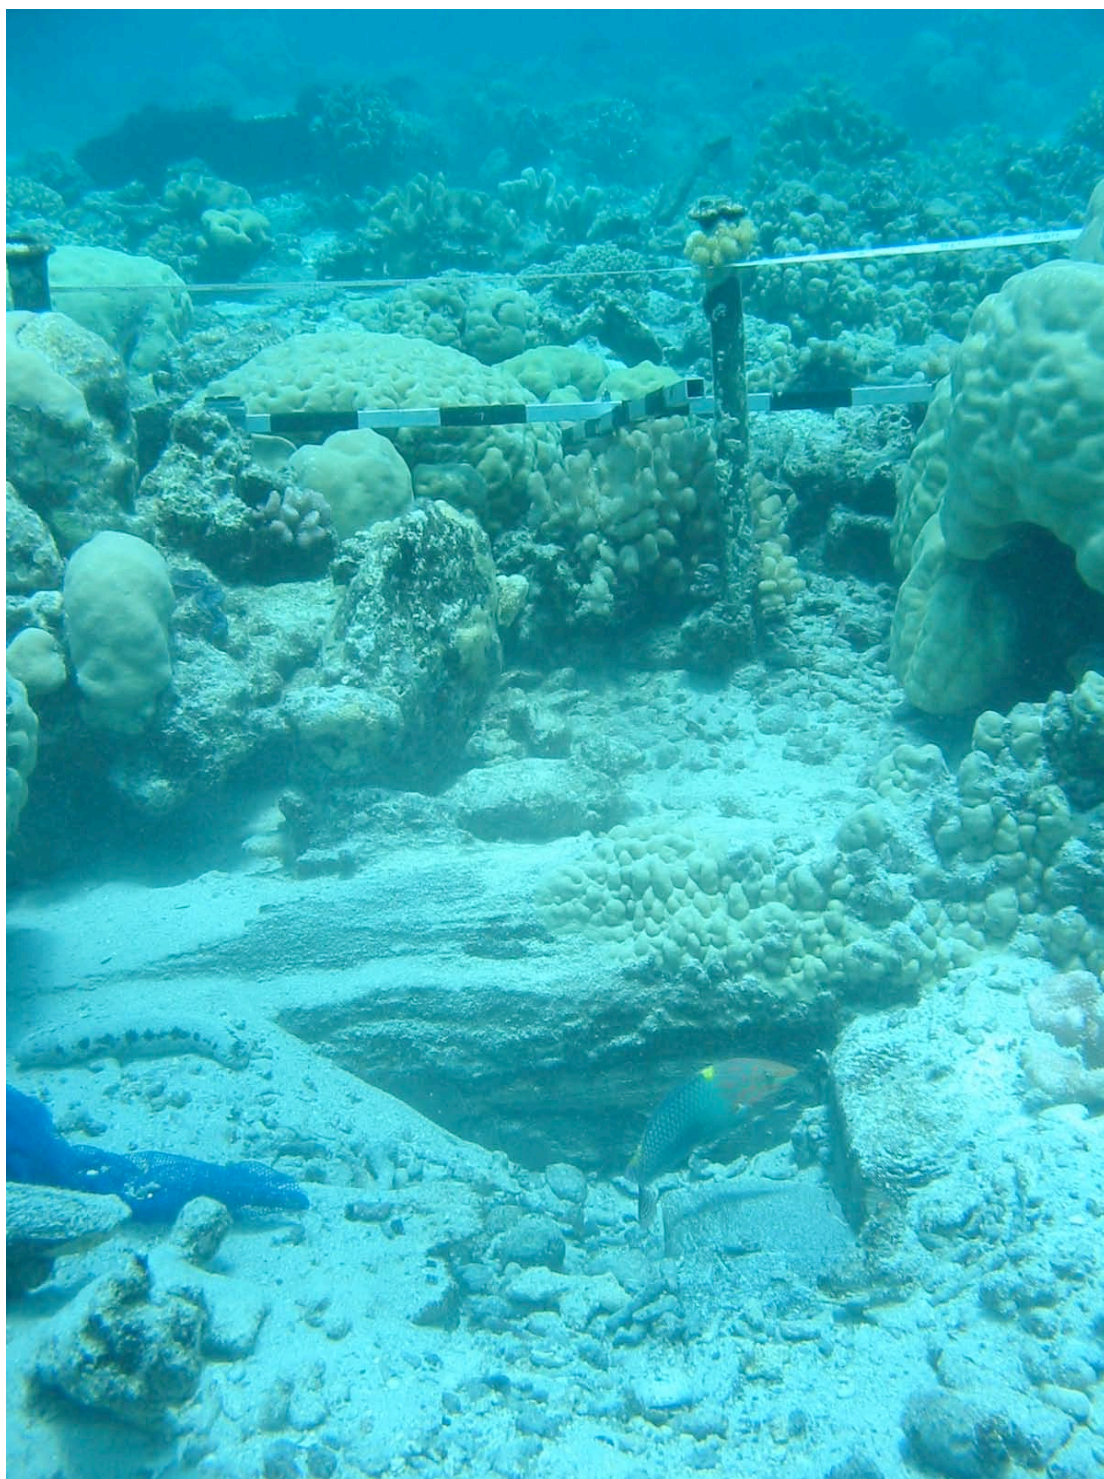
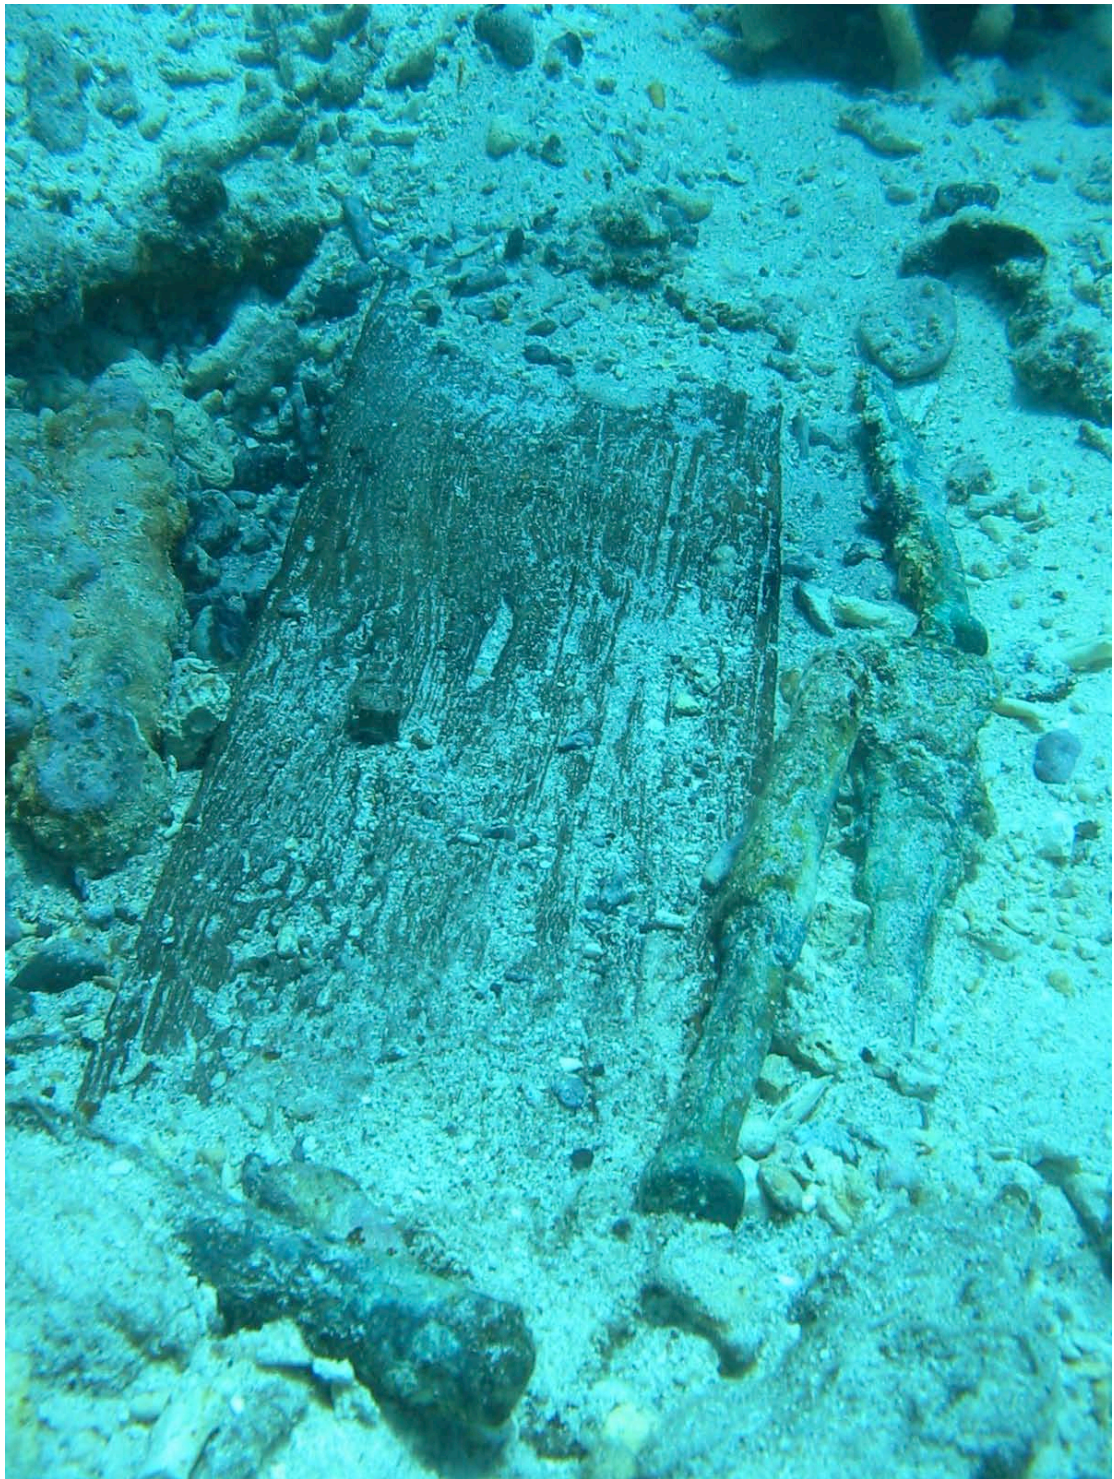
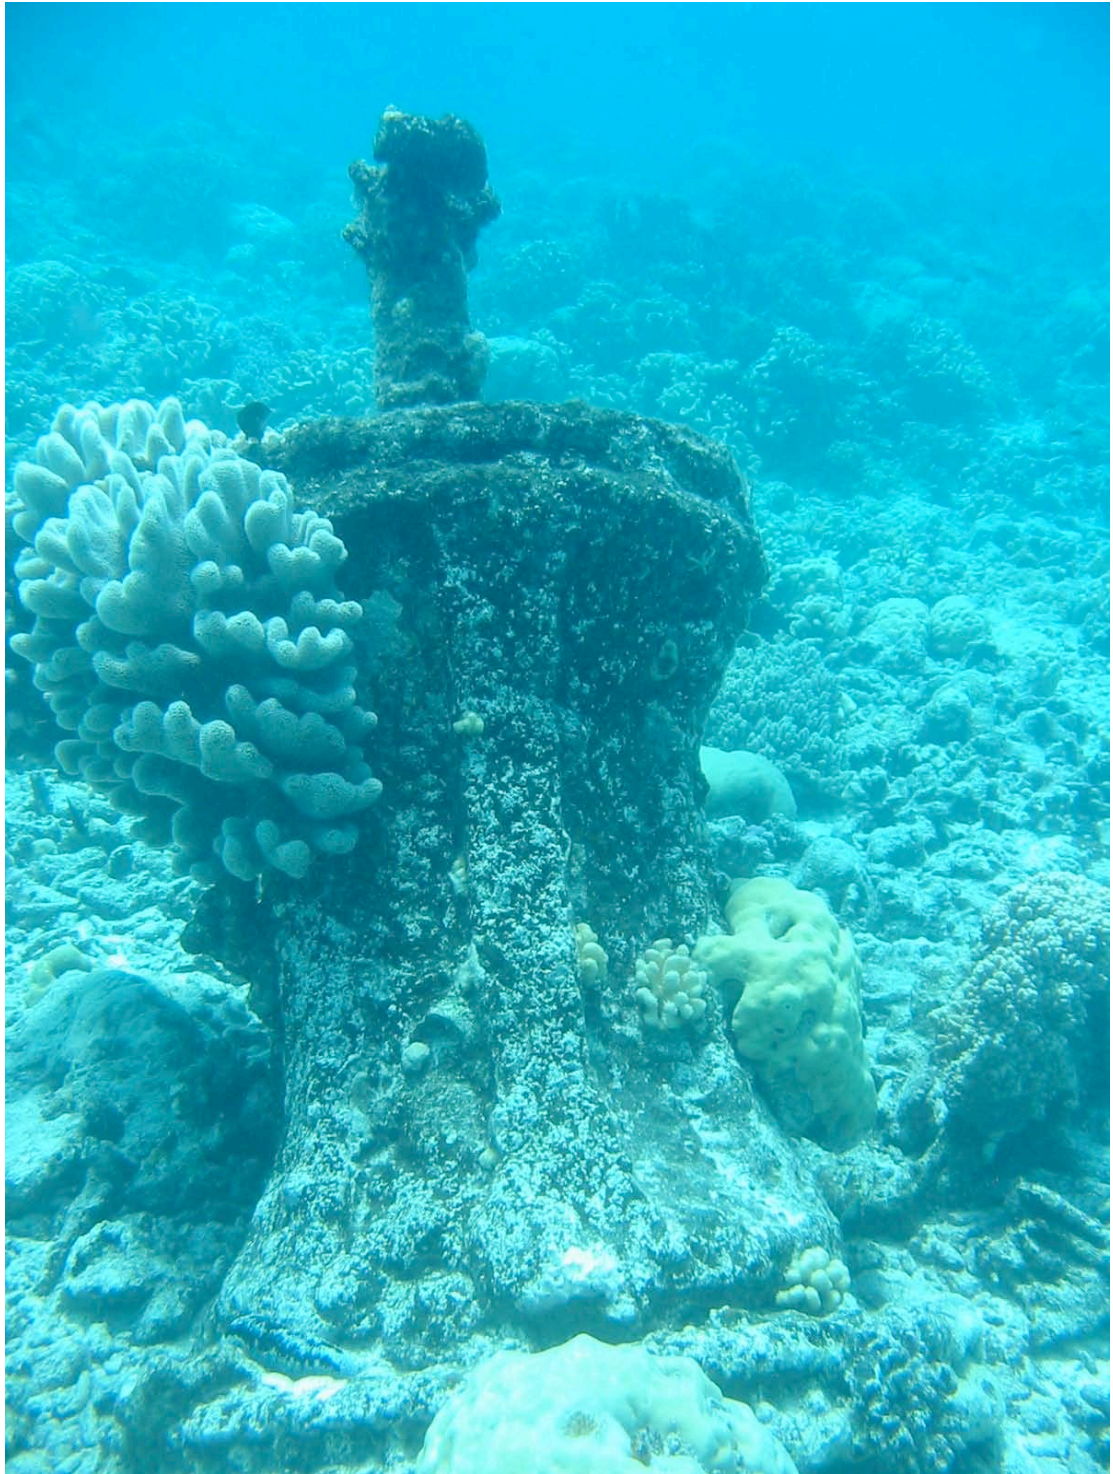
Views of the site

(By R. Thorn, G. Henderson, M. McCarthy)

Measuring 46 m long, this 'pristine', wreck lies in c.4m of water, almost upright on a sand bottom amongst coral outcrops and on an axis of 060/240°M. Crumpled sheathing is visible at the bow, which lies towards the southern end of the site. Where it is not buried, the wooden hull of this wreck has entirely disintegrated, leaving only metal work and other non-organic materials visible above the seafloor. Loose copper-alloy fastenings (mainly bolts) lie around the site and a row of nearly-vertical copper alloy keelson bolts is visible atop the degraded remains of the keelson. These are the most distinctive feature of the site and they led to its first being called the '*Peg [fastening] Wreck*', by Parks Australia staff. These bolts stretch along the length of the site and below them lie the keel, which is visible when the sand is cleared away by hand fanning.

At the forward end of the site (0m) and 11m to starboard of the line of bolts at the bow lie the remains of a heavily-degraded iron tank. Directly opposite on the other side of the bow, 12m to port, lies a capstan. A further 3m on again (at the very SE extremity of the site) lies one barrel of a windlass that has broken in two to finish with its bare axle projecting at an angle upwards towards the surface. The other half of the axle and what appears to be one of the pawl rims lies closer to the site. The other barrel is located quite some distance away, closer to the line of keel bolts and 4m aft of the bow. It has a very heavy chain comprising c. 10 inch 'D' links tightly wound around its whelps.

Many large copper-alloy bolts (often termed 'drift bolts' to differentiate them from equally large through bolts) lie loose on the seabed throughout the site.¹ Some of these were 42 inches (1.46m) in length by 1 and a quarter inches (c.30mm) in diameter. In the stern area on the port side copper alloy 'through bolts' measuring 30 inches (c 86cm) by 1 and a sixteenth inch diameter are also visible. Two lines of smaller bolts are visible 1.5m apart, and 1.5 m from the keel midships on the starboard side between the 24-30m mark aft. A single line of bolts is visible on the port side, a similar distance from the keel and between the 15 and 21m mark.
