ENGINEERING GEOLOGY OF THE PROPOSED CANBERRA LAKE

L. C. Noakes and D. E. Gardner

RECORDS 1958/75

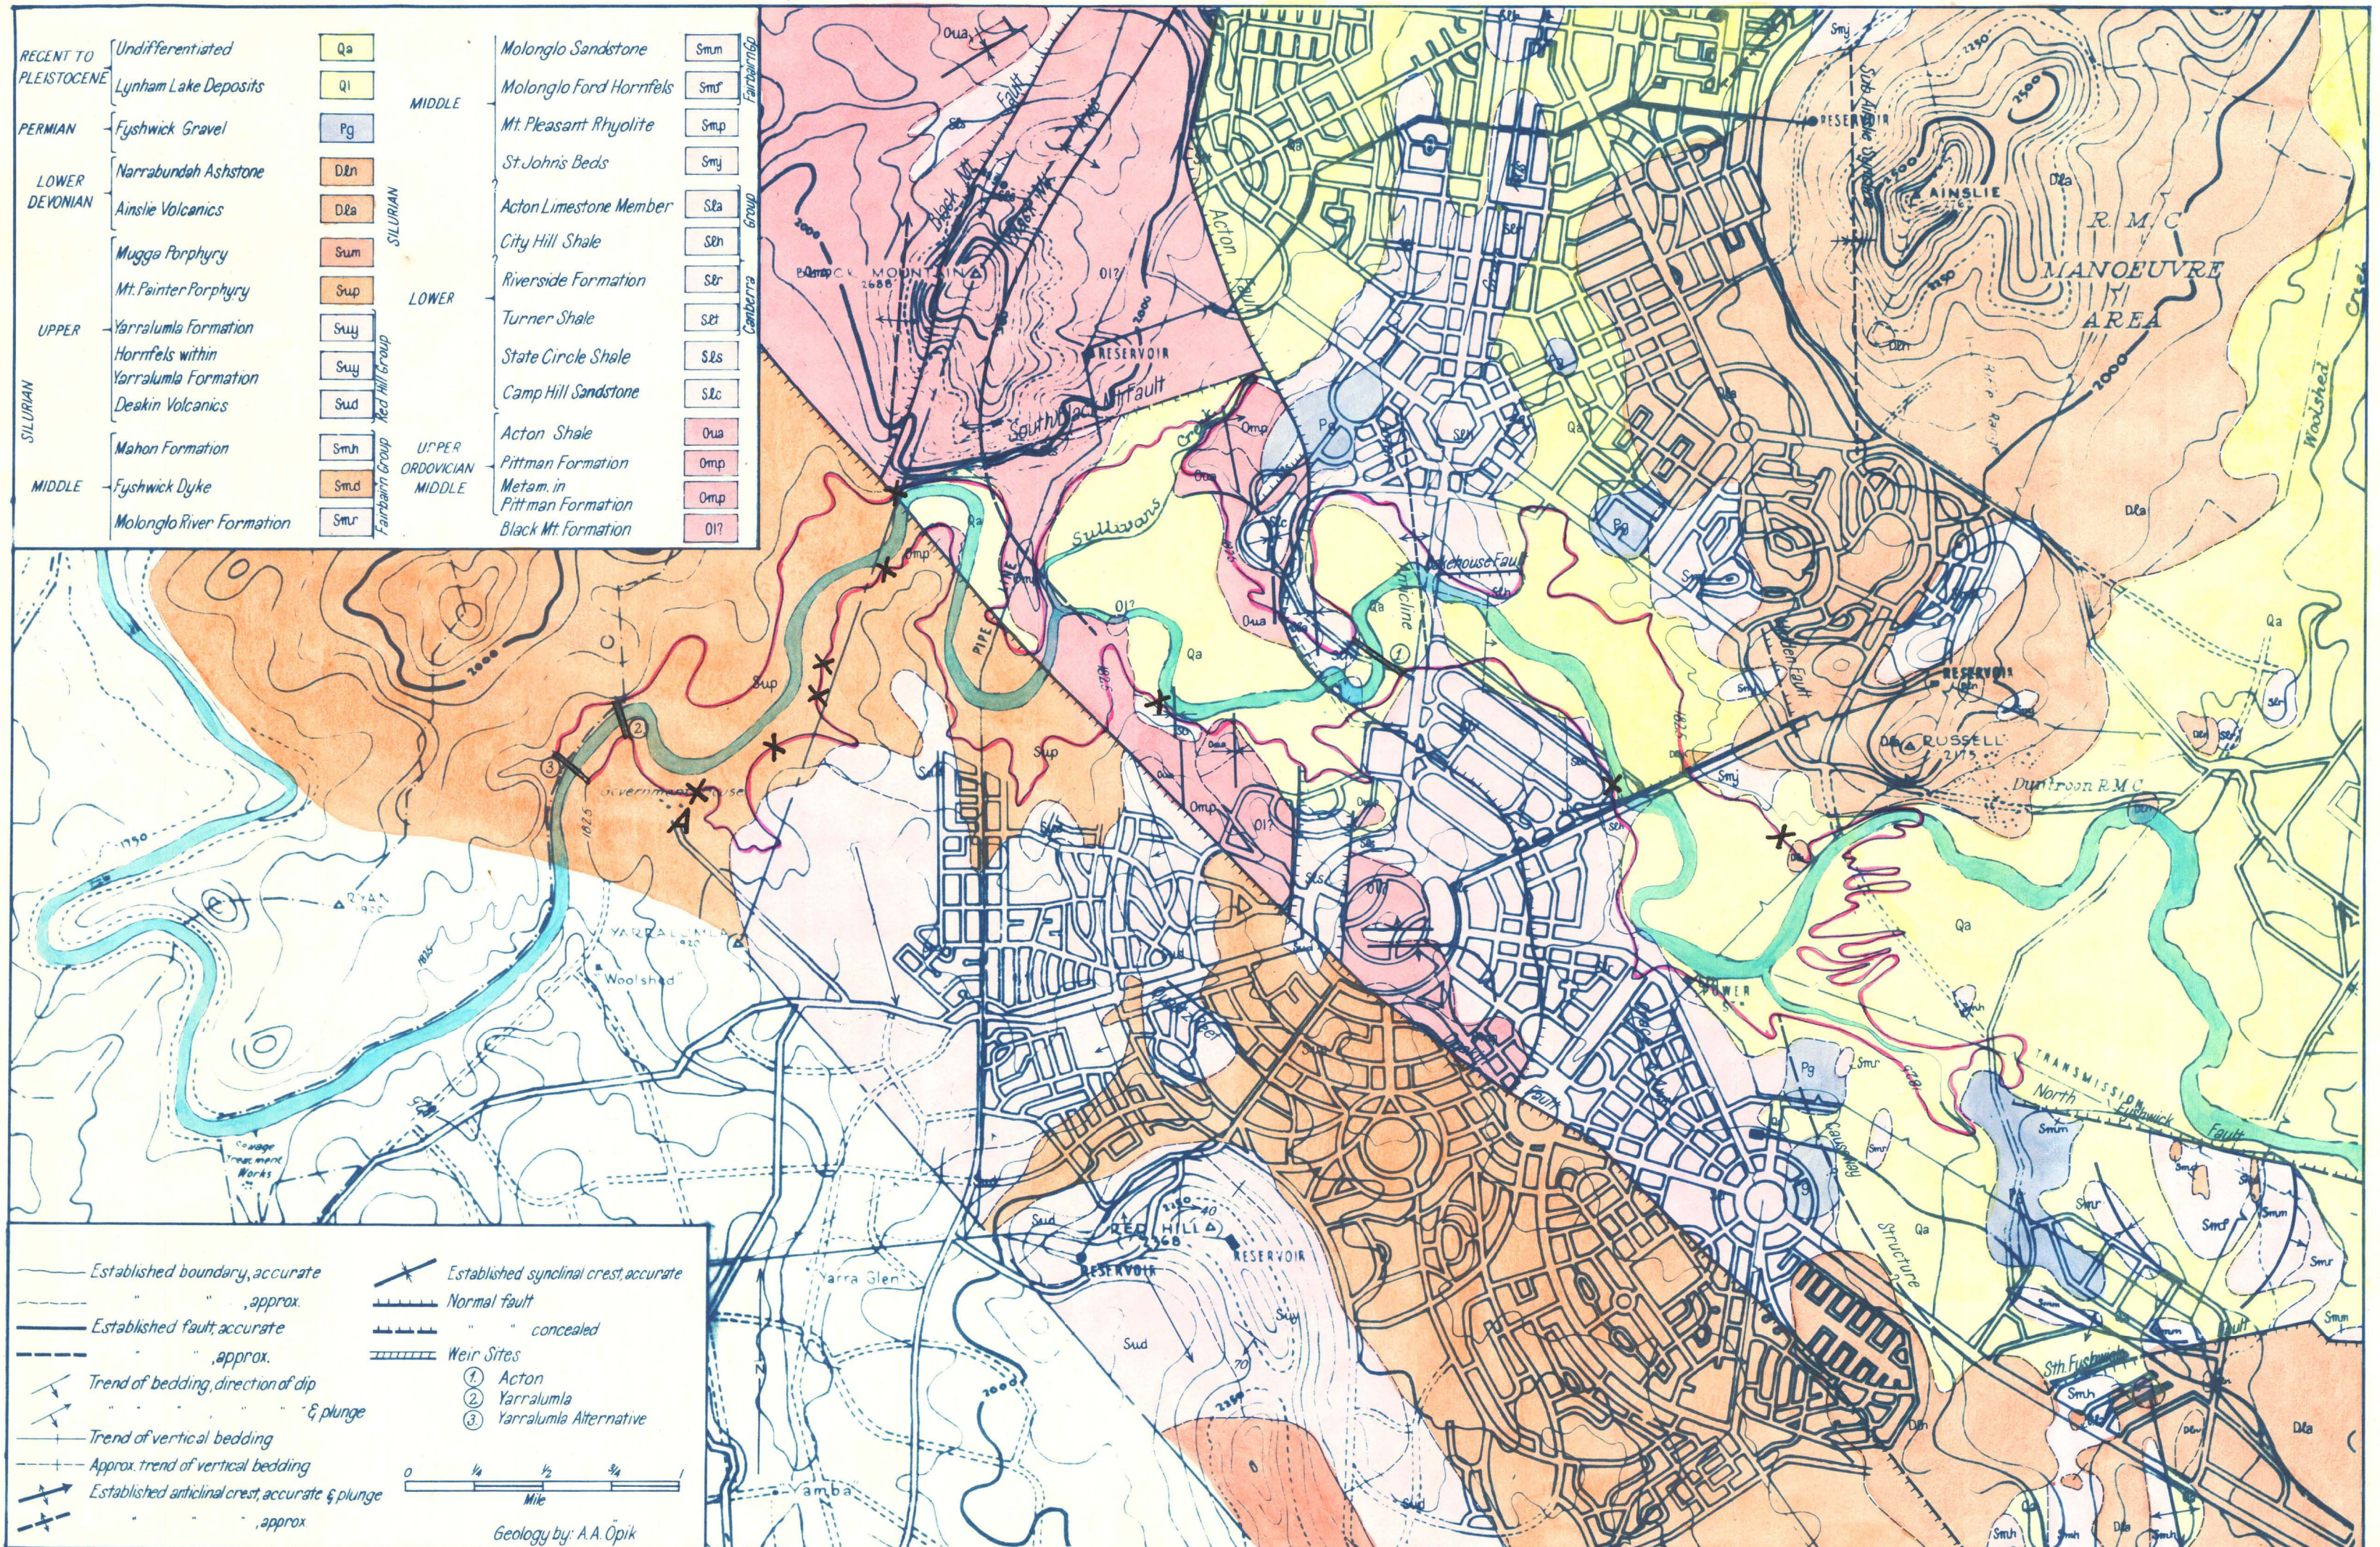
# GEOLOGICAL MAP CANBERRA CITY

The basis of the work is the detailed geological and structural map of Canberra produced by A.A. Opik, 1953; this covers the whole of the basin and is reproduced on a scale of half a mile to one inch, with pertinent contours, as Plate 1 of this report. The writers have examined the margins of the proposed lake in the field. Although the site for the weir to impound the lake has not yet been determined, the maximum storage level has been fixed at the 1825 contour for all three weir sites, so that the examination of the storage related to the proposed weir site at Yarralumla which is farthest downstream covers the maximum area of lake. Over much of the storage, the 1825 contour has been marked by concrete or wooden survey pegs. The assistance of the survey section, Department of Interior, in determining the position of this contour in critical unmarked sections was greatly appreciated.

Superficial deposits could only provide channels for leakage from the storage where porous beds occupy a saddle or a ridge on the perimeter of the basin and extend below the storage level of 1825'. Examination of the storage indicates that, apart from the weir sites themselves, there is only one locality, a saddle near the entrance to Government House grounds, where alluvial terrace deposits may extend below the level of 1825' and could lead water out of the storage. This locality marked "A" on Plate 1 is under consideration.

There are however, a number of places around the lake shore where very minor slips could occur in gravel and sand; these are indicated by a cross on Plate I. These are only possible slips and do not appear of sufficient importance to warrant any stabilisation before the lake fills.
